A FIELD STUDY OF THE PERFORMANCE OF POLYMER-MODIFIED BITUMEN ROOFING

WALTER J. ROSSITER JR.

RANDY D. DENCHFIELD

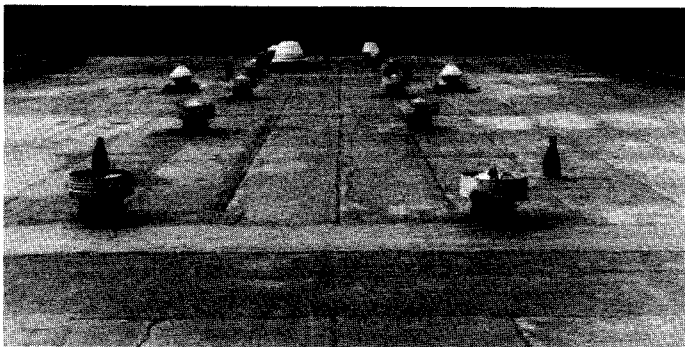
Considering the limitations mentioned above, the overall performance of these relatively young roofs was considered to be satisfactory (Figure 2); that is, 70 percent were assigned a rating of either 4 or 3. This was not unexpected and consistent with previous comments on performance by members of the CIB/RILEM Committees and others cited previously.^{8,9,12}

Figure 2 Example of a roof that was providing satisfactory performance.

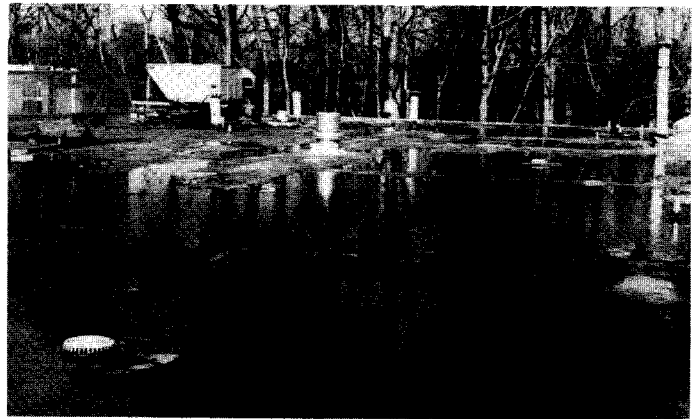
Ponding—For the majority of the roofs, sufficient slope was present and the roofs generally drained well. Nevertheless, slope was not always adequate over all sections of the roof. Over 50 percent of the roofs were noted as having some degree of ponding, including five roofs being described as extensively ponded (Figure 3). In these five cases, the modified bitumen had been applied in re-roofing applications with opportunity to install slope or drains.

Figure 3 Example of a roof that had extensive ponding.

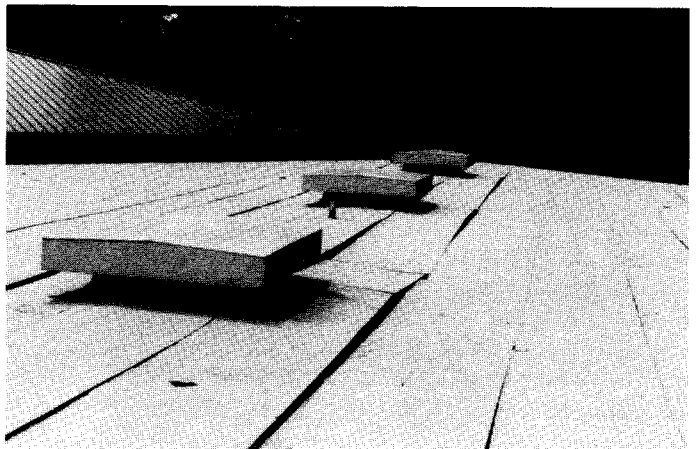
Slippage—Slippage, whereby one or more plies of a bituminous membrane slide down a slope often exposing a base ply or substrate, was observed on seven roofs. All roofs had SBS membranes with base plies installed using conventional roofing asphalt, and were located in the warm climates of Dallas and Jacksonville. The membrane ply sheets

were applied parallel to the slope, which was about 40 mm/m ($\frac{1}{2}$ in./ft.) for the roofs in question. The extent of the problem was, in some cases, limited to small highly sloped sections of a roof; whereas, in other cases, it occurred over large sections of the field of the roof (Figure 4). In no case had slippage occurred to the extent that the roofs were reported to be leaking through the membrane.

Figure 4 Slippage of an SBS membrane in the field of the roof.

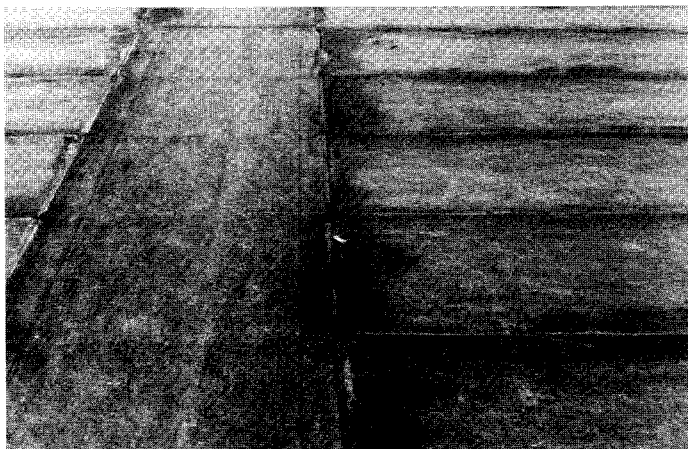
APP Membranes—The majority of the APP roofs were unsurfaced (Table 2). Many of these appeared to be in satisfactory condition (Figure 5) without any visible signs of cracking or other major surface defects. The oldest age of these roofs was about 11 years. In some cases a superficial surface craze was noticeable on some sheets, and one membrane surface had a few pockmarks. In the case of a specific membrane product that had a fiber glass reinforcement close to its top surface, some glass fibers were exposed (fiberglass bloom) due to erosion of the asphaltic surface of the membrane material. The bloom imparted a silvery-gray sheen to the surfaces. No evidence was obtained that the bloom was detrimental to the functionality of the roofs, as it appeared to be limited to the surface. The oldest of the roofs with fiberglass bloom was 11 years.

Figure 5 An example of an unsurfaced APP membrane showing a surface in satisfactory condition.

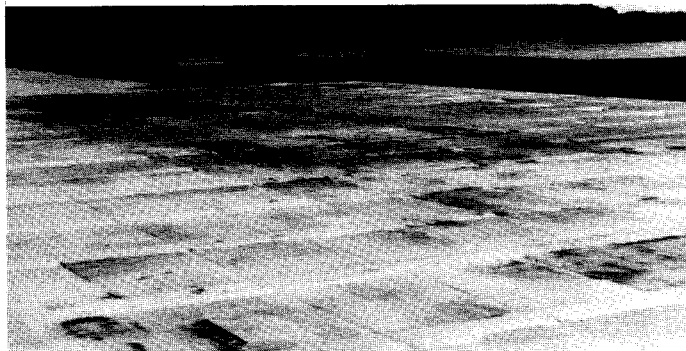
Eight of the APP membranes were coated with aluminized coatings with ages ranging from six to 120 months. Figure 7 illustrates an aluminized coating that was 96 months old. In all cases, the coatings were considered acceptable without any alarming signs of flaking or peeling, even in areas of ponding. Normal weathering often resulted in uneven exposure of the modified-bitumen surfaces, as indicated by some sections of roofs showing the black of the membrane. For the roofs in question, the 120-month old coating was the most extensively weathered and in need of re-coating. The limited observations that the coatings inspected during the study exhibited no flaking in ponded areas of the roof were positive and in contrast with some past experiences of the authors where aluminized coatings in ponds had flaked.

Figure 7 A 96-month old aluminized coating; the darker sections are due more to dirt collection in ponds than coating erosion.

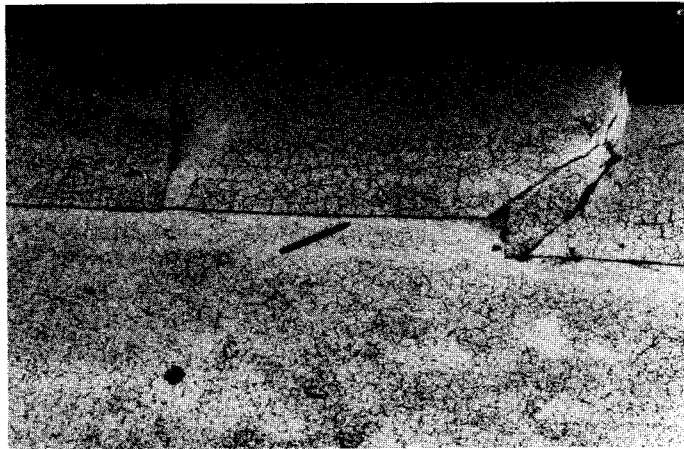
In addition to granule loss, cracking of granule surfaces was observed on a couple of roofs, but generally limited to a few sheets (Figure 8). Also, the inspections included two roofs where a few sheets of the membrane material developed small blisters (or bubbles) in the granule surfacings. These blisters resembled those that develop at times in the granule surfaces of asphalt shingles. At one location, the defect had been extensive enough that sheets with blisters had been overlaid with additional membrane material. The isolated instances of granule loss, cracking, and blisters raised questions as to their causes and steps that may be taken to minimize the risk of future occurrences. The availability of criteria to evaluate the ability of products to resist such defects would help assure that only SBS membrane materials having acceptable surface protection are installed.

Figure 8 Cracking of a granule-surfaced SBS membrane material including the base flashing.

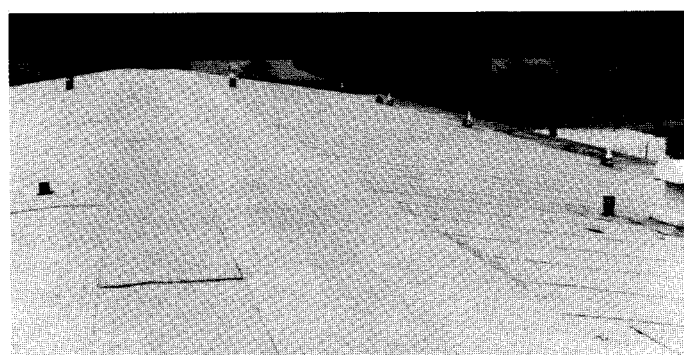
Figure 9 Laps of a SBS membrane illustrative of many observed in the study; both the end and side laps were tight.

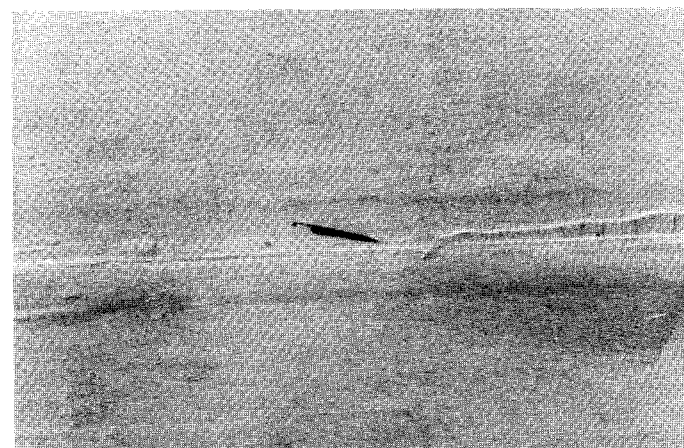
It was also observed that many of the roofs had laps without "bleed-out." This is an industry term applied to the relatively narrow ribbon of asphalt that flows away from the lap during its fabrication (Figure 10). It is taken by some, but not all, practitioners as an indication that adequate heat and/or asphalt was applied during membrane construction. However, caution must be exercised in interpreting the significance of bleed-out, because its presence does not necessarily indicate that proper fusion of the lap sheets has occurred. On the basis of the field observations, no evidence was obtained that the laps without bleed-out were performing differently than those with bleed-out.

Figure 10 Example of asphalt bleed-out at the edge of a lap of a coated APP membrane.

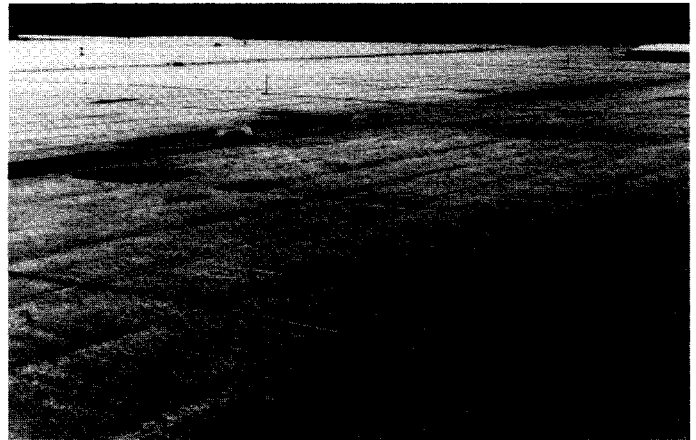
The exception to the generally positive findings on lap performance involved membranes constructed from a torch-applied APP product that had been, but is no longer, available from a particular manufacturer. Twelve of the 53 roofs included in the study had such membranes. For five of these 12 roofs, the visual evidence was that the laps were in satisfactory condition without signs of disbond or lap repair. The ages of these roofs ranged from 54 to 96 months. In contrast, six of these membranes, with ages ranging from 74 to 131 months when inspected, showed indications of serious lap problems at some point during their service. One of these roofs was found to have sections (a few millimeters to a half of meter in length) of laps that were unbonded (Figure 11), and a number of patches had been made. Note in Figure 11 that no unusual signs of distress such as pulling or rippling of the membrane were apparent where the blade is inserted in the section of open lap. Five of the other roofs had laps with a considerable number of patches, as exemplified in Figure 12. Generally the patches were located randomly across the membrane. However, the relatively large roof depicted in Figure 12 had the patches concentrated in relatively small areas, while other sections were patch-free.

Figure 12 Example of an APP membrane with repair patches made to the laps.
