FIELD PERFORMANCE RESEARCH OF APP MODIFIED BITUMEN ROOF MEMBRANES AND COATINGS

JAMES D. CARLSON and THOMAS L. SMITH

National Roofing Contractors Association
Rosemont, Ill.

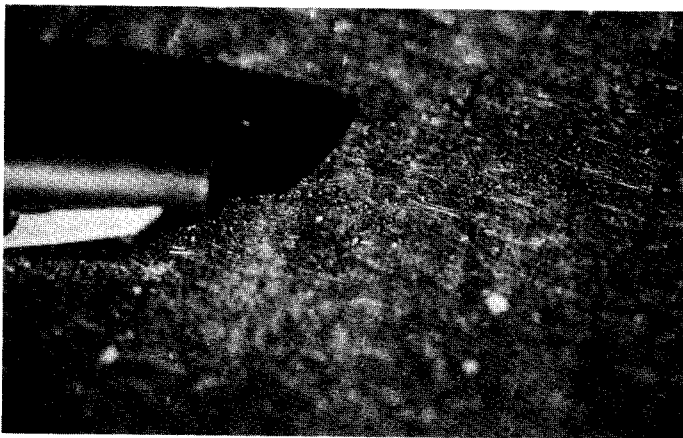
Figure 1 Twelve-year-old APP modified bitumen membrane near New Orleans shows very little weathering effect. A few grains of sand and dirt are on the membrane, and some reinforcement fibers can be seen on the surface. An ink pen shows the scale.

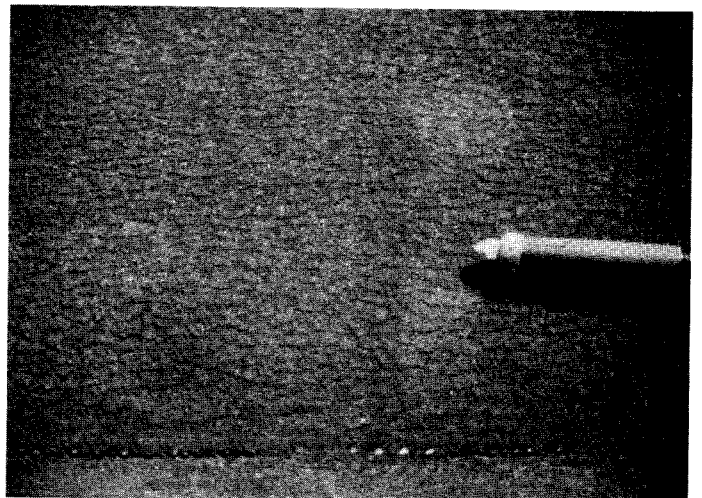
APP modified bitumen roofing has been used throughout the majority of the different climatic regions of the U.S. In some regions, this material has been used for more than a decade. The majority of these roofs have been left uncoated. Many roofs have exhibited limited signs of weathering (see Figure 1). However, numerous roofs have exhibited premature degradation (e.g., surface cracking) (see Figure 2).^{1,2}

Figure 2 Surface cracking on six-year-old APP modified bitumen membrane near Chicago. A lumber keel shows the scale.

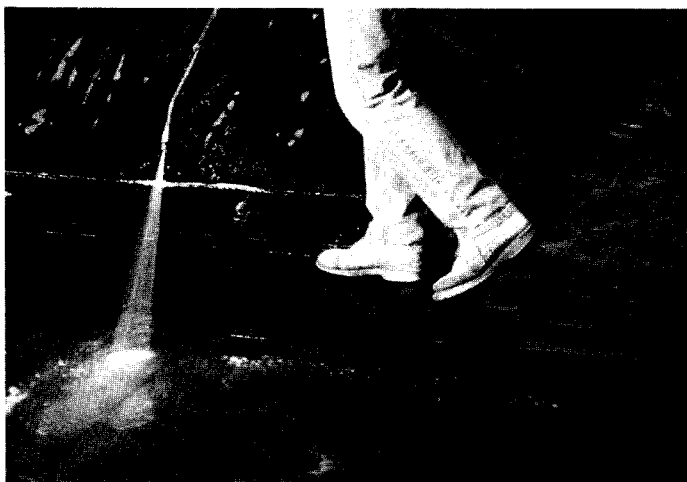
Since the RCMA/ARMA guide document references "water blast" as one option for cleaning, the membrane surfaces were washed with water from a "power washer" (see Figure 6). The washer did not have a gauge, but it is believed that it delivered approximately 600 to 800 psi (4.1 to 5.5 MPa). After squeegeeing small areas and allowing them to dry, the white cloth test was performed. Even after pressure washing, all seven membranes still failed the white cloth test. Therefore, a garden hose was used to wet the areas and they were scrubbed with a 24 inch (600mm) stiff bristle push broom (see Figure 7). After scrubbing, rinsing and being allowed to dry, all seven membranes passed the white cloth test. However, several footprints were on the membranes, as a result of walking through dirty water during preparation work.

Figure 6 Phase 2 cleaning with a power washer. This was found to be ineffective with the apparatus used on this project (see Figure 7).

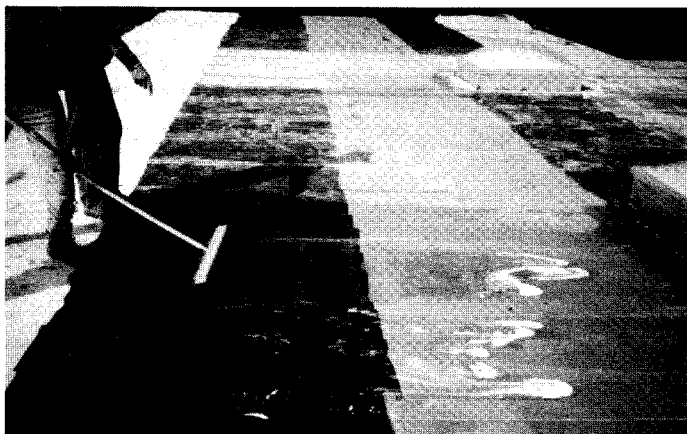
Figure 7 This area was rinsed with the power washer, but it failed to pass the white cloth test. A push broom was then used to scrub the membrane. Note the amount of dirt on the coating to the right, which the power washer did not remove from the exposed membrane.

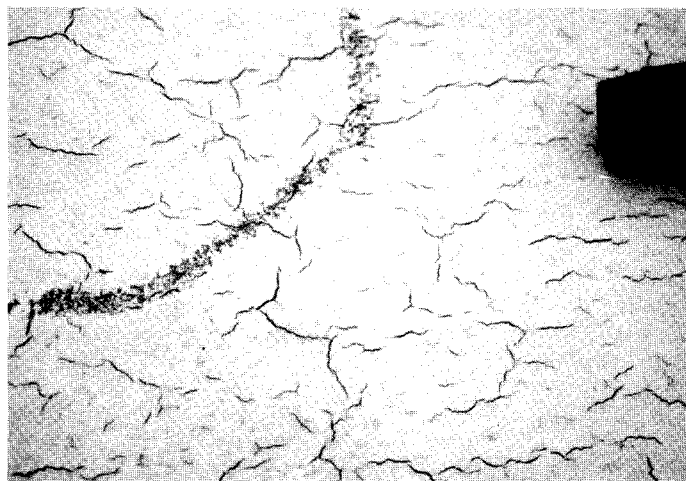
Latex "A": After approximately 10 months of weathering, extensive coating cracking occurred over APP membrane products #3, #4 and #5. Approximately one month later, smaller cracks were observed over product #6. After 17 months, coating "A" was severely cracked. A significant premature failure (i.e., peeling) of this coating appears eminent (see Figure 8).

6. Latex coating "A" will likely experience a significant premature peeling failure. The problem appears to be related to the coating material.
7. Coatings "B," "C" and "D" have exhibited signs of deterioration by weathering, but in general they are performing reasonably well.
8. Exposed products #1 through #5 have exhibited signs of deterioration by weathering, but in general they are per-

Figure 8 Severe cracking of latex "A" over APP product #3 (Nov. 24, 1992, after approximately 17 months of coating exposure). The problem appears to be related to the coating material. An ink pen shows the scale.

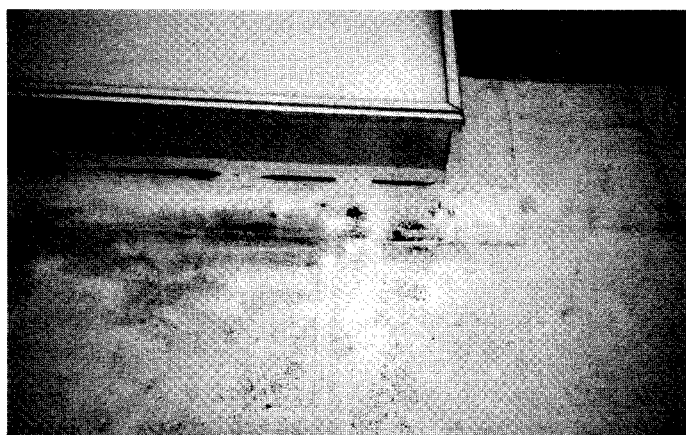
10. The latex manufacturer's recommendation to apply the coating in two applications appears to be valid. In the experimental area where coating "B" was applied in one application, coating peeling was experienced. Also, the "hiding" (coverage) capacity of the coating is greater when applied in two applications.
11. Reflective coatings reduce maximum membrane temperatures. Some coatings provide a significant reduction of peak temperatures. Reduction in membrane temperatures may also result in increased membrane service life (due to reduced heat aging), though the magnitude of the increased life (if any) will not be quantifiable for several more years.

Figure 9 Isolated peeling of latex "B" over APP product #1 (Nov. 24, 1992). This is the area where the coating was applied in one application. The affected area was approximately 4 feet x 4 feet (1,200mm x 1,200mm). See Figure 10.

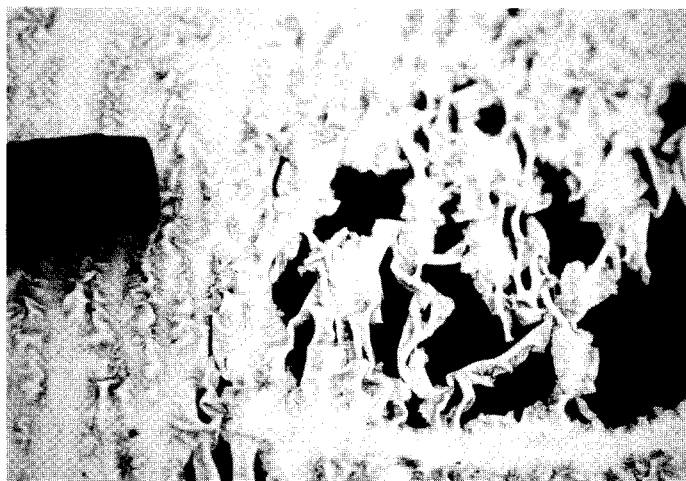
Figure 10 Close-up view of the most severe peeling (shown in Figure 9). An ink pen shows the scale.

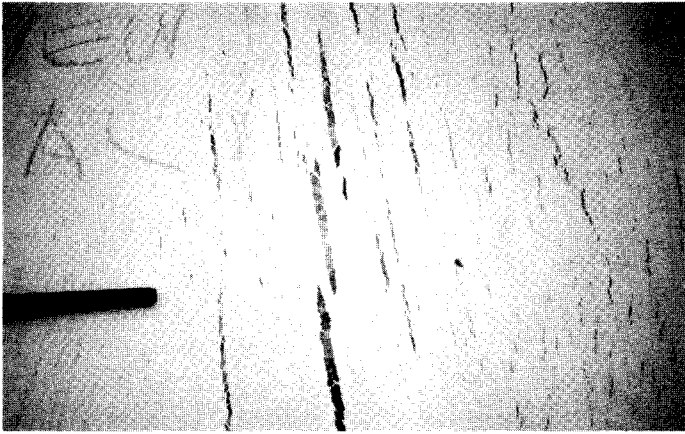
Aluminum-pigmented asphalt "C": Coating cracking that appeared to be related to mechanical forces (rather than weathering) occurred on Phase 1 at products #1, #6 and #7. These stretch cracks at #1 and #6 were noticed the day after the coatings were applied. Stretch cracks at #7 were observed about a month after coating application. The cracks at #1 and #6 increased in width during the first month after application. Since June 1991, the cracks at #1, #6 and #7 have changed very little. The largest crack is approximately $\frac{1}{4}$ inch (6mm) wide (see Figure 11).

Figure 11 Stretch-cracks in the Phase 1 aluminum-pigmented asphalt coating "C" over APP product #1 (Sept. 27, 1991, approximately 20 weeks after the coating application). The largest crack is approximately $\frac{1}{4}$ inch (6mm) wide.

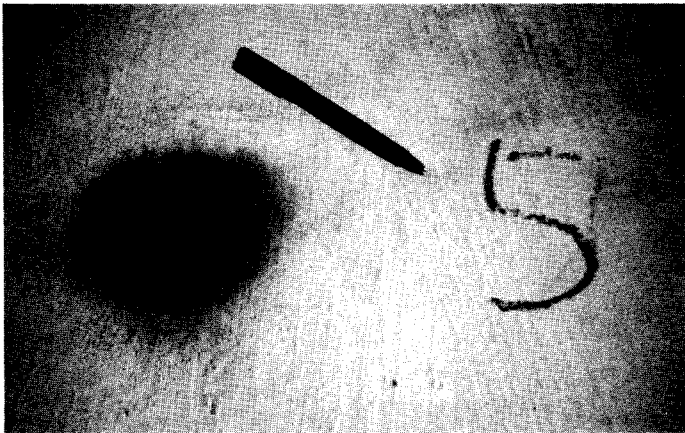
Coating "C" also has some minor cracking and peeling that appears to be related to weathering. This was observed at Phase 2, products #3, #4 and #5. It was also observed at Phase 1, products #4 and #5. At one of the areas on Phase 1, product #5, the cracking and peeling occurs at a small bird bath, which previously held exudate residue (this occurred after the coating application). See Figures 12 and 13.

At small isolated areas, exudation may have caused or influenced coating peeling at coatings "B" and "C," and checking at coating "D" (see Figures 12 and 13).

Figure 12 Exudation in a small bird bath at the Phase 1 aluminum-pigmented asphalt coating "C" over APP product #5, approximately six weeks after the coating application. The exudation developed after the coating application. See Figure 13.

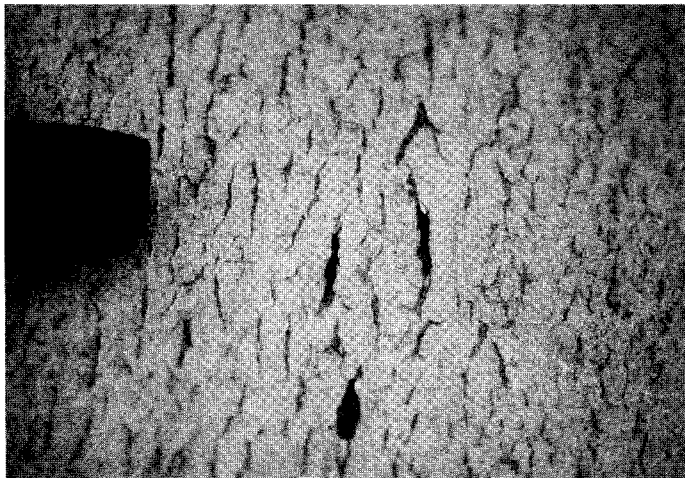
Figure 13 Close-up view of Figure 12 taken on Nov. 24, 1992 (approximately 18 months after the coating application). The coating has cracked and has begun to peel in the area that previously held exudate residue.

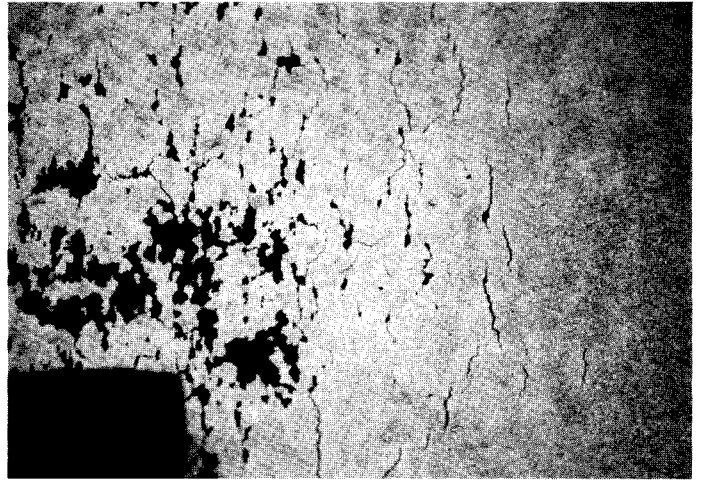
- Minor loss of the aluminum-pigmented asphalt and the reflective emulsion (coatings "C" and "D") has been experienced (Figures 14 and 15). Based upon visual observation at 8x magnification, it appears that this was due to erosion. Erosion is defined as the gradual loss of coating over time, due to weathering. Erosion is the desired cause of coating loss, compared to an undesirable premature loss due to cracking, peeling or flaking.

Figure 14 Close-up view of an area of minor erosion of the aluminum-pigmented asphalt coating "C" taken on Nov. 24, 1992. The width of the eroded area was $\frac{1}{2}$ inch to 2 inches (13mm to 50mm) and the length was approximately 24 inches (600mm).

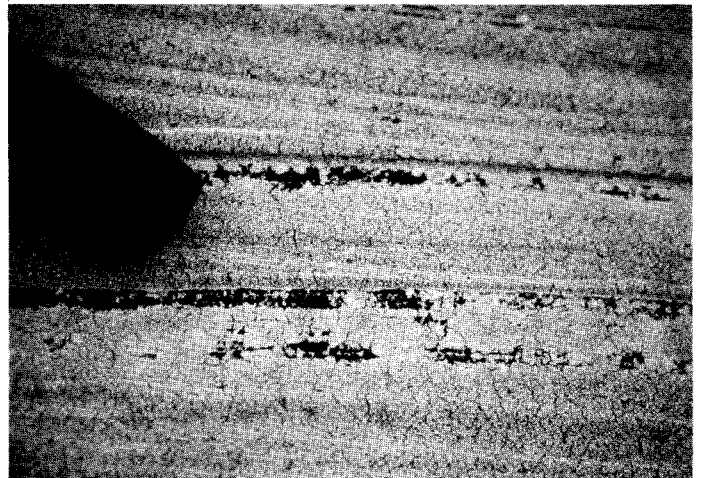
Figure 15 Close-up view of an area of minor erosion of the reflective emulsion coating "D" taken on Nov. 24, 1992. The dark horizontal lines are brush marks. Apparently, the broom-applied coating was relatively thin in the bristle-marked locations.

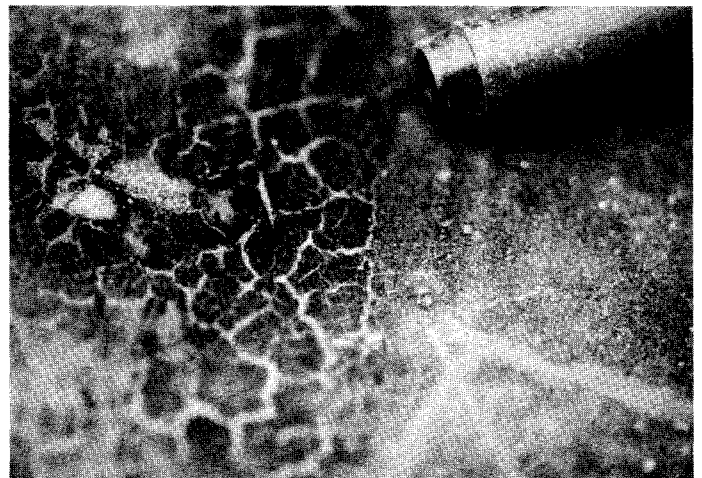
Exposed membranes: Weather-checking was observed on product #1 about four months after application. By November 1992 (approximately 19 months after membrane application), via visual observation, the depth of the checking had increased (see Figure 16).

Figure 16 Weather-checking at exposed (uncoated) APP product #2 (Nov. 24, 1992, approximately 19 months after the membrane application).

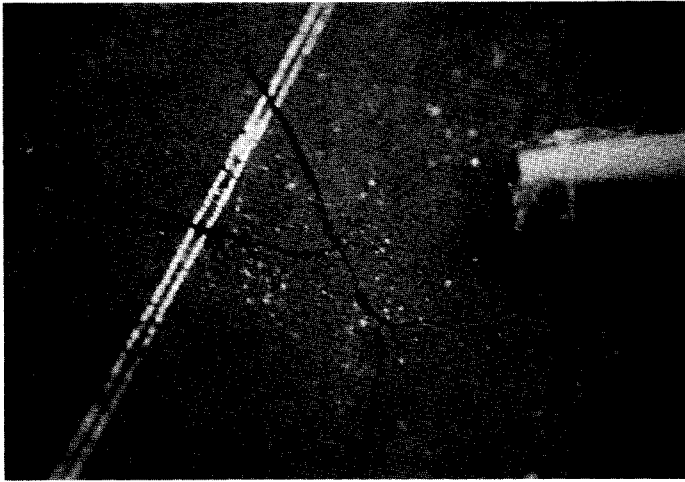
Product #2: Small linear cracks developed by November 1992. One large star-shaped crack was also observed (see Figure 17).

forming reasonably well. Exposed product #2 developed a large star-shaped crack that may present premature problems. Exposed products #6 and #7 have not exhibited signs of degradation by weathering.

Figure 17 A large, relatively deep star-shaped crack at exposed APP product #2, (Nov. 24, 1992).

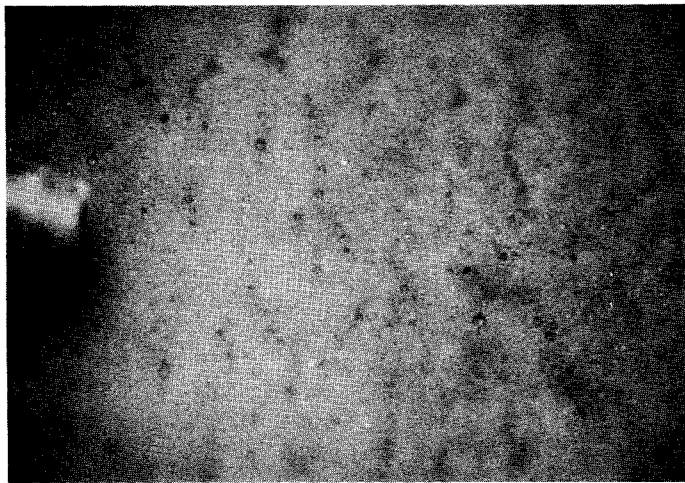
(hemispherical surface cavities), with two or three cracks typically extending from them (see Figure 18).

Figure 18 Small craters at the exposed APP product #4 (Nov. 24, 1992). Two or three small cracks typically extended from the craters.

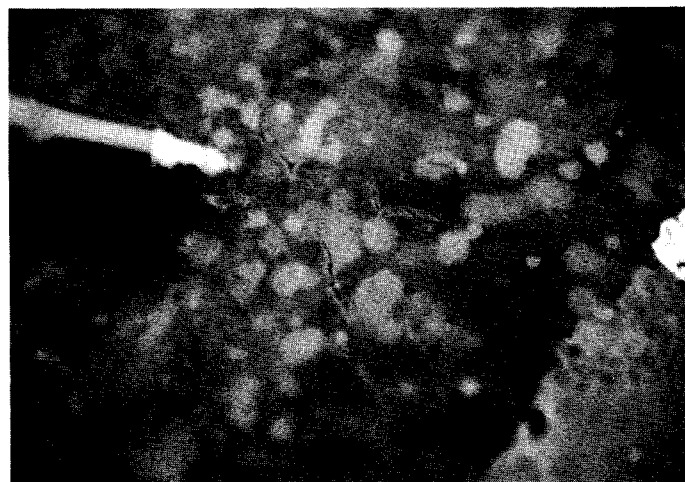
Product #5: Weather-checking was observed about five months after application. By November 1992, cracking had developed (see Figure 19).

Figure 19 Cracking at the exposed APP product #5 (Nov. 24, 1992).

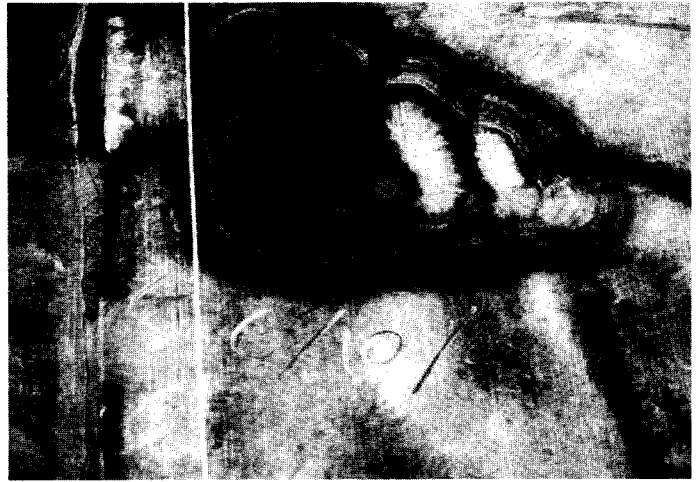
Exudation: In June 1991 (approximately six weeks after membrane application), exudation was observed in the field of all seven exposed membranes (see Figure 20).

Figure 20 Pool of exudation on an exposed membrane (June 10, 1991, approximately six weeks after membrane application). Similar conditions were observed on all seven exposed APP products.

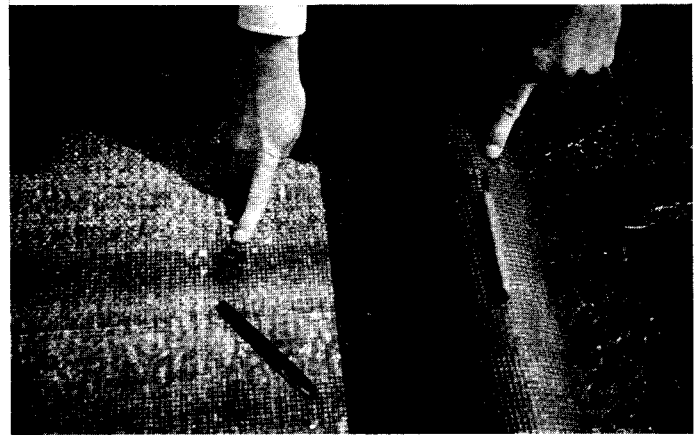
2. At several locations on one roll of product #5, the reinforcement became exposed because the roll stuck together during unrolling (see Figure 22). It is likely that such a condition would not be observed by the applicator. By coating the membrane, future problems may be postponed or avoided. Had the membrane not been coated, premature degradation and eventual leakage may have eventually developed due to the partially exposed reinforcement.
3. The RCMA/ARMA guide's⁵ criteria for membrane surface cleanliness may be overly conservative. The cleanliness evaluation prior to the Phase 1 application failed on all seven membranes, even though they had only been in place for a short time. Even after hosing with water, all seven membranes still failed the cleanliness test.

Figure 21 At several locations on one roll of APP product #5, the reinforcement became exposed because the roll stuck together during unrolling.
