# SHATTERING OF UNREINFORCED PVC ROOF MEMBRANES: PROBLEM PHENOMENON, CAUSES AND PREVENTION

**RALPH M. PAROLI**

**BRIAN J. WHELAN**

**THOMAS L. SMITH**

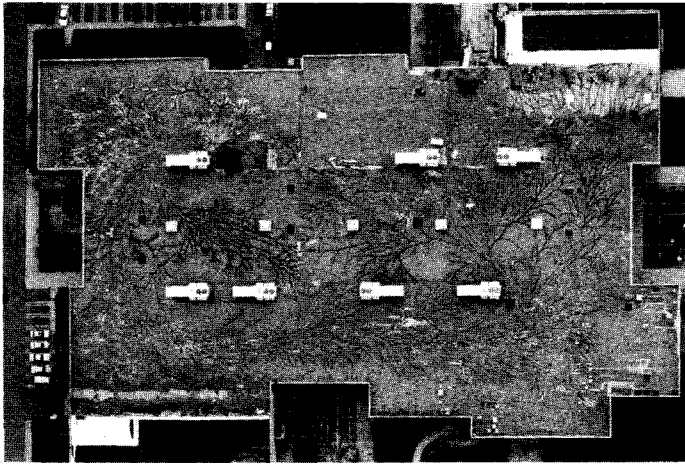
If an unreinforced membrane accumulates enough tensile stress, it may rupture. The rupture may be spontaneous or it may occur by someone walking on the roof or by some object falling on the roof. Upon rupture, the membrane usually lacks sufficient strength to prevent propagation of the split. As the split propagates, it branches into multiple lines of rupture, as can be seen in Figures 1 to 3.

**Figure 1** Aerial view of shattered ballasted unreinforced PVC roof system. Shatter initiated at the upper left, where indicated by the arrow. The shatter propagated in a counter-clockwise direction. One area at the top center portion of the roof did not initially shatter. However, it shattered a few days later. Membrane replacement is underway at the upper right and lower left corners.

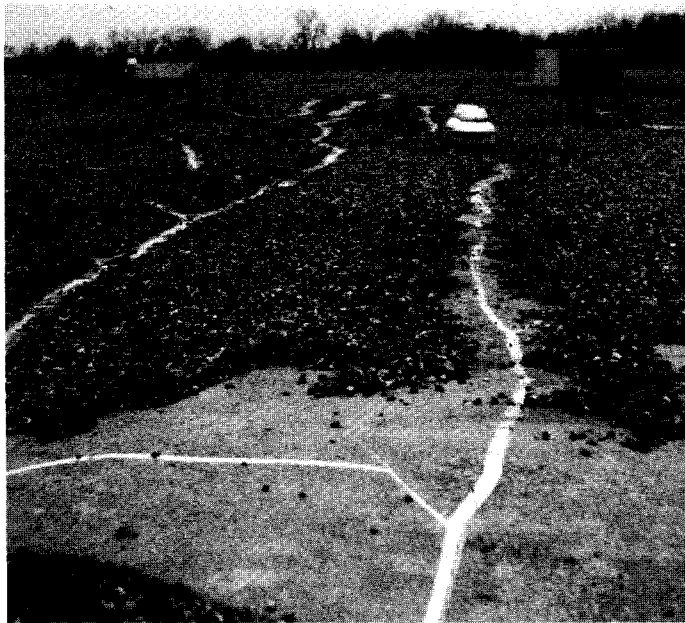
**Figure 2** General view of a shattered ballasted unreinforced PVC roof system.

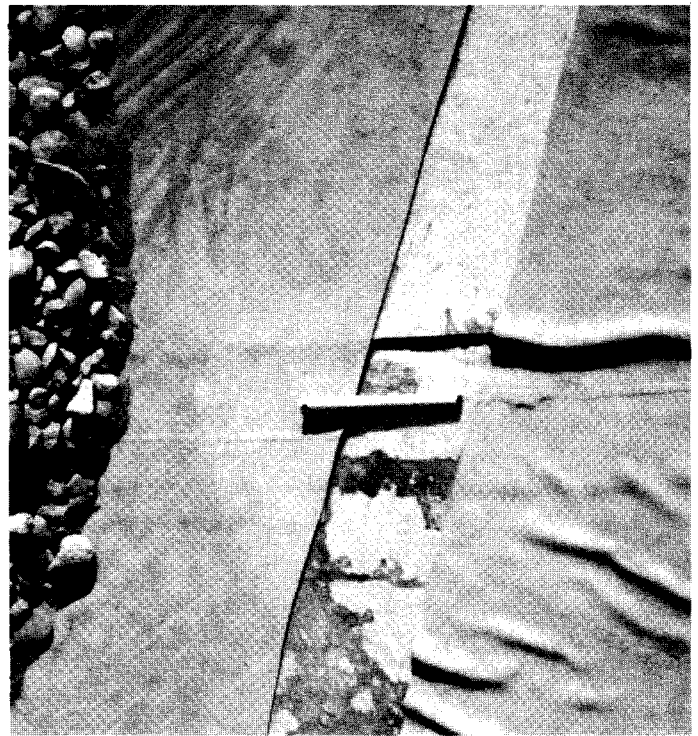
**Figure 4** View of a rupture line of a ballasted unreinforced PVC system. A seam line occurs to the right of the ink pen. On the other side of the rupture line, the seam line is below the pen. Hence, the membrane moved left-right and top-bottom. At lines of rupture, the membrane is often open by several inches, as it is in this figure.

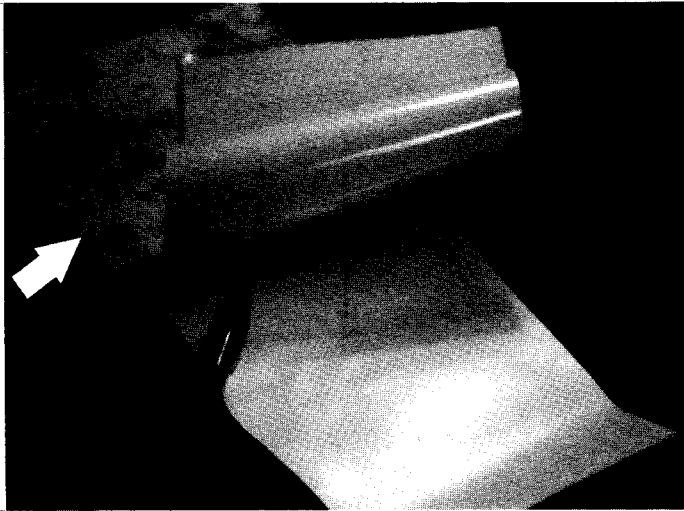
Figure 6 View of an "unbonded flap." The seam occurs where indicated by the arrow. The ink pen is laying on the unbonded flap, which extended underneath the membrane for several inches beyond the lap.

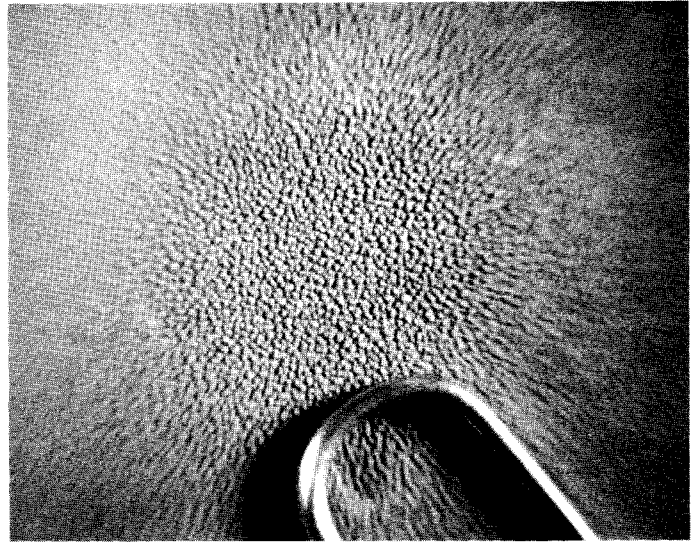
Figure 7 Surface checking of a 7.5 year old mechanically attached unreinforced shattered PVC roof system (90/91-23). A paper clip shows the scale of the checking, which is visible with the naked eye.

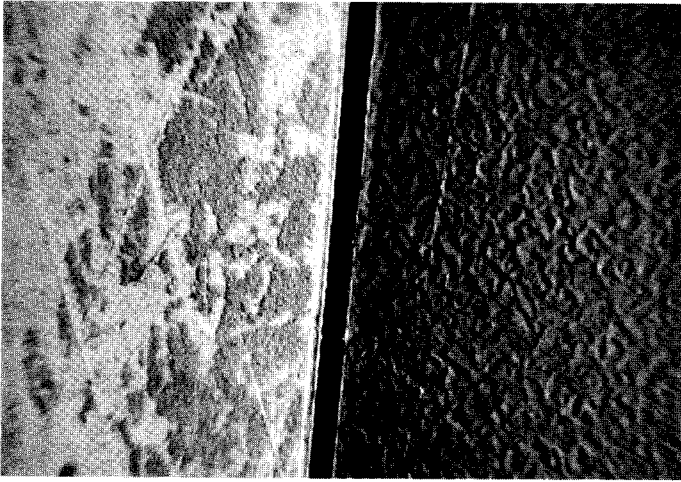
On some of the samples from 90/91-2 (10 years old, ballasted, Virginia), an "orange peel" surface was visible on the top side of the sheet. This only occurred on samples that were fairly clean. Other samples from this job had a good deal of dirt on the membrane. These samples exhibited a smooth surface after the dirt was removed. (See Figure 8.)

**Figure 8** Side-by-side comparison of two samples from the same shattered ballasted unreinforced PVC roof system. The sample on the right side has an "orange peel" surface. This sample was fairly clean. The sample on the left was fairly smooth. This sample had a good deal of dirt on it (most of which was washed off prior to taking the photo).

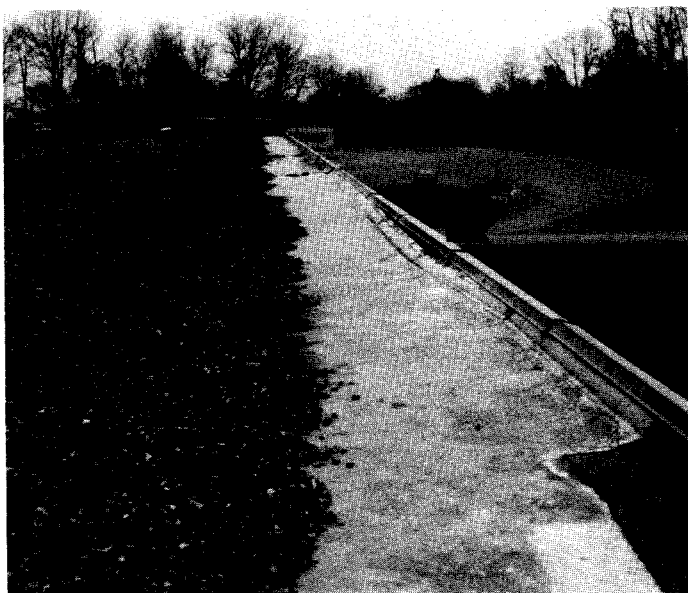
**Figure 10** Shrinkage of an unreinforced ballasted PVC roof system: the ballast has moved inward away from the parapet by a few feet. Also, the exhaust pipes have been slightly pulled over, and a portion of the base flashing has pulled away from the parapet (see arrow). These conditions are potential early warning signs of shattering.

- If potential early warning signs are observed, membrane replacement or repair work is recommended.

As a repair to relieve membrane stress, new membrane material may be added around the building perimeter and at penetrations (if needed) as Carlson described in 1991.<sup>39</sup> However, the repair may or may not be successful in greatly extending the roof's service life. The shattered roof in Figure 1 reportedly had relief strips added at the perimeter a year or two before the job shattered. Prior to executing repairs or maintenance to relieve stress or for other reasons, it is recommended the manufacturer of the membrane be contacted for recommendations. If the manufacturer is no longer in business, refer to Carlson's articles.<sup>39</sup>

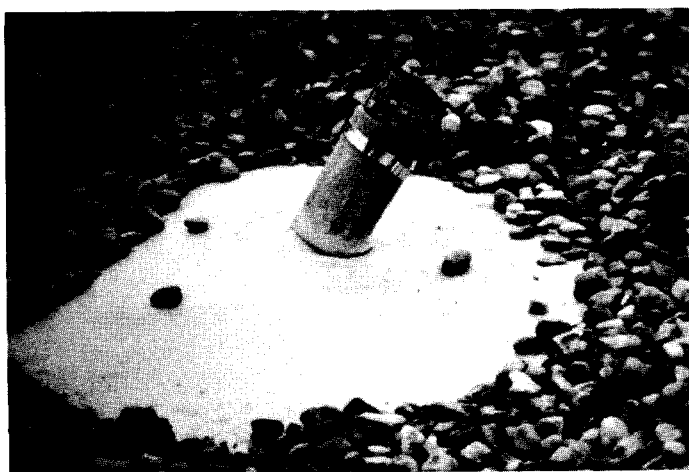
**Figure 11** Shrinkage of an unreinforced ballasted PVC roof system has resulted in displacement of this plumbing vent. This too, is a potential early warning sign of shattering.

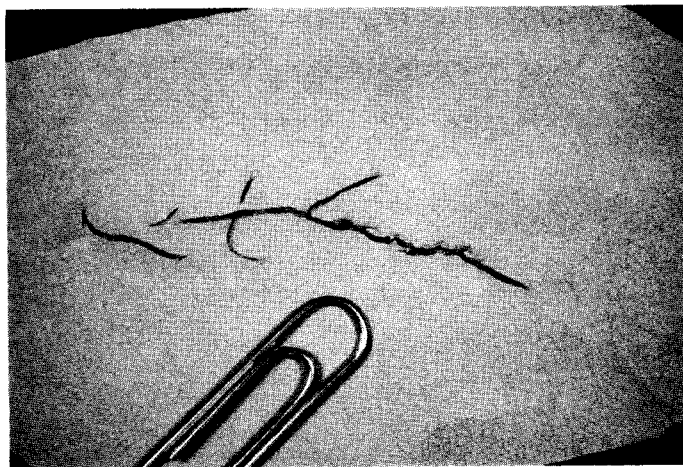
Figure 12 is of a reinforced PVC membrane that has cracked completely through the sheet (however, the reinforcement is still intact). While repairable, this condition does allow water infiltration. And if this type of problem occurs extensively, repair is problematic.

**Figure 12** Cracked reinforced mechanically attached PVC membrane roof system. The crack extends completely through the membrane. However, the reinforcement that bridges the crack was not ruptured. Surface checking is also visible to the naked eye. The roof had approximately 10 similarly cracked areas, none of which appeared to be due to abuse or neglect. This sample was 35 mils thick. Unlike shattering, cracking may be repairable, and it is not a catastrophic failure. This job was approximately 12 years old when the problem was reported in 1991. A strengthened ASTM D 4434 is needed to differentiate between those sheets that offer a long service life from those that do not.
