STEEL DECK CORROSION ASSOCIATED WITH PHENOLIC ROOF INSULATION: PROBLEM CAUSES, PREVENTION, DAMAGE ASSESSMENT AND CORRECTIVE ACTION

THOMAS L. SMITH and JAMES D. CARLSON

National Roofing Contractors Association
Rosemont, Ill.

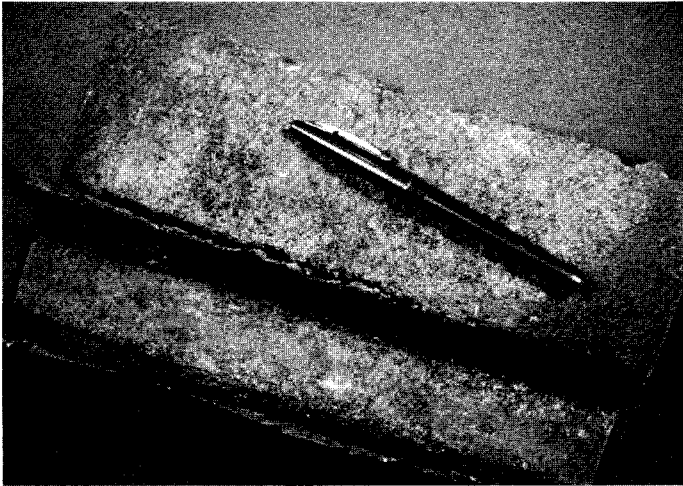
Figure 1 Corrosion-induced separation of top flange from the shoulder (flange/web intersection). Phenolic sample "EP-2" (Table 1) came from this job.

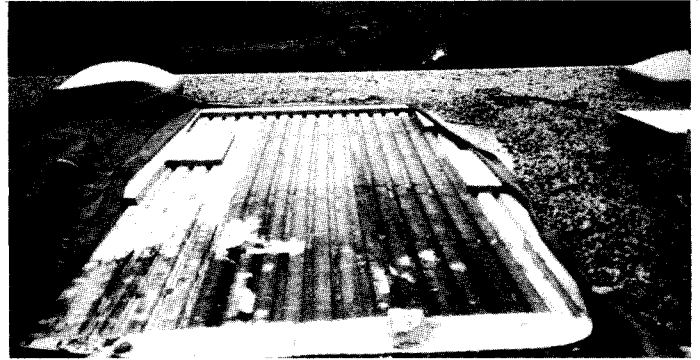
Figure 4 NRCA in-situ corrosion research (Figures 4 to 13). Figure 4 to 6 were taken in November 1992, approximately 19 months after application. Figure 4 shows the area where phenolic "I" insulation was installed. Galvanized deck occurs on the left, and prime painted on the right. The wet boards occurred in the foreground. See Figure 7 for close-up.

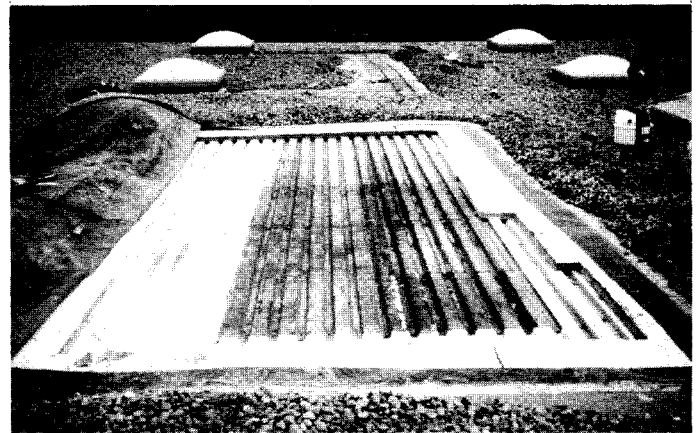
Figure 5 Phenolic "II" (with corrosion inhibiting facers).

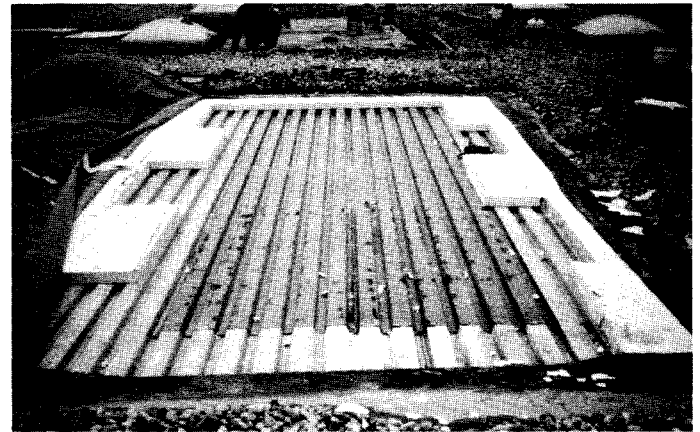
Figure 6 Polyisocyanurate "III."

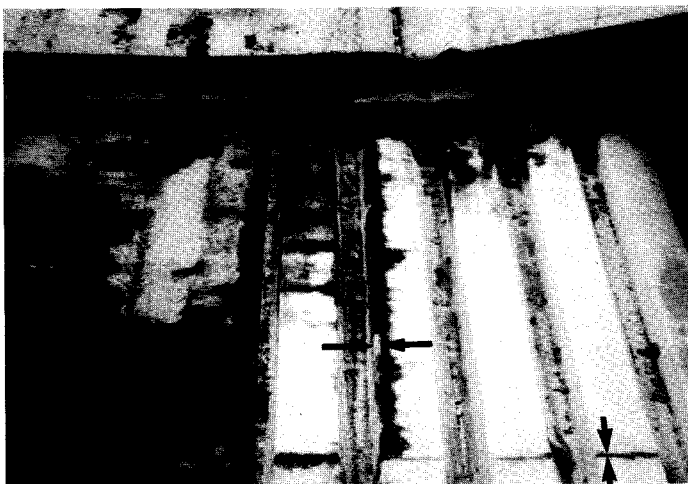
Figure 7 Close-up view of Figure 4 (phenolic "I", but in opposite direction). The galvanized deck is on the right—the dark areas are red rust (see Figure 10). Notice the enhanced corrosion that occurred at insulation side and end joints (see arrow). The prime painted deck is on the left—the entire surface is very corroded. The light colored areas on the left area are where the facer stuck to the deck.

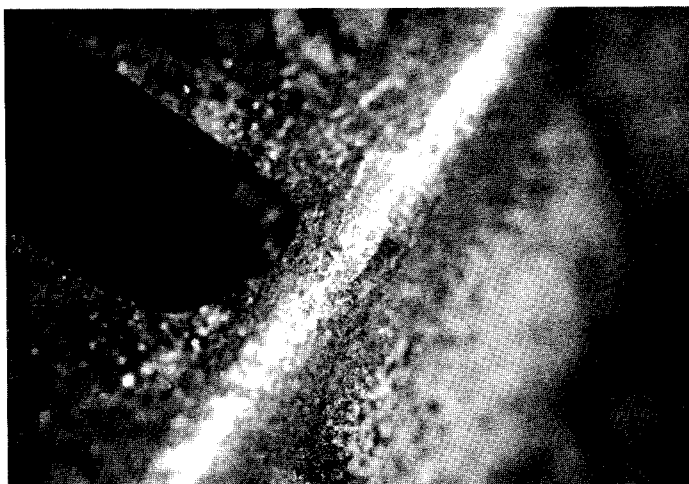
Figure 8 Phenolic "I" in May 1992 (approximately one year after application). The loose scale was removed from the primed deck at the shoulder—several large pits occur at this area (near the end of the ink pen).

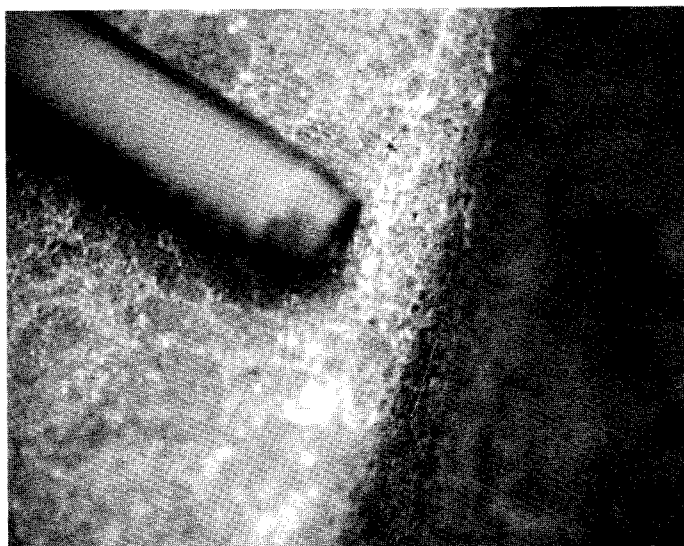
Figure 9 Phenolic "I" in November 1992, approximately 19 months after application. The loose scale was removed from the top flange and shoulder of the primed deck by sanding. Many large diameter pits and a few deep pits (dark areas) occur. Compared to Figure 8 (seven months earlier), the pits have enlarged and interconnected, and become deeper.

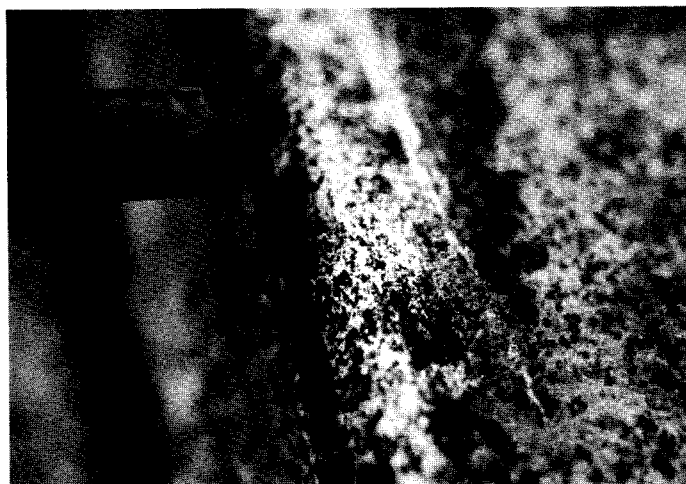
Figure 10 Phenolic "I" in November 1992. The loose scale was removed at the shoulder of the galvanized deck by sanding. This occurred at the insulation end joint shown in Figure 7. The shoulder is pitted, but not nearly as greatly as at the primed deck (Figure 9).

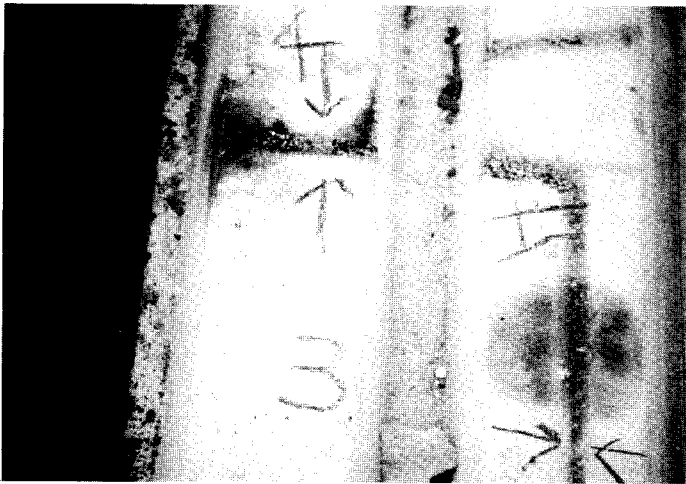
Figure 11 Phenolic "II" (corrosion inhibiting facers) in November 1992. Galvanized deck is on the right—the dark line occurs at insulation side and end joints. The dark area is the prime painted deck—see Figure 12.

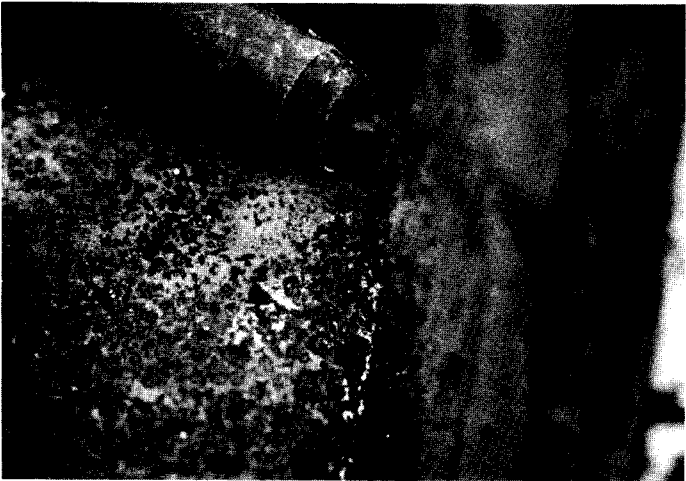
Figure 12 Phenolic "II" at the prime deck/insulation joint location shown in Figure 11. The shoulder area was sanded. Pitting at the insulation joint area was similar to that observed under phenolic "I"—see Figure 9.

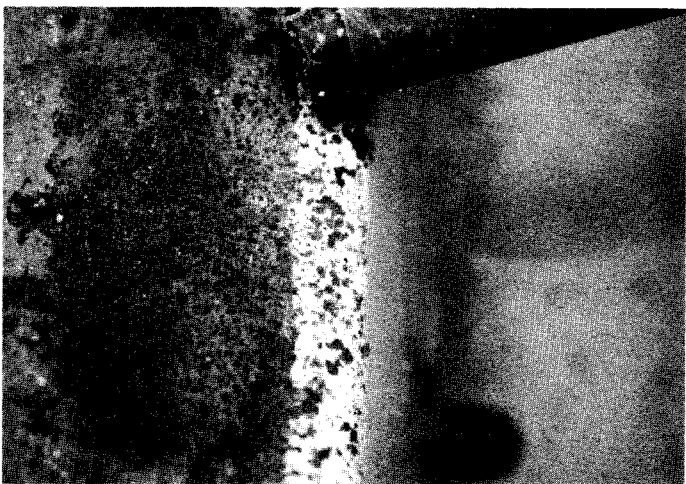
Figure 13 Polyisocyanurate "III" in November 1992. The primed deck was sanded at the shoulder area. In this very early stage of steel corrosion, the large quantity of pitting is apparent. Also in this early stage, the joining together of two or more pits to form one large pit can be seen.
