SOME OBSERVATIONS ON THE BEHAVIOUR OF BUILT-UP ROOFING MEMBRANES OVER EXPANDED POLYSTYRENE IN THE U.K.

J. R. Carver

John Laing Research & Development Limited, Boreham Wood, Hertfordshire, England

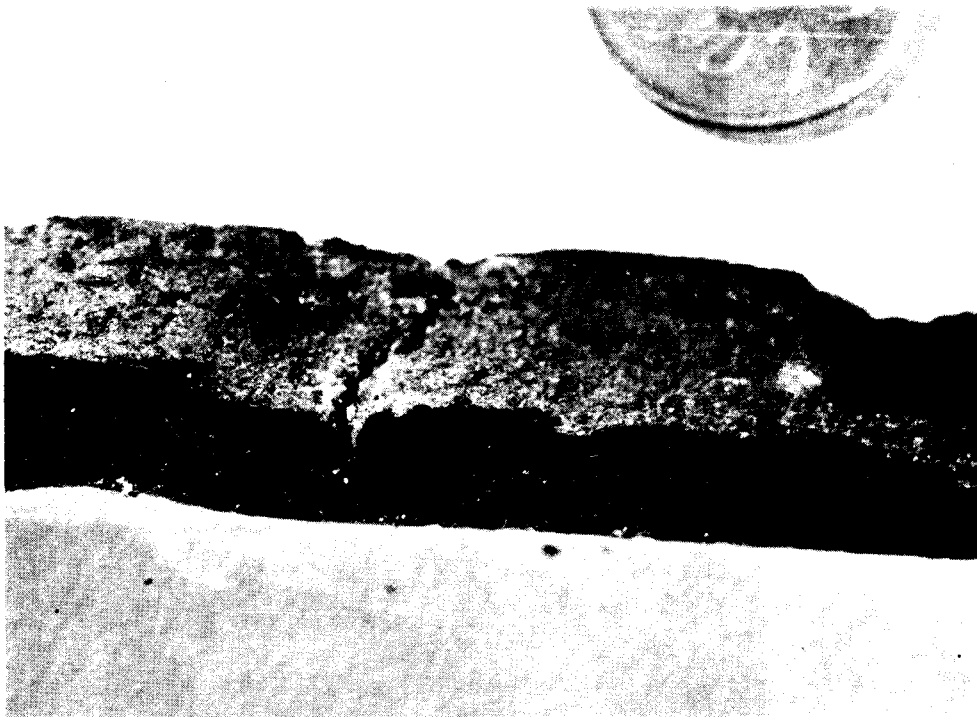
2.1.2. The roof of a community centre completed in 1973 consisted of a plywood deck laid to falls with bituminous felt vapour barrier and 25 mm extruded polystyrene insulation, fully bonded. The membrane consisted of a first layer of asbestos based felt, fully bonded to the insulation and two layers of organic fibre based felt, with reflective chippings. Leaks occurred in less than a year and these had been traced to numerous short splits close to the central gutter. The splits were aligned with the runs of felt and in most but not all cases coincided with joints in the insulation. The gutter and splits had been re-felted and treated with aluminum reflective paint in the Spring of 1976. The roof was inspected in June, 1976, when further splits were found. In two cases these proved to be confined to the top layer of felt (see Fig. 1; although they were over joints in the insulation. Three short splits were found near the gutter in another part of the roof. Examination of the membrane revealed that only two layers of felt had been laid in this area.

The association of all splits with the central gutter was considered significant, although there was no obvious structural cause. The membrane in other parts of the roof appeared to be in good condition.

FIGURE 1 - SPLIT IN UPPER SURFACE OF MEMBRANE AND OVER JOINT IN INSULATION (NOT SHOWN). NOTE SLIGHT RIDGE (CASE STUDY 2.1.2)

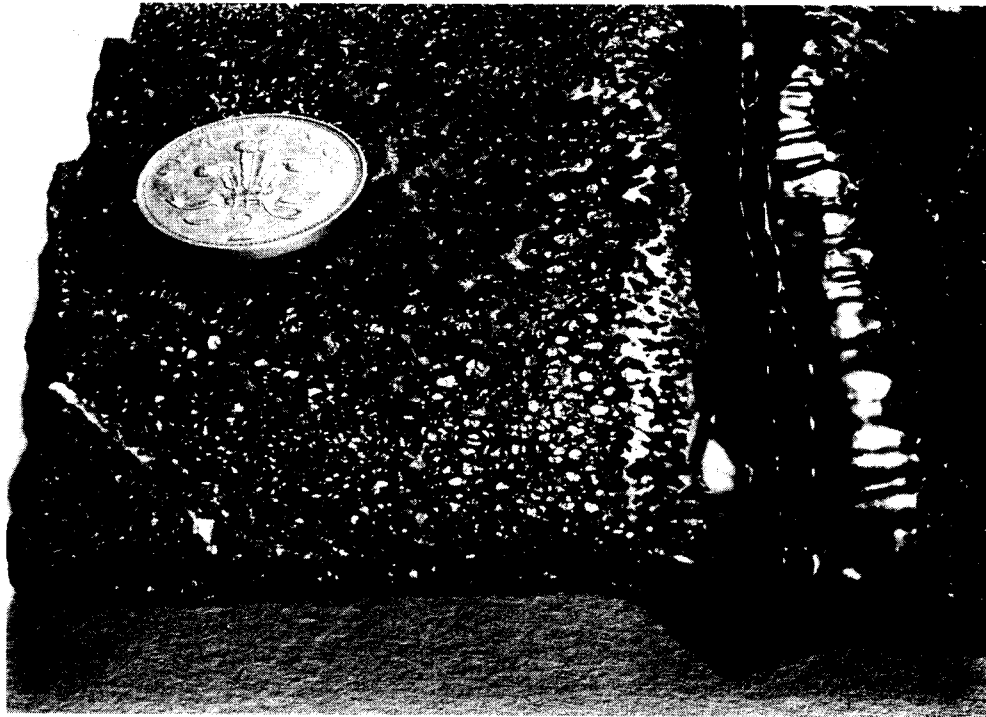
No splits were found in the area where insulation had been laid diagonally, but an isolated ridge was examined in this area near the Western perimeter. The ridge was transverse to the machine direction of the felt and the underside was characterised by smooth polished bitumen with no evidence of previous contact with the insulation (see Fig. 3). Thickening of bitumen between the layers of felt was noted on both sides of the ridge.

FIGURE 3 - RIDGE ACROSS RUNS OF FELT NEAR PERIMETER OF ROOF. NOTE DIAGONAL JOINT IN INSULATION AT BOTTOM LEFT CORNER AND THICKENING OF BITUMEN. (CASE STUDY 2.2.3)

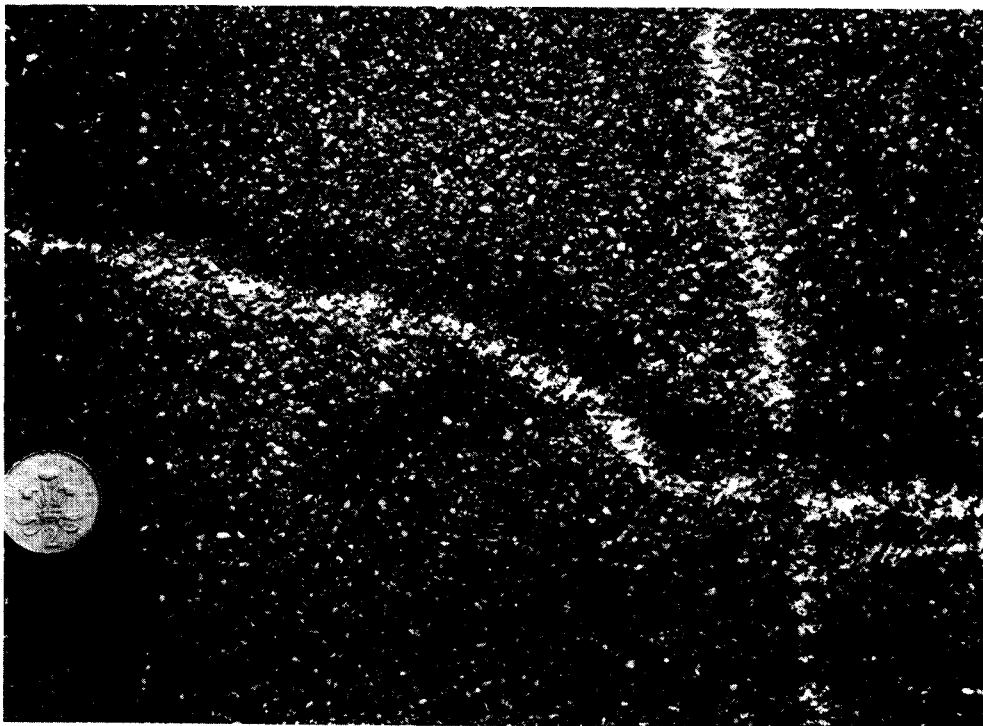
2.3.2. A 15° pitch metal decked roof over a warehouse was completed in 1970. 25 mm extruded polystyrene insulation was fully bonded to a bituminous felt vapour barrier which was bonded to the deck. The two layer membrane was partially bonded by the ribbon method and consisted of a base layer of glass fibre felt with granular surface and a top layer of glass fibre felt with mineralised finish. The felt was laid in the direction of the slope and contact area between the membrane and insulation was estimated at 5%.

Numerous patches were noted running in the machine direction of the felt. An opening was made in the longest patch which revealed a bow shaped split (see Fig. 4) running across the middle of an insulation board, between joints in adjacent boards. A split in another part of the roof was found in a repaired patch which had been laid a few months previously.

FIGURE 4 - CURVED SPLIT, PARTIALLY ALIGNED WITH JOINT IN INSULATION. NOTE ABSENCE OF BONDING BITUMEN. (CASE STUDY 2.3.2)
