# SUGGESTED REPAIR SPECIFICATIONS FOR BUILT-UP ROOFS OVER WET LIGHTWEIGHT CONCRETE DECKS

SMITH A. FUNK

Celotex Roofing Products  
Tampa, Fla.

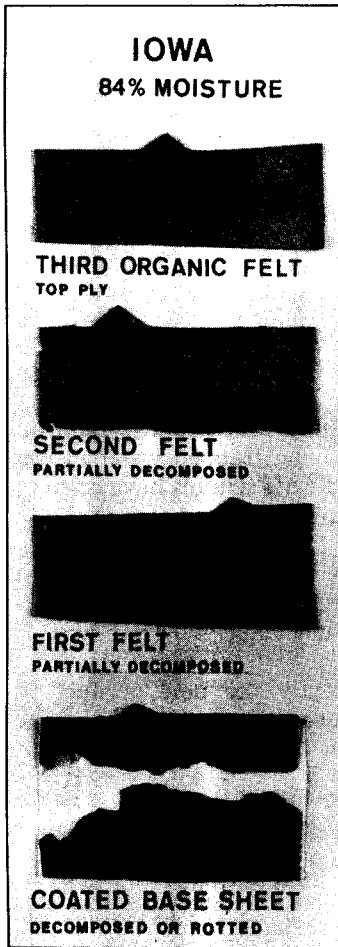
Figure 1 shows a typical four-ply organic roof consisting of a base sheet and three plies taken from a wet deck in Iowa. The deck contained 84 percent water in 1981. The roof was applied in 1970, and splits began to occur in 1976. The organic felts exhibited a combination of rotting and deterioration prior to splitting.

Samples in Figures 1 and 2 were made by preparing a small 3- x 5-inch sample of the membrane without gravel, and putting it in a circulating solvent bath in the laboratory. The trichlorethylene solvent dissolved all of the asphalt in the membrane samples, leaving only the felts themselves. After the solvent had completely evaporated, the felts were weighed to determine if they met the specifications for dry felt weight. They also were examined for deterioration or rotting. Severe deterioration or loss of weight as shown in Figures 1 and 2 is instantly recognizable.

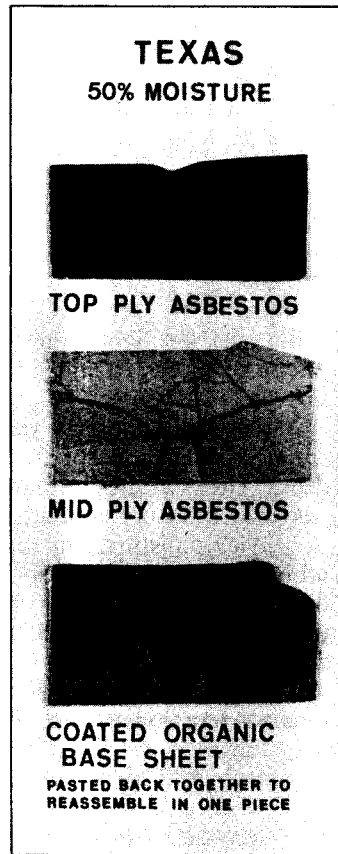
Figure 2 shows a coated organic base sheet and two #15 asbestos felts which were taken from a wet deck in the Rio Grande Valley of Texas. The roof was applied in 1975 and began to leak in 1978 or 1979. The sample was taken in December 1981, at which time the deck contained 50 percent moisture. The base sheet from this sample was so deteriorated that it had to be pieced back together to make the exhibit. This roof split as a result of deterioration and loss of strength. Note that the inorganic asbestos felts did not rot.

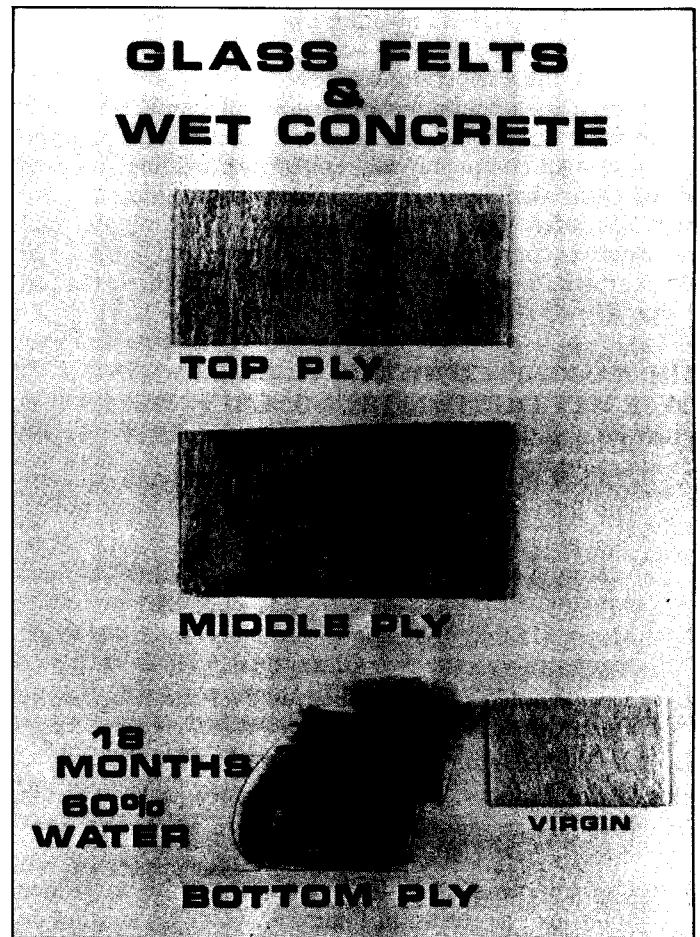
Figure 2a

Those who were evaluating glass felts over lightweight concrete analyzed test cuts from existing installations. Figure 2A shows the results of lab testing a three-ply coated glass roof which had been exposed to a wet concrete deck for 18 months. The bottom ply of glass had degraded 50 percent. The tensile strength of this three-ply Type IV glass membrane, measured by ASTM D 2523 at 70F, was 58.3 pounds per inch. This deterioration is more rapid than that of the organic or asbestos membranes. To meet ASTM D 2178-81 a single Type IV glass felt has a minimum tensile strength of 44 pounds per inch. The strength of the three-ply glass felt roof membrane had been reduced to almost one-ply.

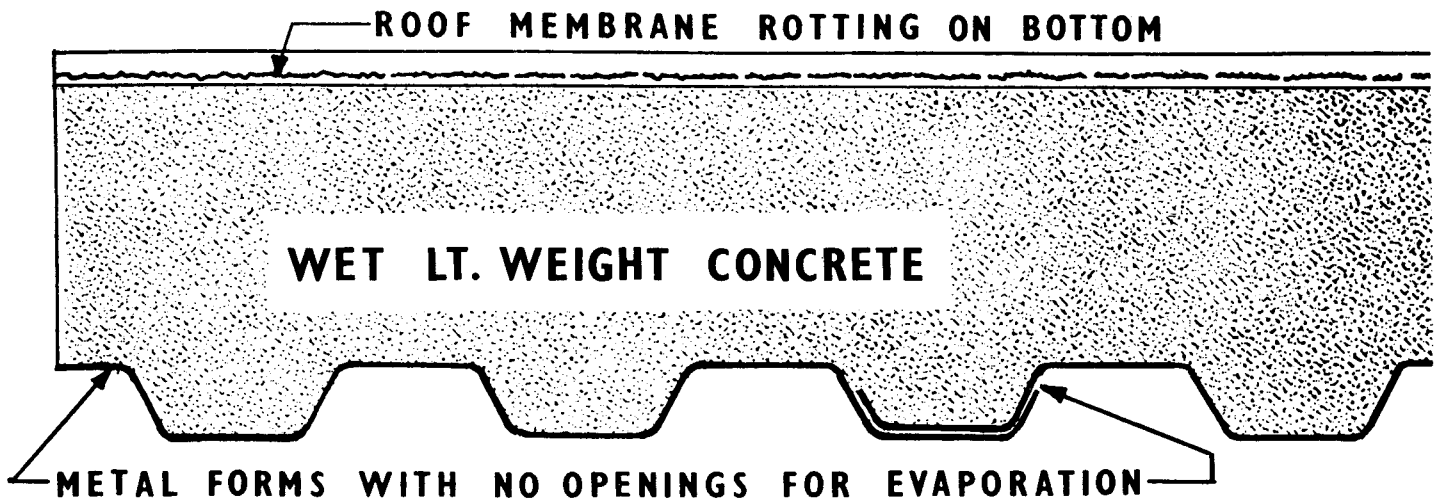
Figure 3 shows a cross section of a lightweight concrete deck with a deteriorating roof membrane. Figure 4 shows the same condition where trapped moisture in the deck has broken through the asphaltic vapor barrier base sheet, penetrated the board insulation, and reached the roof membrane. Failures or problems of this magnitude have been observed in Missouri and Texas.

Figure 3 The basic problem

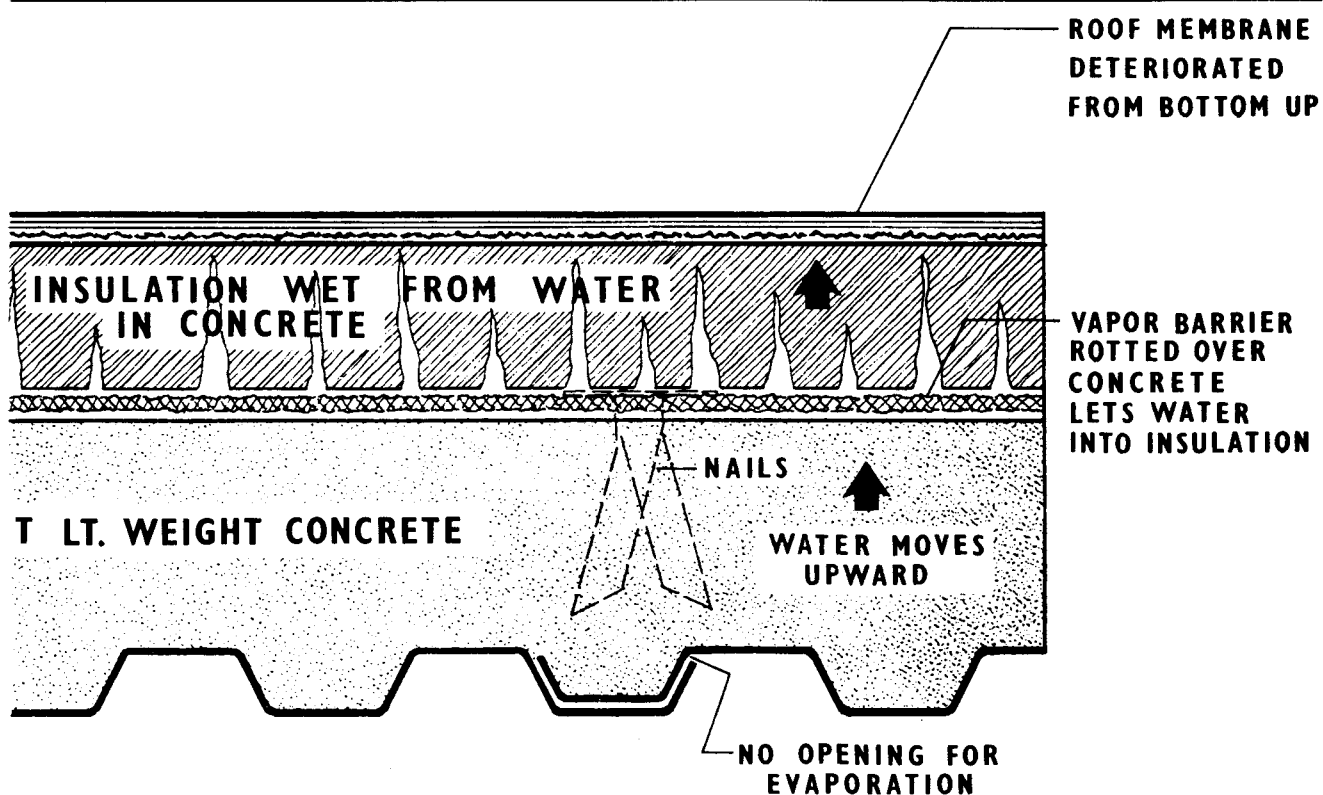
*The other problem (with insulation)*

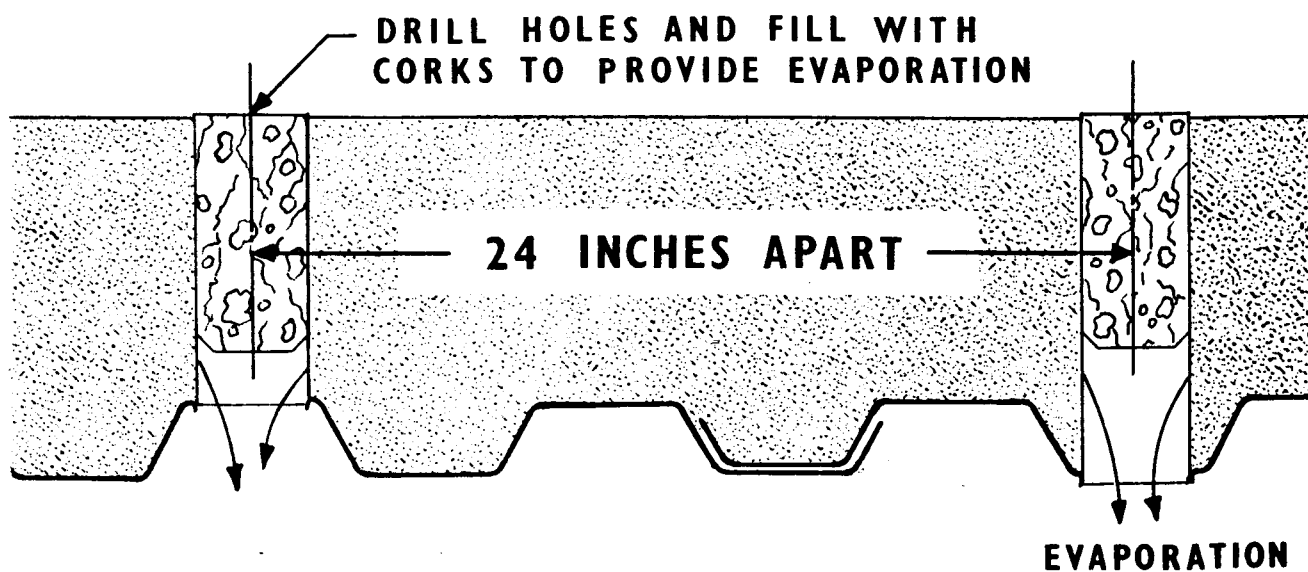
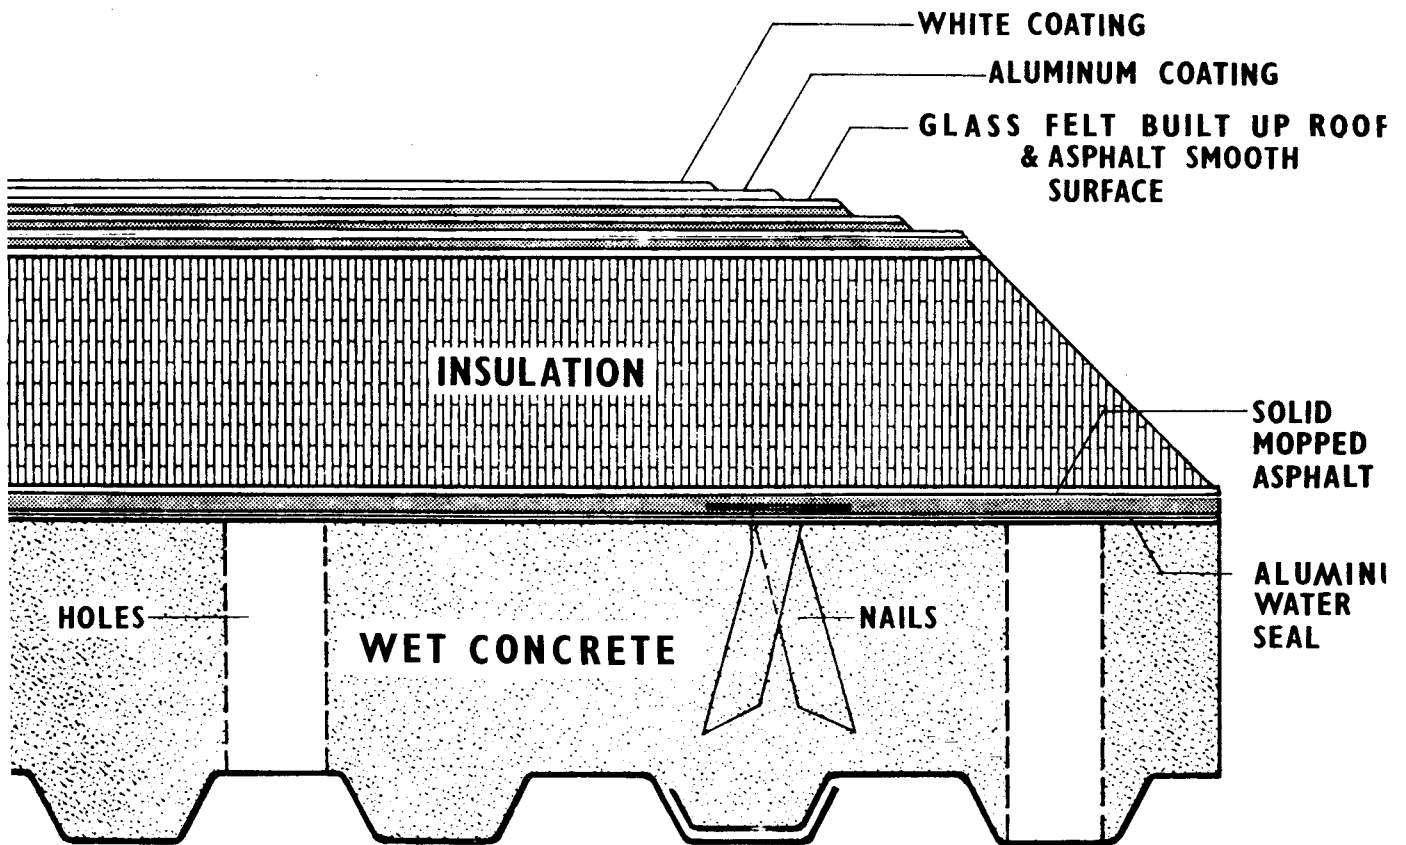
Figure 6 Glass felt built-up roof

Figures 5 and 6 show the cross section of a typical deck which has not dried, but has been drilled with  $\frac{3}{4}$ -inch diameter holes on 24-inch centers. Drilling allows moisture from the wet concrete to evaporate downward into the building. Obviously, more holes will accelerate drying, but will also cost more. Experience shows that  $\frac{3}{4}$ -inch holes on 24-inch centers costs about \$15 per square for labor. Corks costing 4.5 cents each may be put in the holes from the top to act as insulation if a new roof is to be put directly over the wet deck. Application of new board insulation directly over the wet deck is recommended. In this case, the corks can be eliminated. The owner gets the thermal value of new insulation immediately and does not have to wait years for the wet concrete to dry. This solution is depicted in Figure 6 with a smooth glass felt roof membrane, coated white, applied over the insulation.

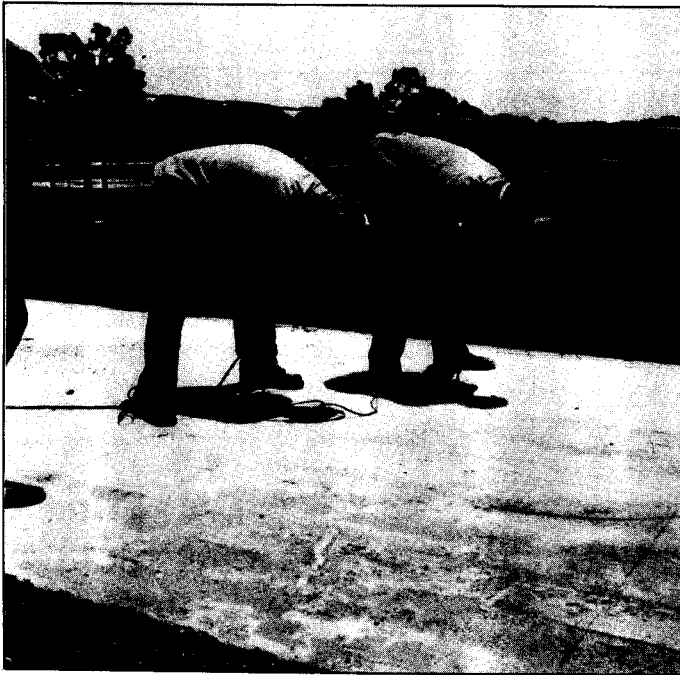
Figure 7 First drilling of holes, August 1982, Riverview School, Fla.

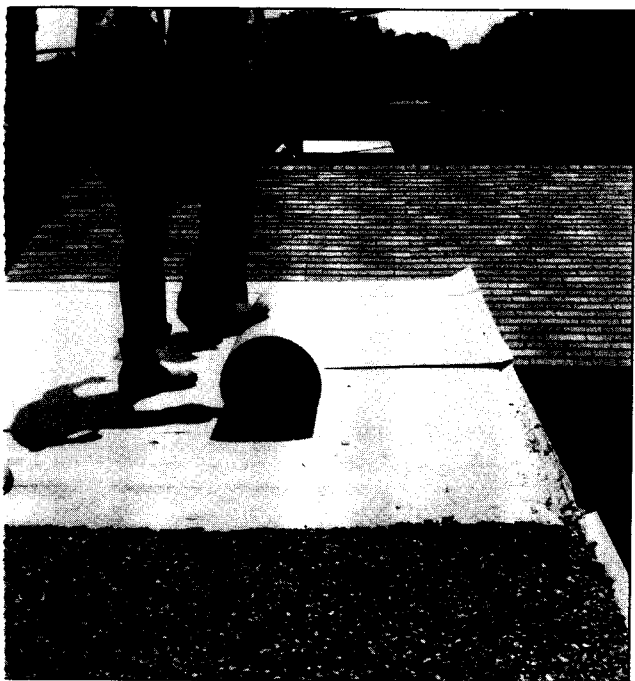
Figure 9 First use of foil, Riverview, August 12, 1982

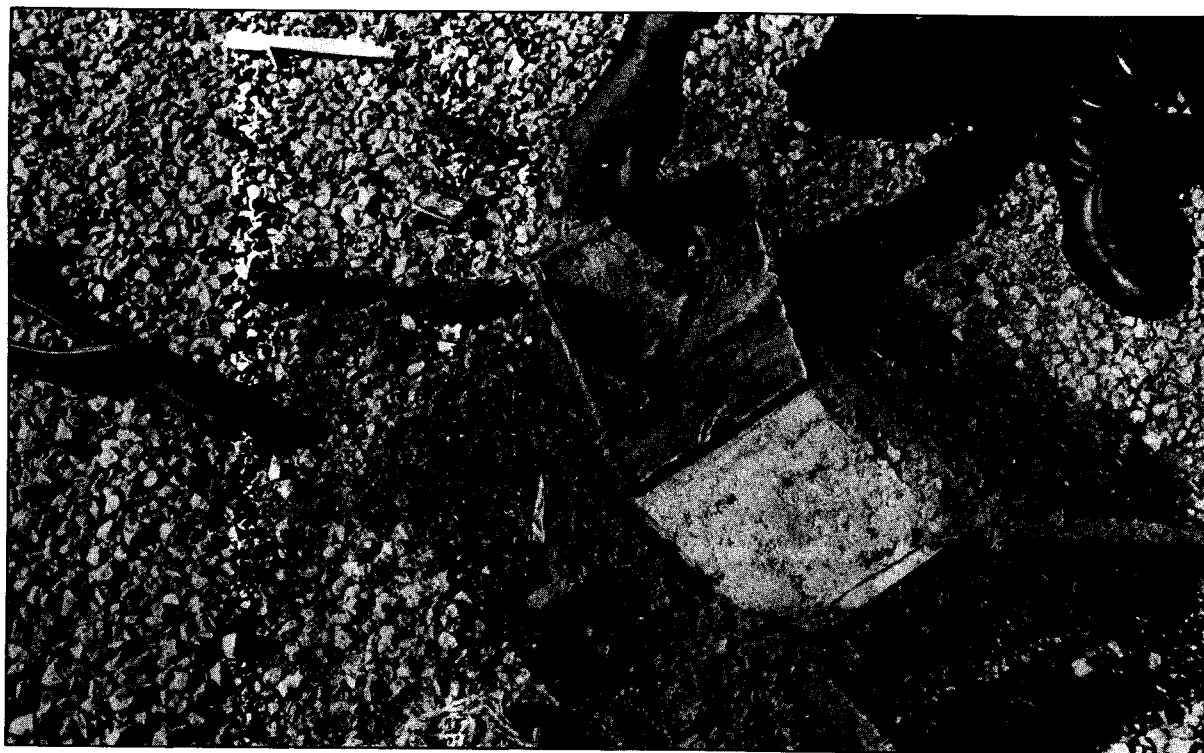
Figure 11 shows a cut of the Riverview roof in 1984. Holes are on 24-inch centers. The foil is still intact, showing no alkaline attack; and the roof and 1/2-inch insulation are dry. The roof and 1/2-inch insulation are dry. The deck has lost moisture from the original 108.3 percent to 98 percent in two years.

Figure 11 Riverview cut 1984: membrane dry, foil in good condition

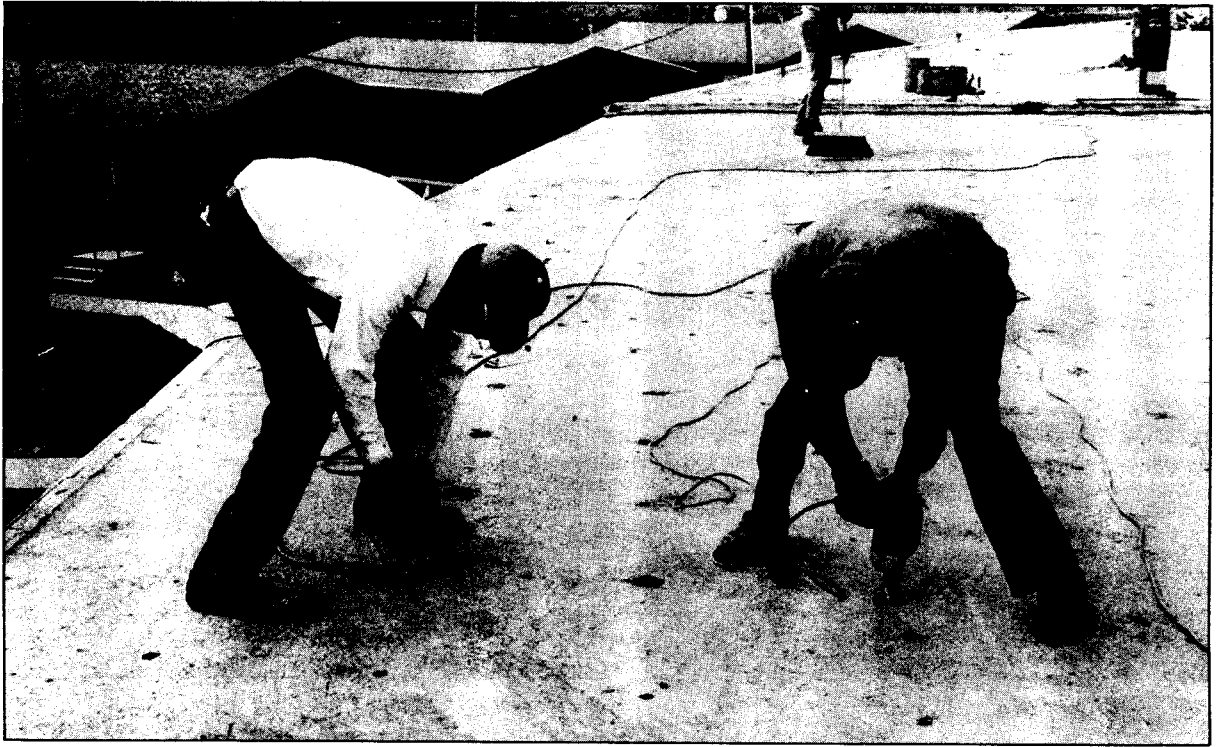
*Figure 12 Drilling Limona School, Brandon, Fla. 1982*

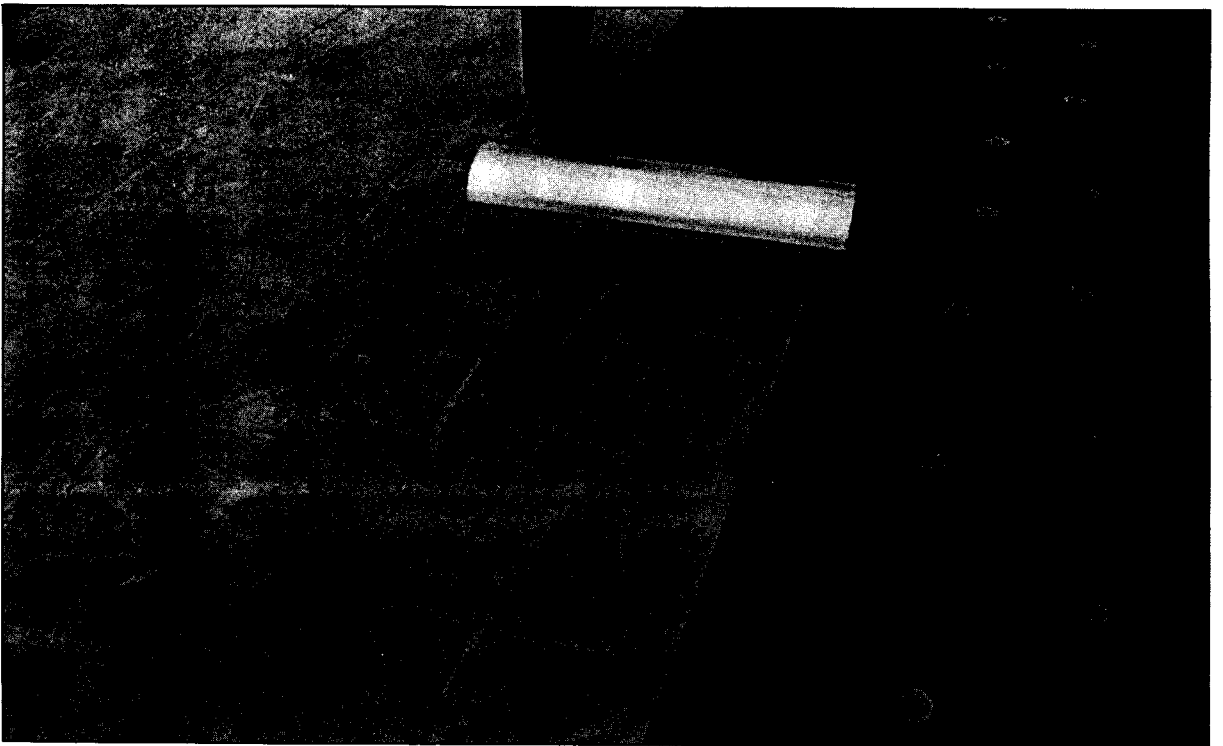
*Figure 13 Foil placement over drilled deck*

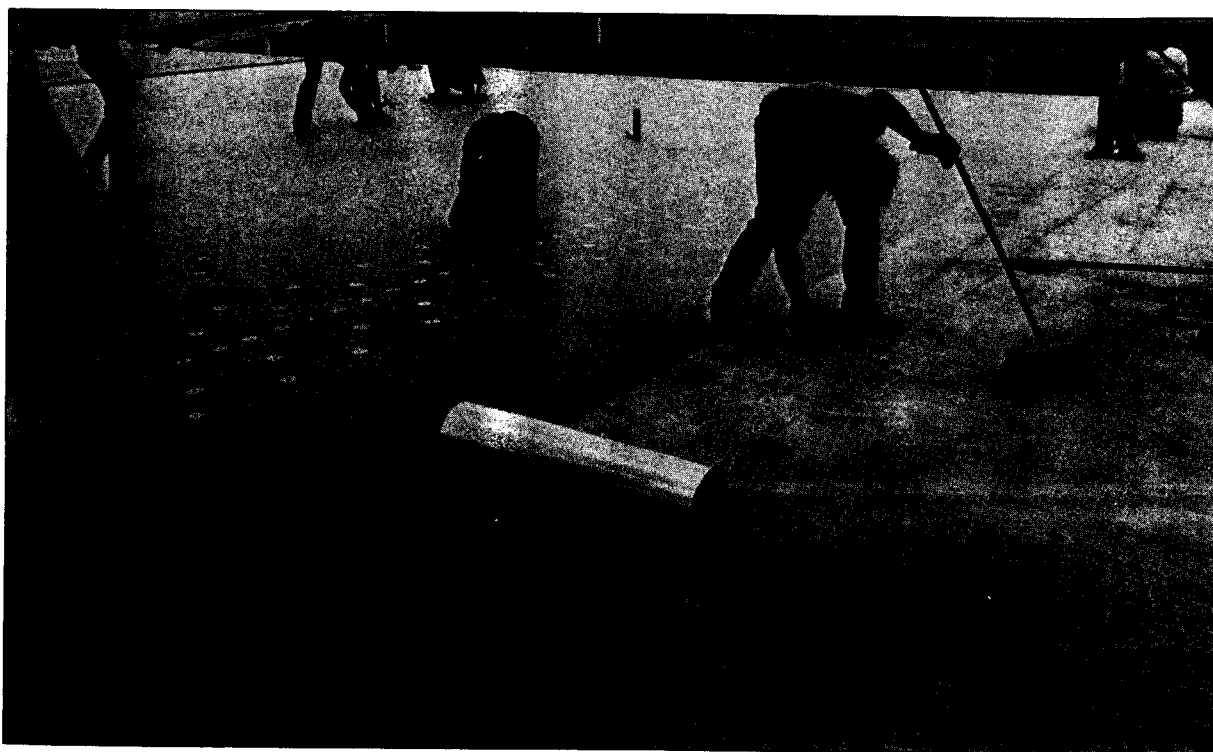
*Figure 15 Application of foil water seal, Kingswood School, Brandon, Fla. 1982*

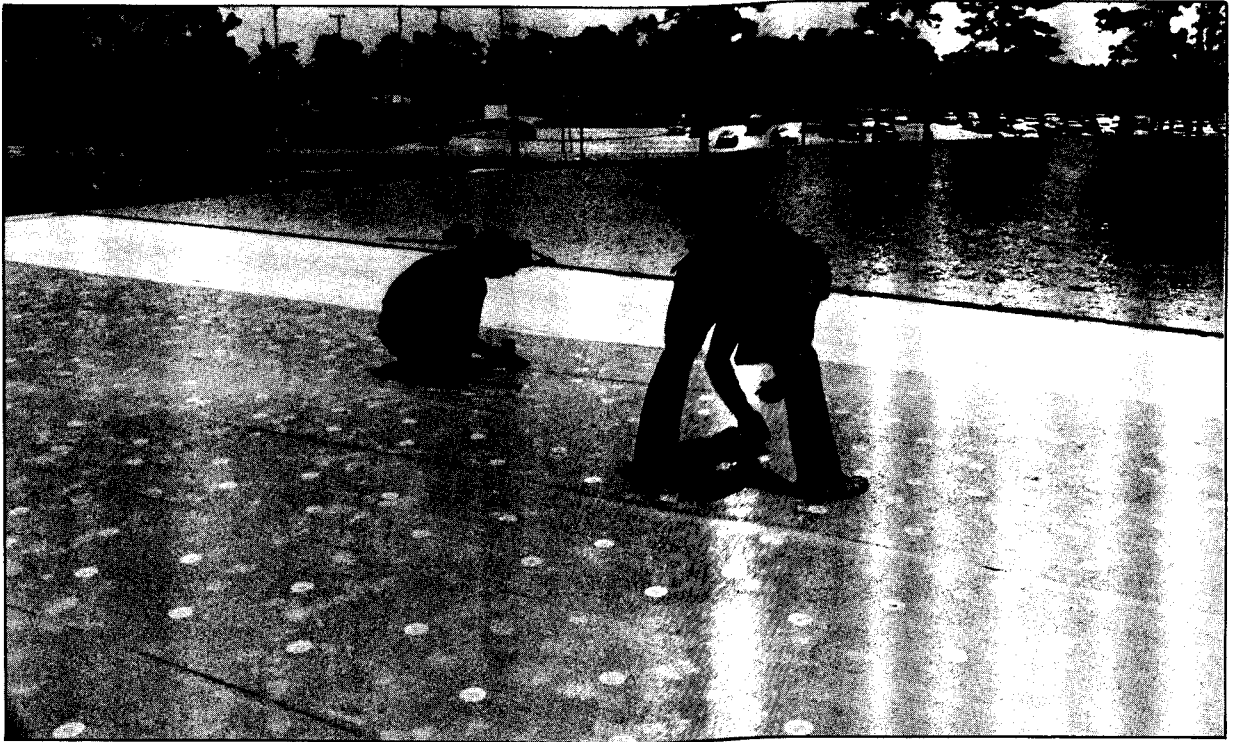
*Figure 16 Foil water seal, Kingswood School*

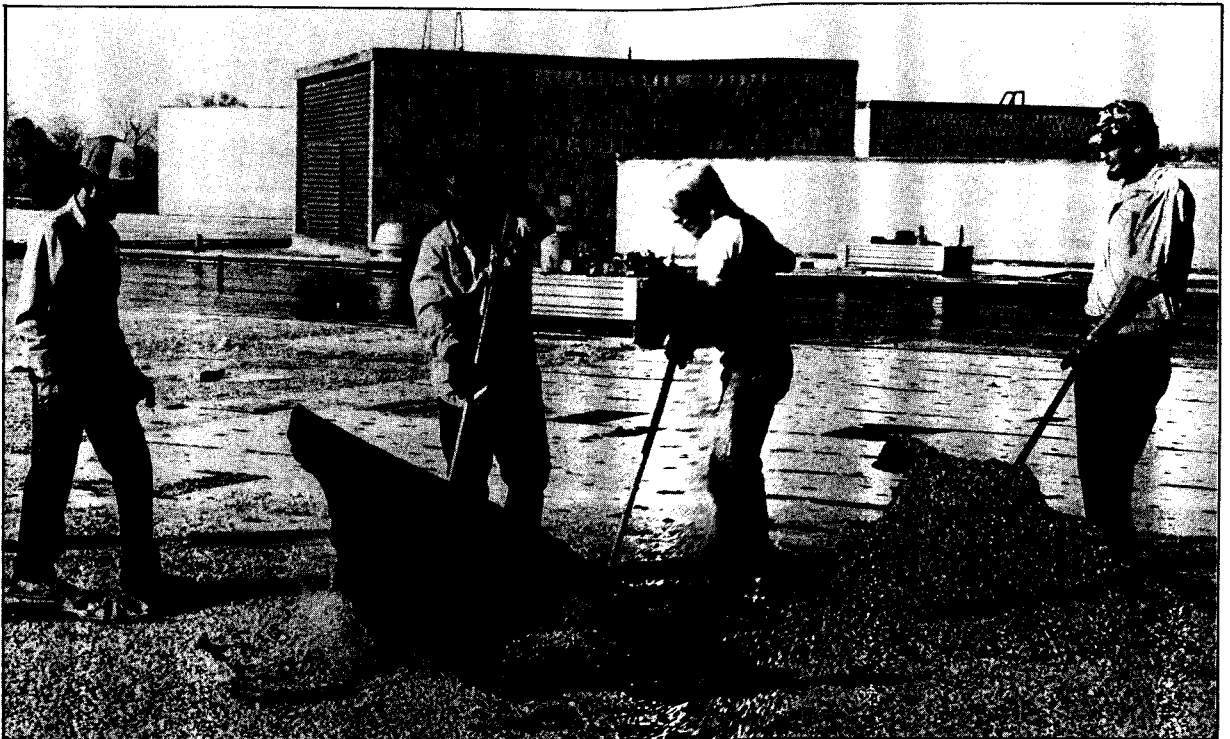
*Figure 17 Tear-off of original built-up roof from wet deck*

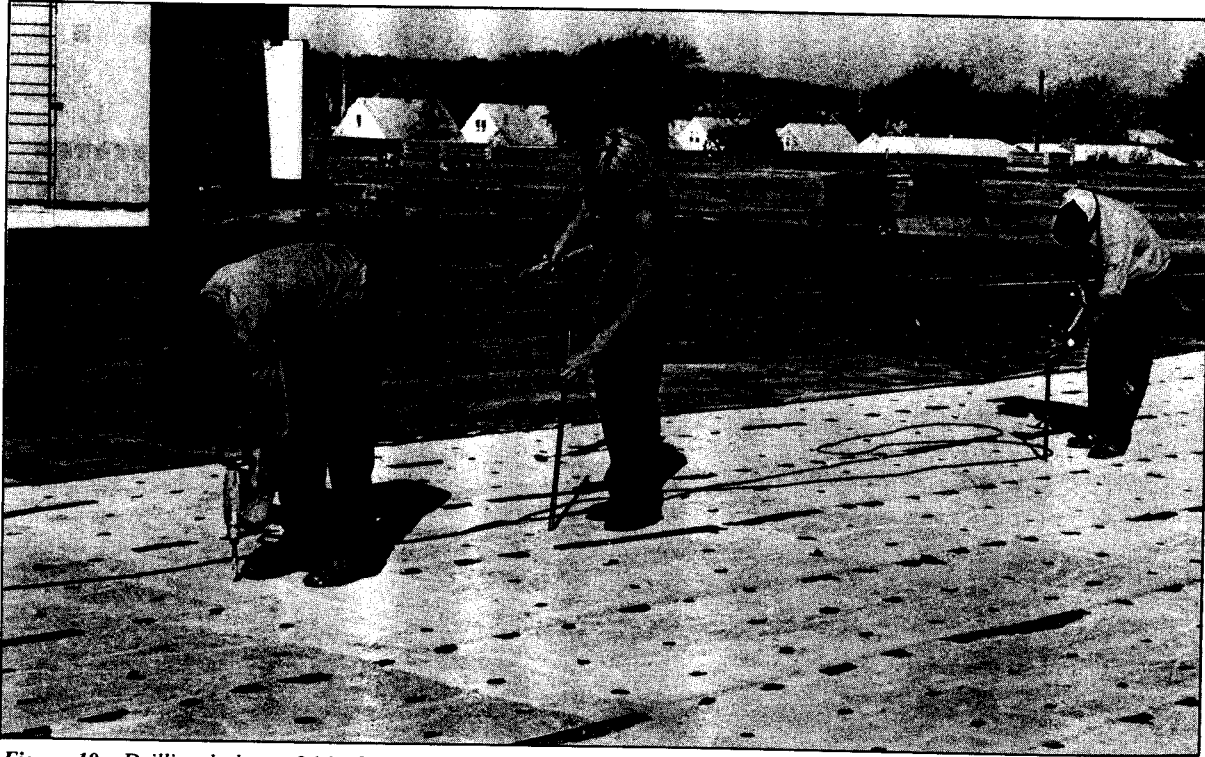
*Figure 18 Drilling holes at 24-inch centers. Steel rod is used as punch when drill bit slides on surface of flutes.*

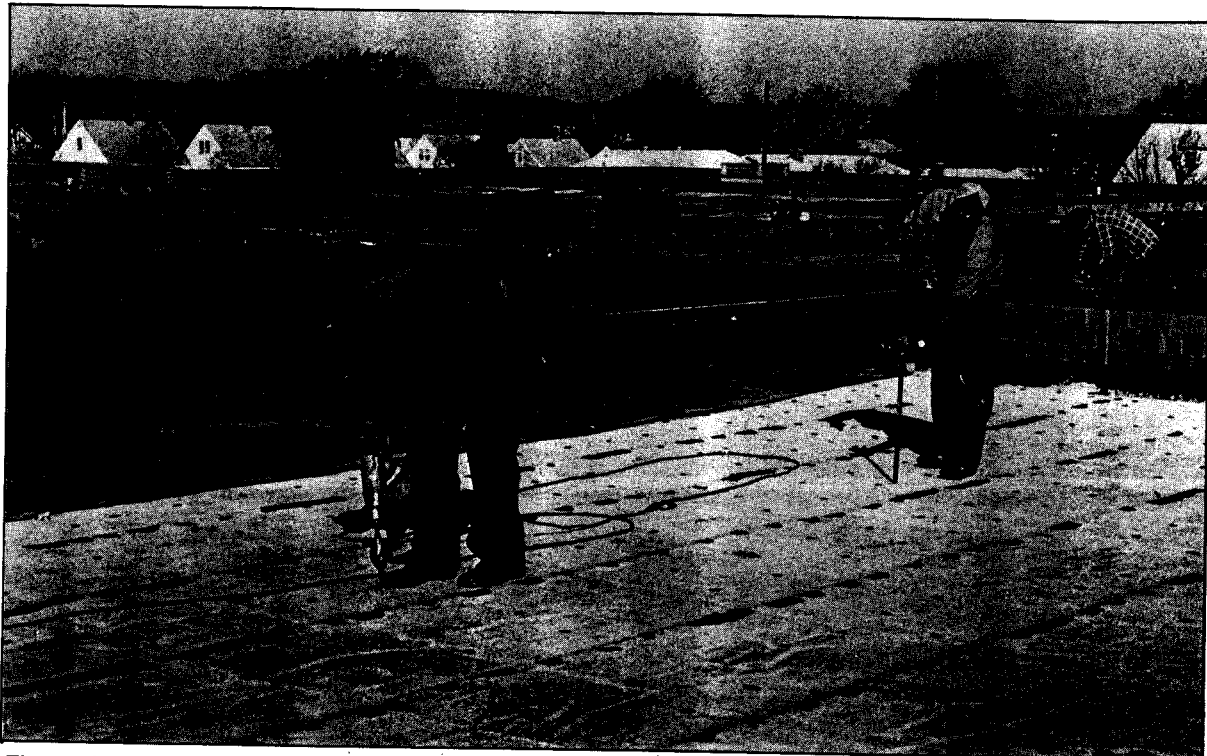
*Figure 19 Drilling and punching deck. This steel supporting deck had deep flutes. Punching not usually required.*

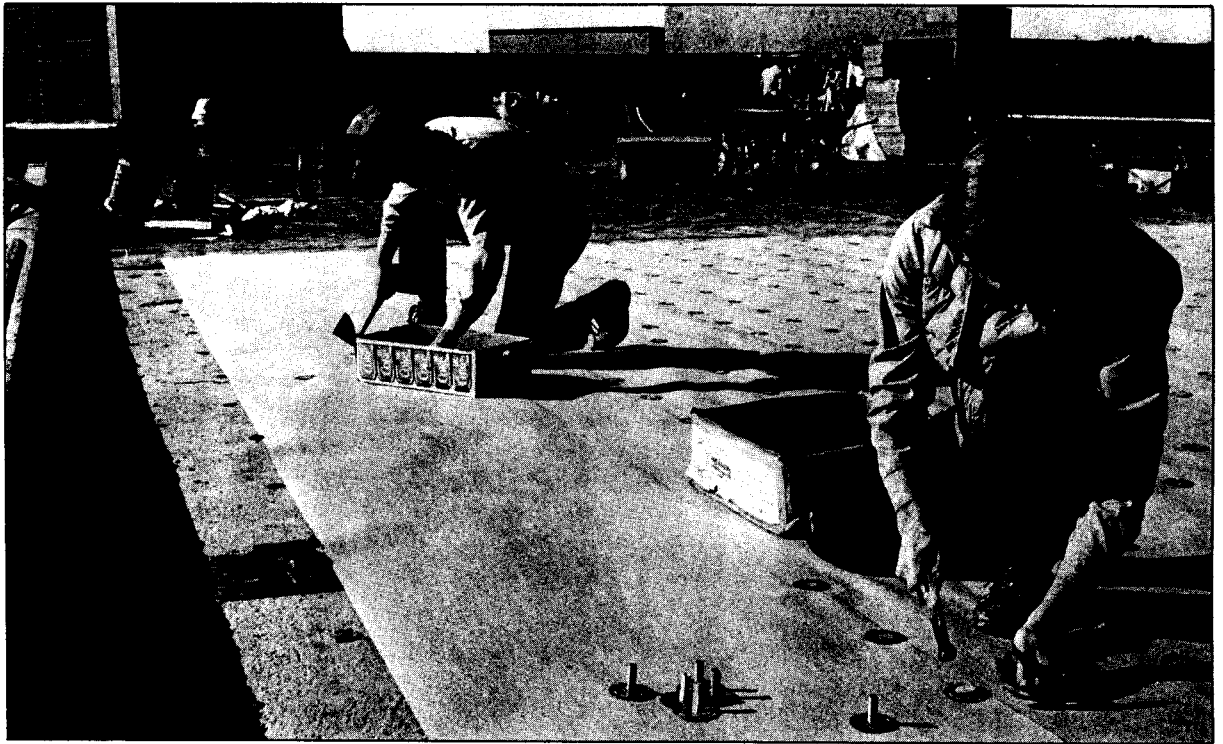
*Figure 20 Nailing aluminum foil water seal with nails and discs, 100 nails per square*

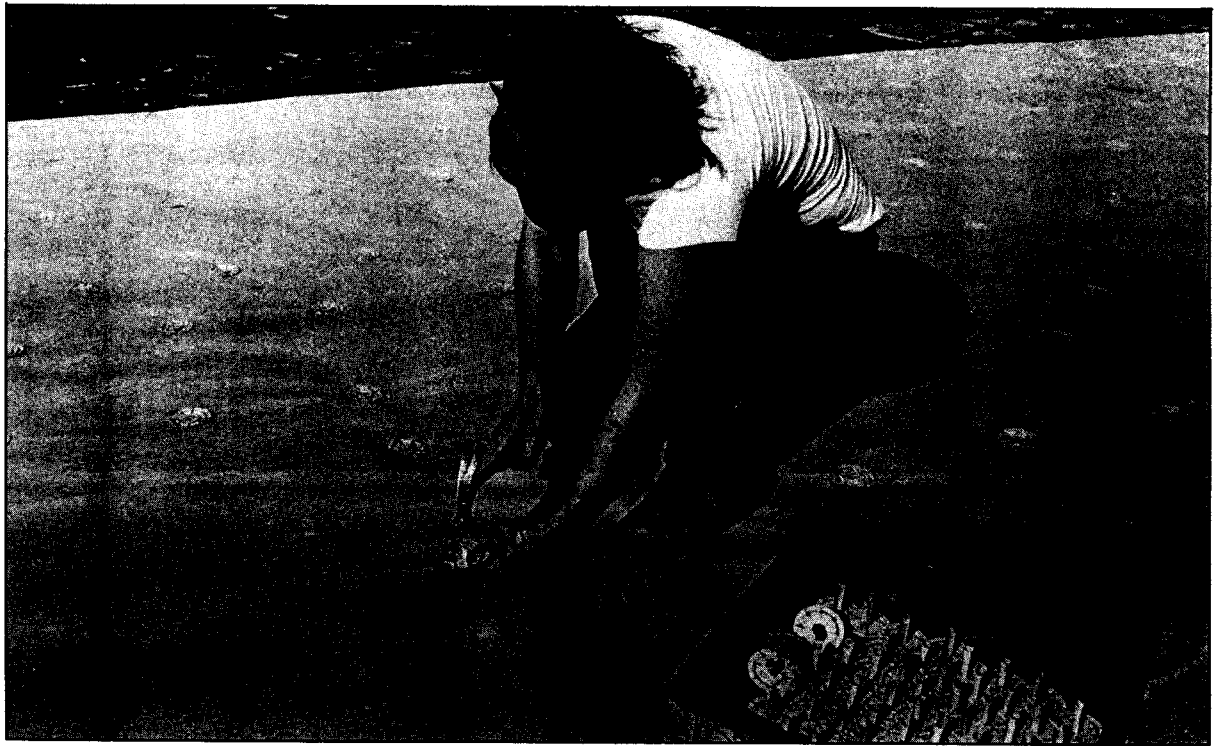
*Figure 21 Close view of nailing and pre-assembly of nails and discs*

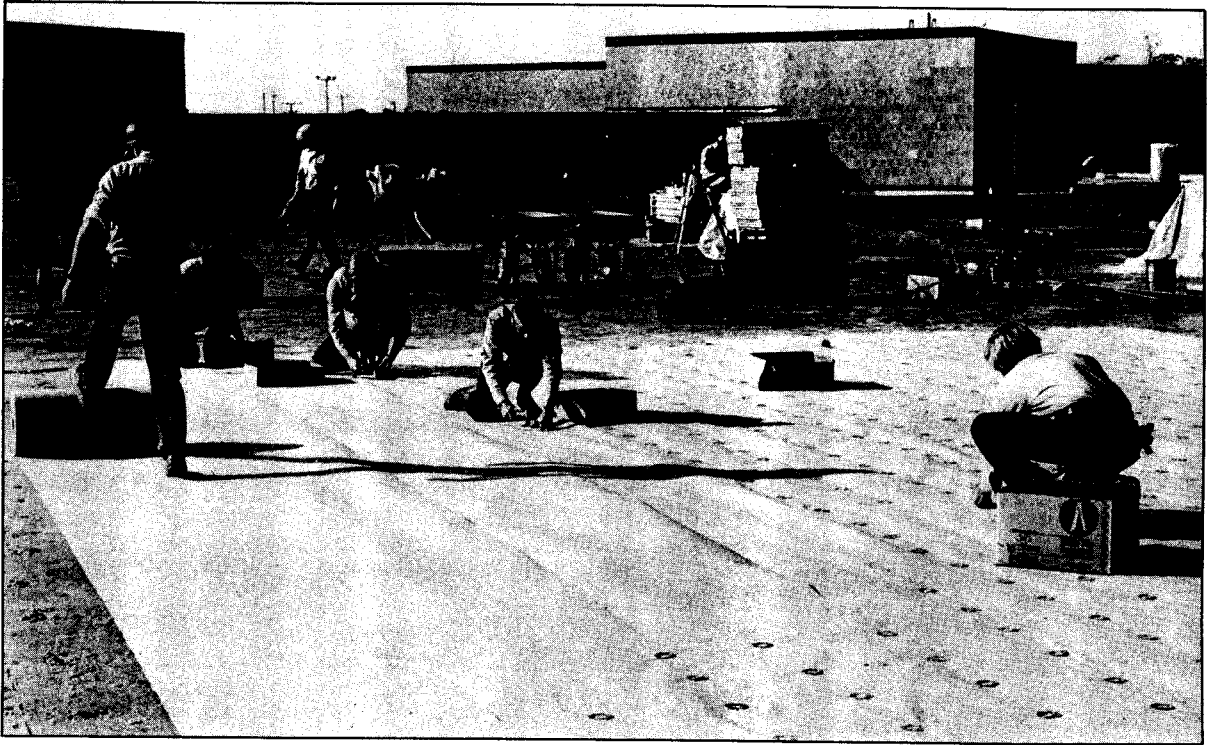
*Figure 22 Covering large area with foil water seal*

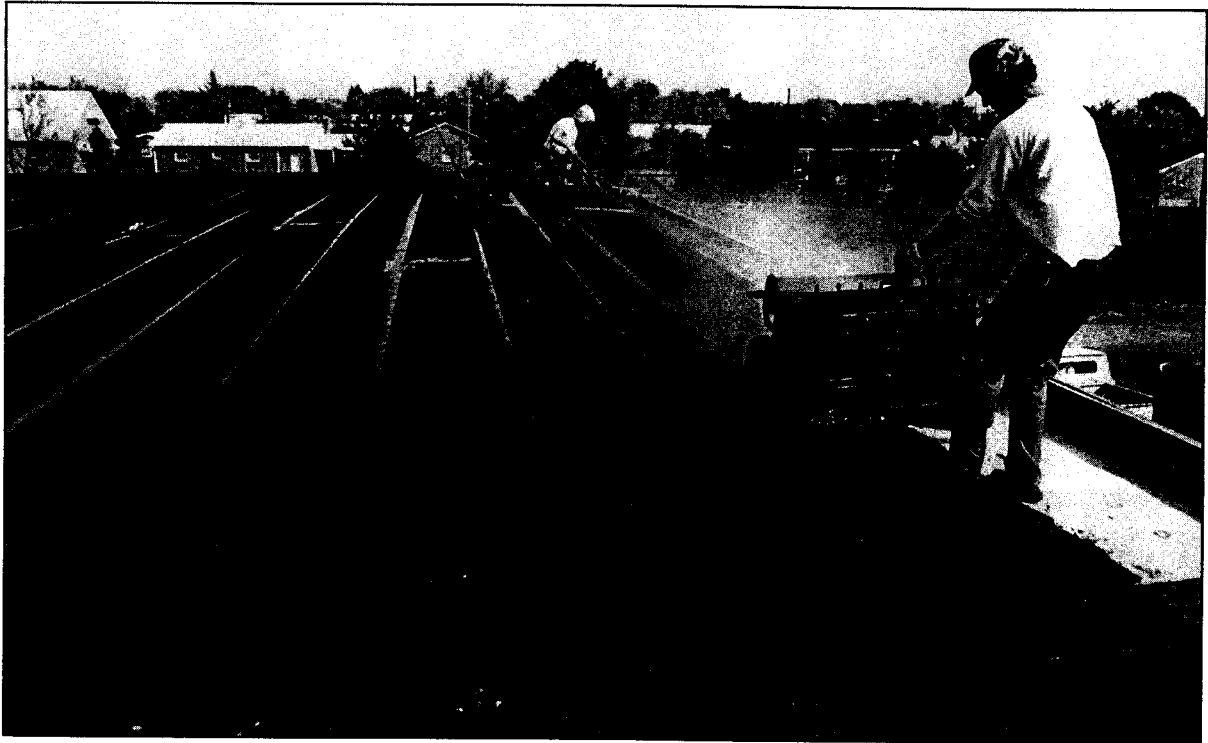
*Figure 23 Covering water seal with No. 15 felt and glazing surface to prepare for insulation application*

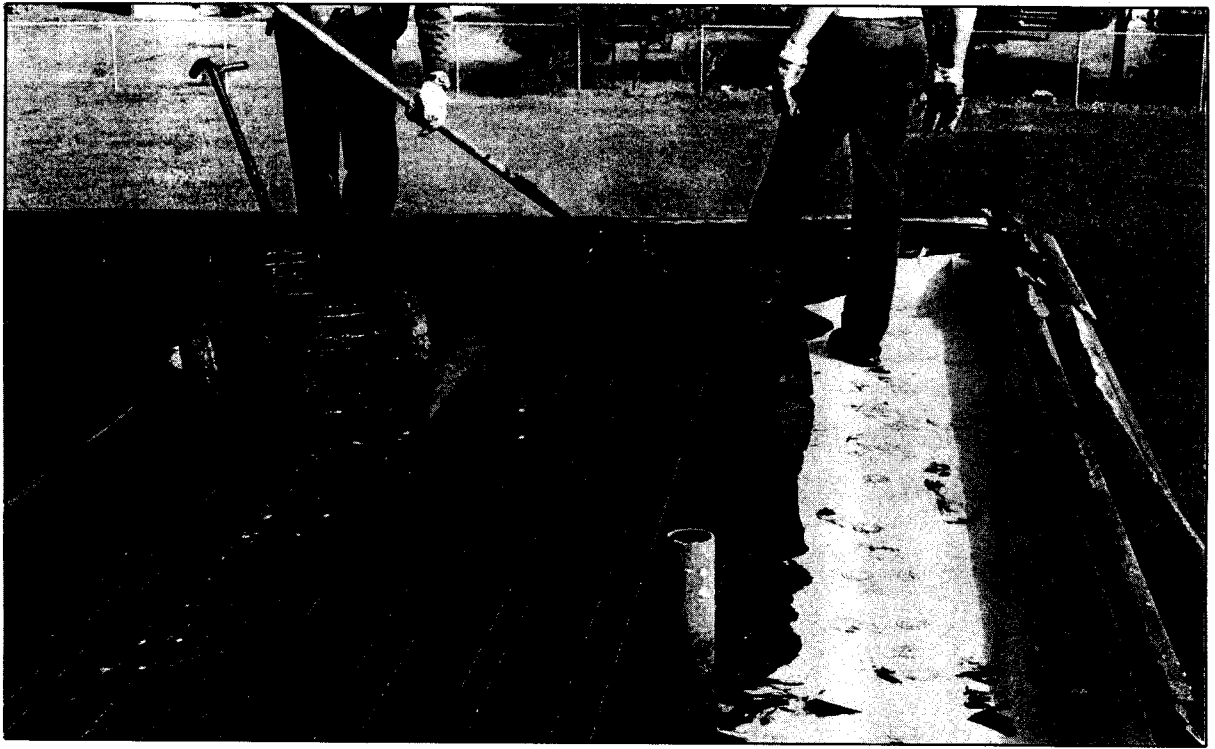
*Figure 24 Mopping No. 15 felt over water seal as temporary roof ready for insulation*

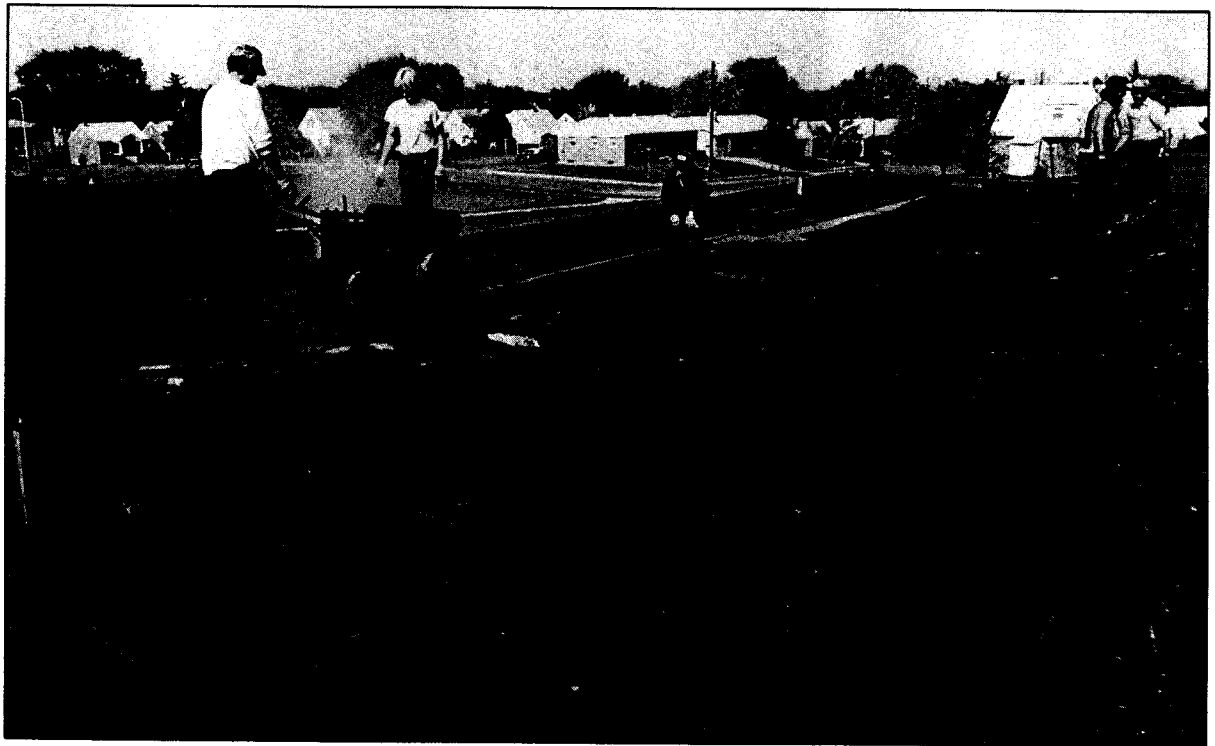
*Figure 25 Application of insulation. First layer is 1.4 inch urethane. Top layer is ½ inch fiberboard.*

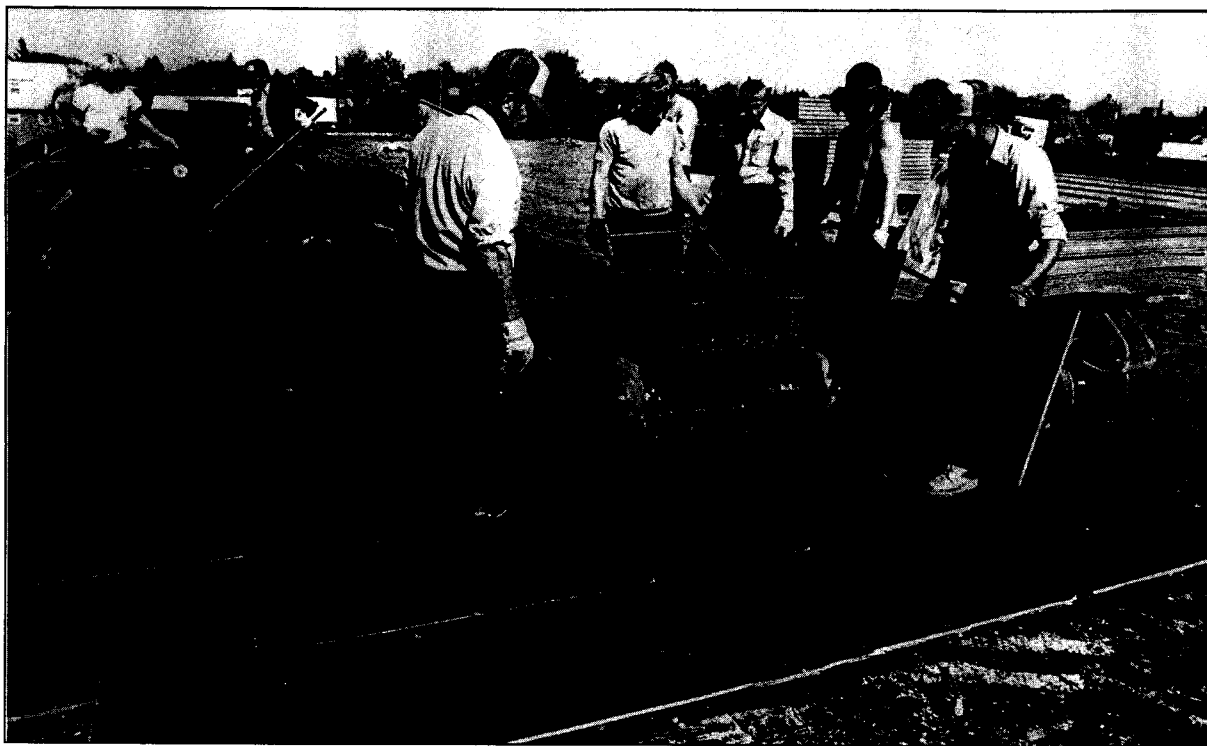
*Figure 26 Application of 1/2-inch fiberboard*

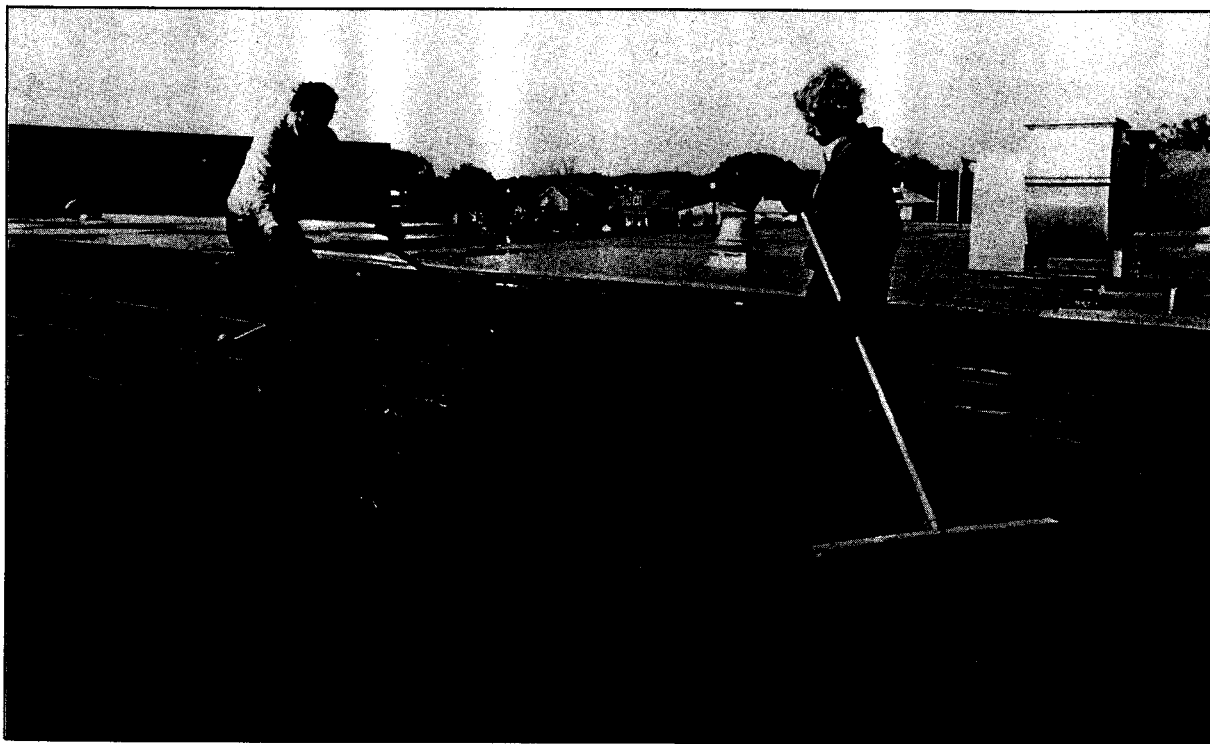
*Figure 27 Application of 3-ply glass felt membrane*

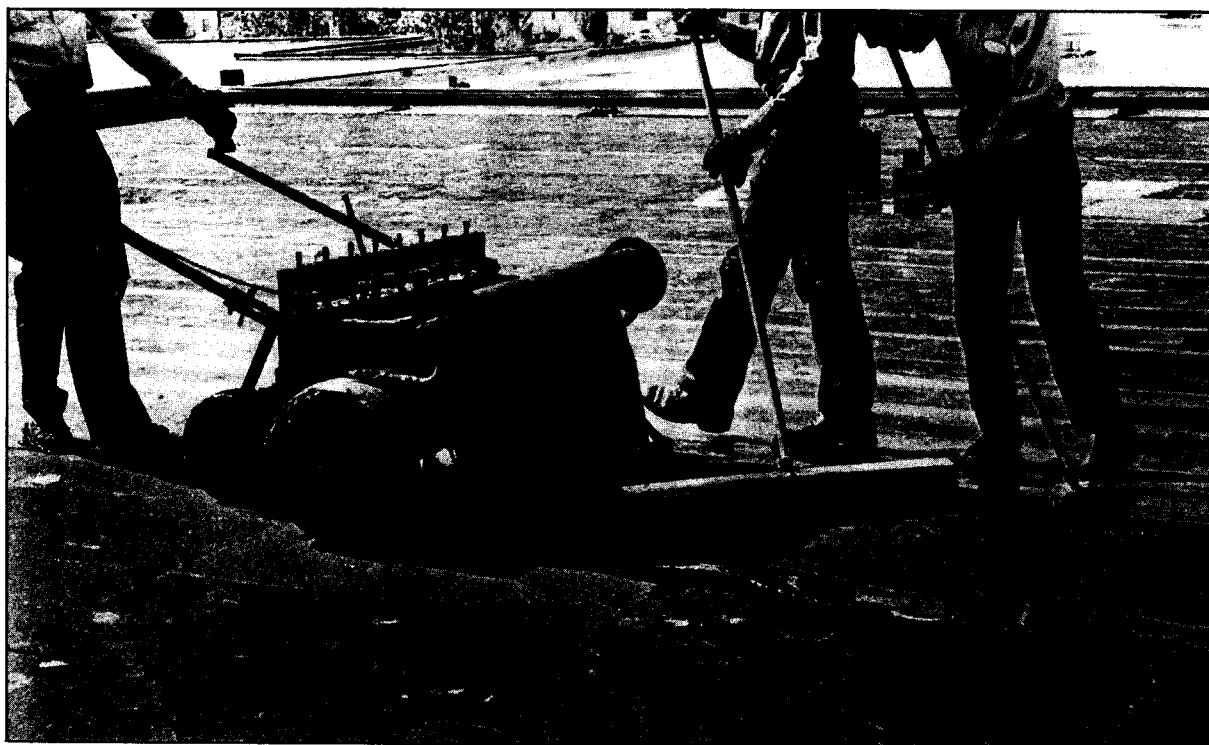
*Figure 28 Application of 3-ply glass felt membrane*
