# SUGGESTED REPAIR SPECIFICATIONS FOR BUILT-UP ROOFS OVER WET LIGHTWEIGHT CONCRETE DECKS

SMITH A. FUNK

Celotex Roofing Products  
Tampa, Fla.

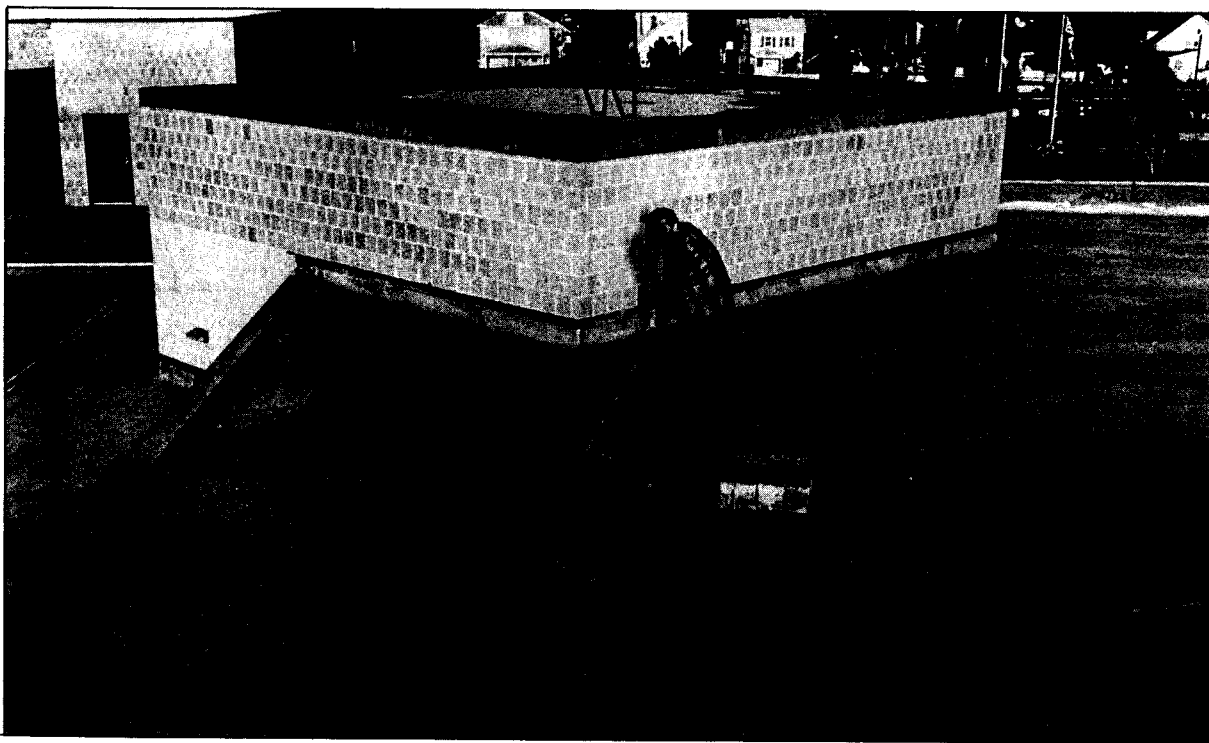
*Figure 29 Application of aluminum roof coating over glass felt membrane*

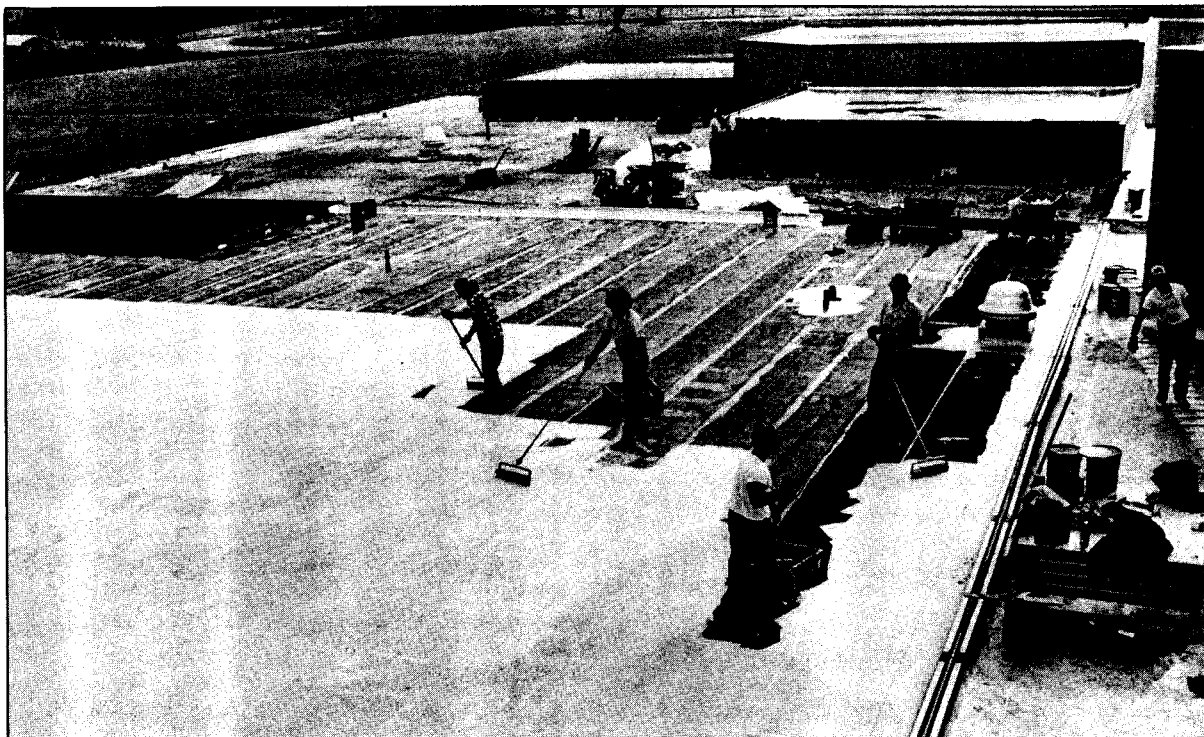
*Figure 30 Application of aluminum coating over glass felt membrane*

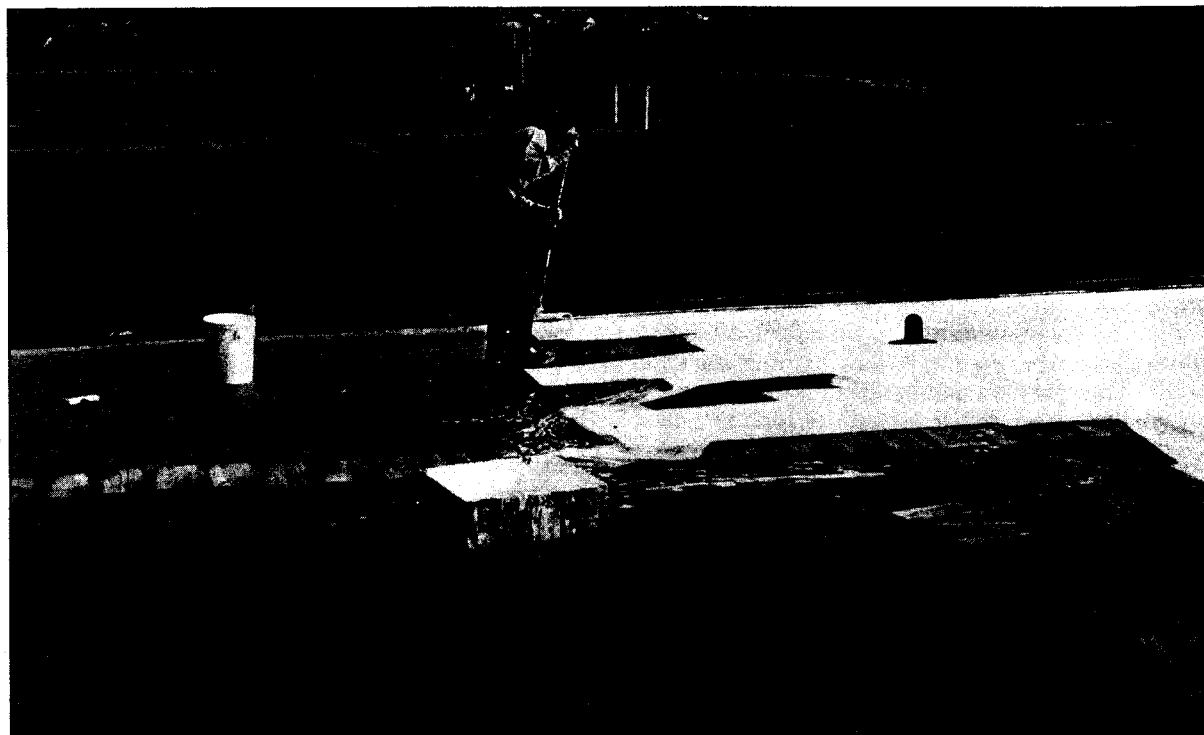
*Figure 31 Application of white coating over aluminum for maximum reduction of solar exposure and heat*

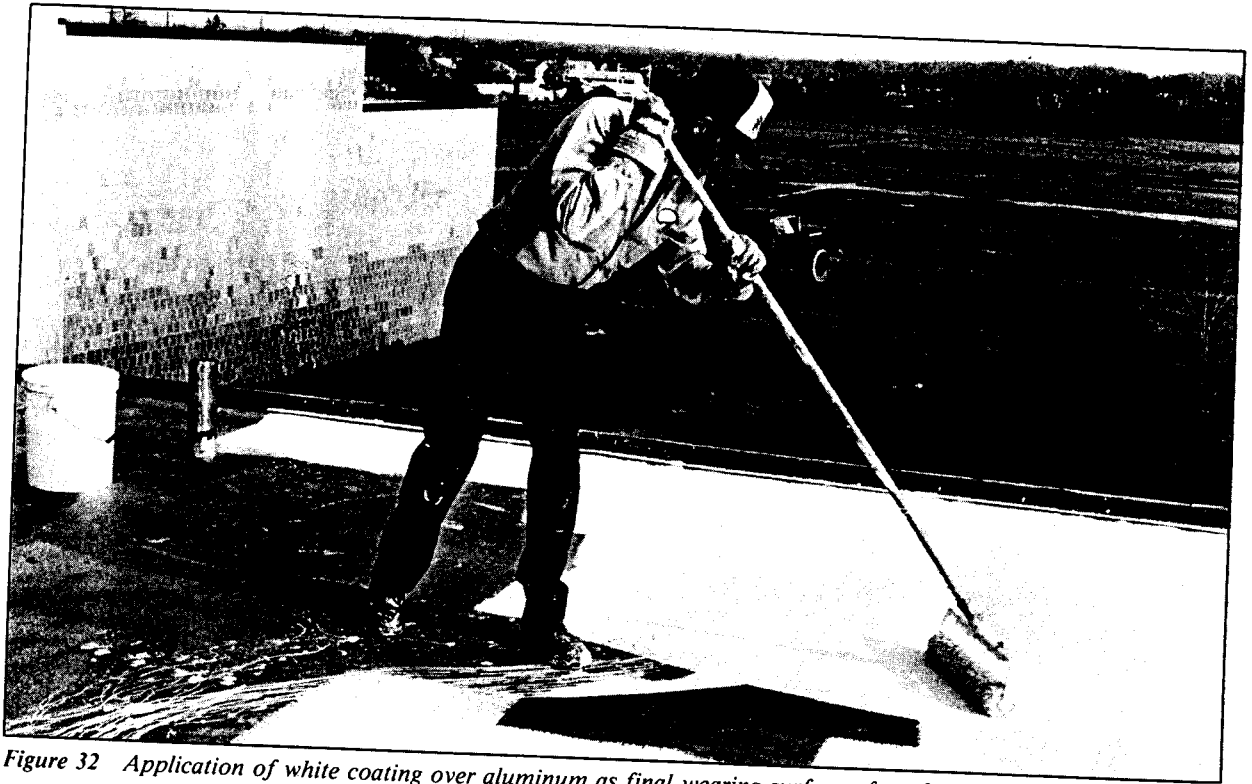
*Figure 32 Application of white coating over aluminum as final wearing surface of roof*
