MAINTENANCE OF SPRAYED POLYURETHANE FOAM (PUF) ROOFING SYSTEMS

R.L. ALUMBAUGH, S.R. CONKLIN and D.A. ZARATE

Naval Civil Engineering Laboratory
Port Hueneme, Calif.

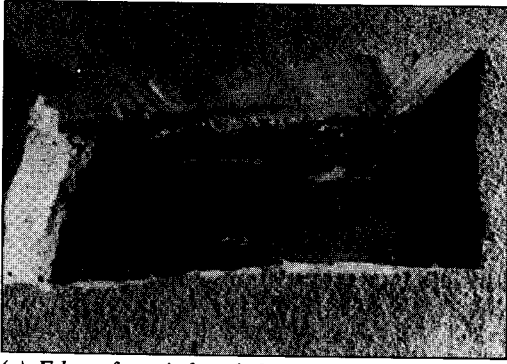
(a) Edge of cut is beveled and all debris is removed.

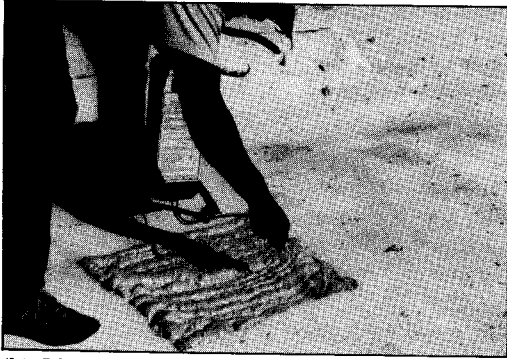
(b) PUF is patched with canned foam.

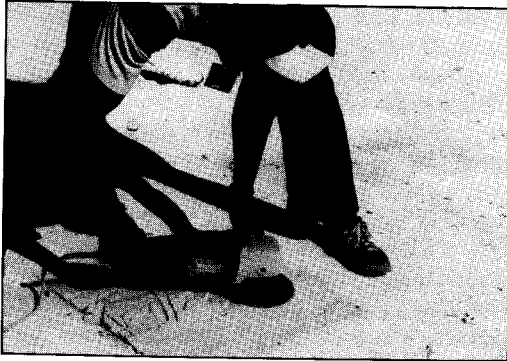
(c) Rough foam surface is smoothed with a disc sander.

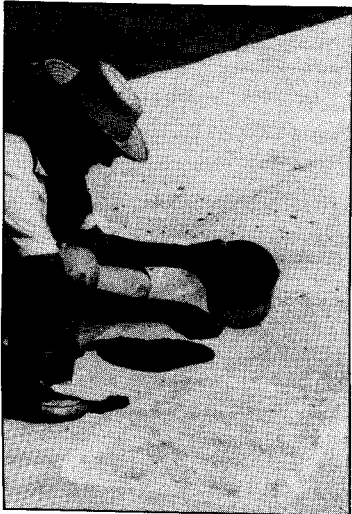
(d) Sanded foam surface is protected with coating or caulking and, where required, roofing granules.

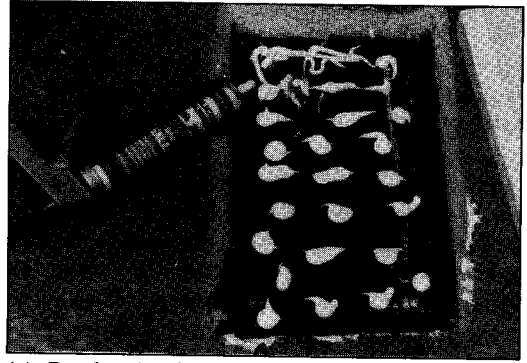
(e) Patch using boardstock is adhered to the roof deck with caulking material.

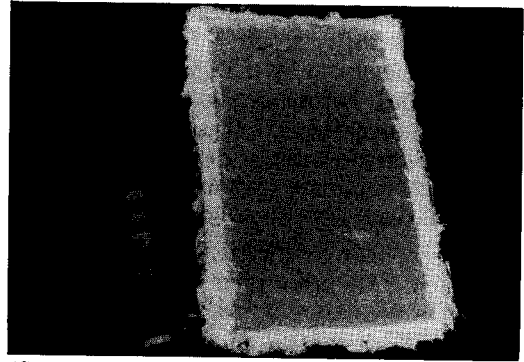
(f) Perimeter of patch is caulked.

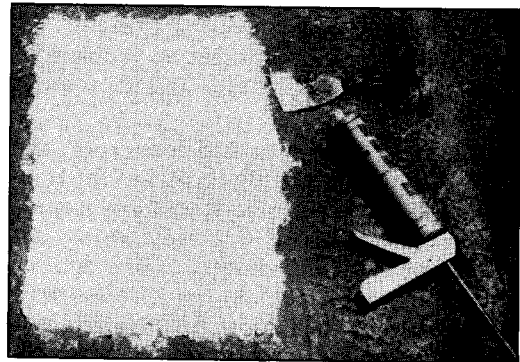
(g) Foam patch is protected with caulking material.
