A STUDY OF SOME STRUCTURAL INTERRELATIONSHIPS BETWEEN POLYURETHANE FOAM AND PROTECTIVE COATINGS

ADRIAN L. JENKINS

Gaco Western, Inc.
Seattle, Wash.

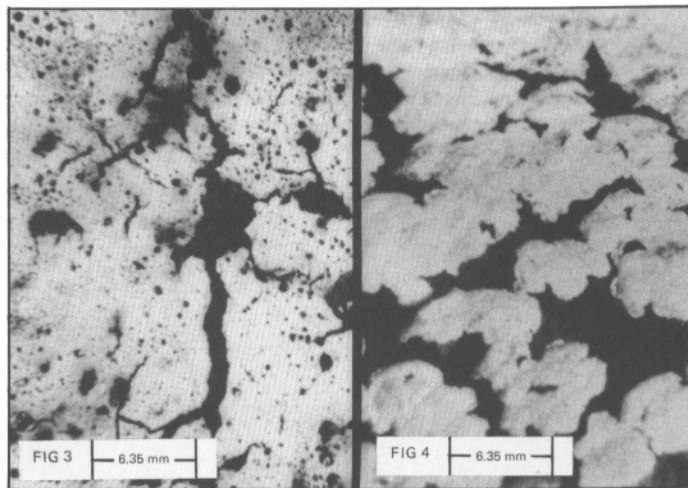
In addition, coatings with a film thickness of less than 20

mils (0.50 millimeters) were also subject to failure caused by delamination or surface cracking (*Figures 3 and 4*).

Figure 3 Thin, rigid acrylic coating from central Idaho after three years roof exposure

Figure 4 Thin, chlorosulfonated polyethylene coating from Pacific Northwest after five years roof exposure

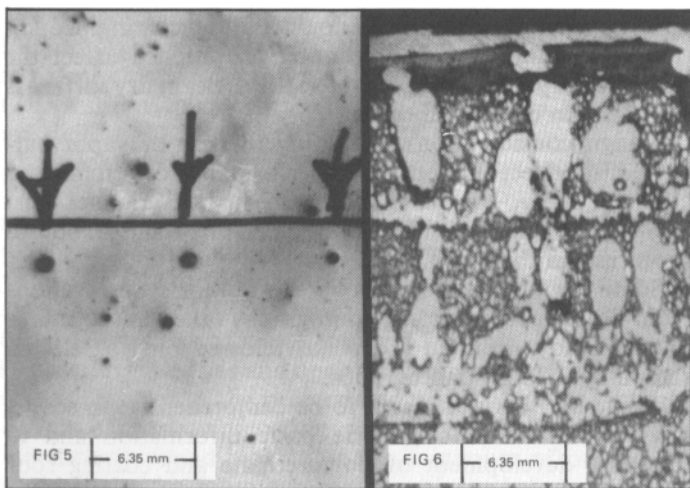
Pinholes are a frequently observed defect in foam coating systems and little is known about the extent to which pinholes affect roofing performance. Pinholes were found to have three primary causes. The first and most prevalent was related to the structure of the foam substrate. Installing polyurethane foam under conditions that allow the over-expansion of gas during foam formation can lead to "blow holes." Over-expansion of gas causes a gas bubble to vertically rise through the foam, rupturing cells and leaving a void or capillary to the surface. When coatings are applied over these voids, expansion of gases (caused by solvent vapor pressure or a temperature increase) makes air within the void expand and rupture the coating. While the coating is still fluid it may heal and reseal; however, if the coating has "gelled" to the extent that it cannot heal, a pinhole is left in the coating. Once propagated, these can recur regardless of the number of coats applied (*Figures 5 and 6*).

Figure 5 Three "pinholes" in a urethane rubber coating from a roof in central Utah after two years exposure. Black line indicates where specimen was cut, then ground to center of the pinholes.

Figure 6 Cross section of pinholes in Figure 5. Light colored voids in the foam are open to water entry through the coating.

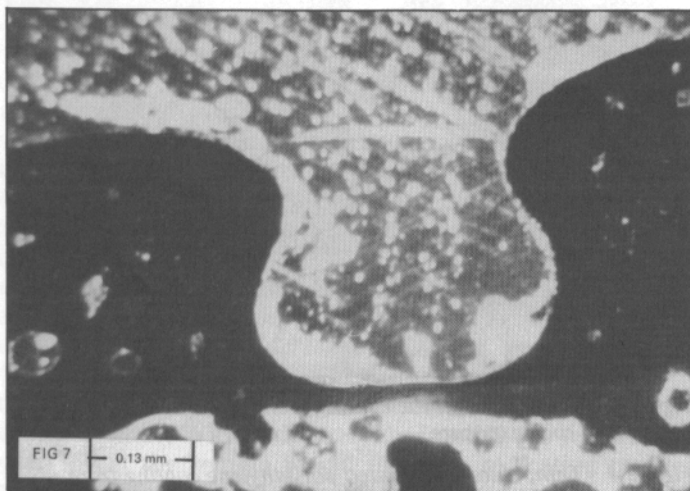
The second cause for pinholes is believed to be air trapped during the coating spray operation. The impingement of droplets of coating in a spray pattern tends to encapsulate and trap small particles of air. If the spray pattern is coarse, the air particles can be of significant size and some of these will rise and break at the surface. This type of pinhole does not completely penetrate the coating, so small air voids become trapped within the coating (*Figure 7*).

Figure 7 Pinhole in laboratory prepared urethane rubber coating. Air in spray application was entrained into the coating.

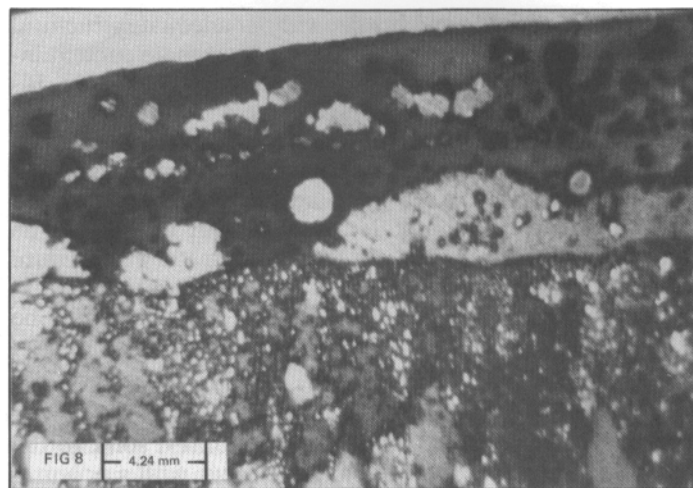
The third type of pinhole appears to be caused by a direct reaction of isocyanate components in urethane coatings with water vapor or moisture droplets in the atmosphere. This reaction results in the generation of carbon dioxide gas which, if present in sufficient amounts, can cause porosity in the coating and pinholes at the coating surface. The major difference between this occurrence and trapped air is that carbon dioxide-generated voids are generally larger and can lead to delamination within the coating (*Figure 8*).

Figure 8 Single component urethane rubber coating from Hawaii after two years exposure. Moisture reaction created considerable porosity in the rather thick coating.

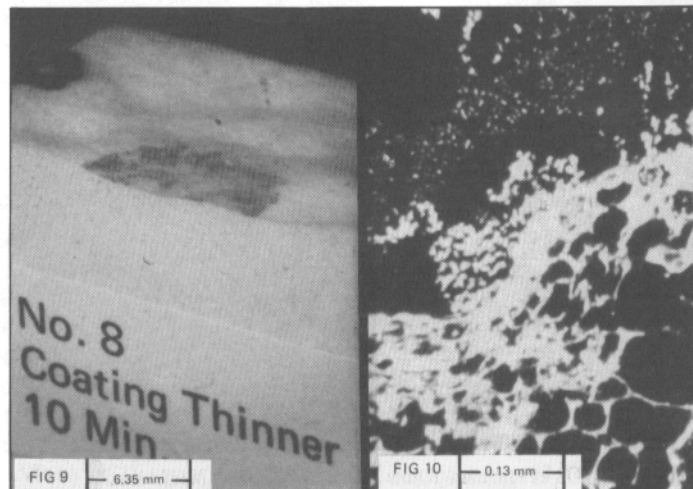
The foam sprayed at an ambient temperature of 50F (10C) showed a sensitivity to methyl-ethyl-ketone and methylene chloride for up to 30 minutes (*Figures 9 and 10*). It was resistant to all other solvents tested after a 10-minute cure time at 50F (10C).

The cure rate of individual foams and the temperature at which the foam cures determine how soon a surface can be coated without risk of dissolving the foam skin. If the skin is dissolved, released gas and open cell foam structure can propagate pinholes in the protective coating. Without testing all types of foam and coatings available, the results of this limited study would indicate that a minimum of one hour should elapse for foam cure before solvent-based coatings are applied. Cold weather applications or foams that otherwise cure slowly could require a longer time before coating.

Figure 9 Cross section showing drop of coating thinner containing a dye placed on three-pound foam 10 minutes after applying foam at 50F (10C)

Figure 10 Cross section of specimen in Figure 9 photographed in dark field. Left side shows collapsed surface foam from solvent effect while right side is unaltered surface.

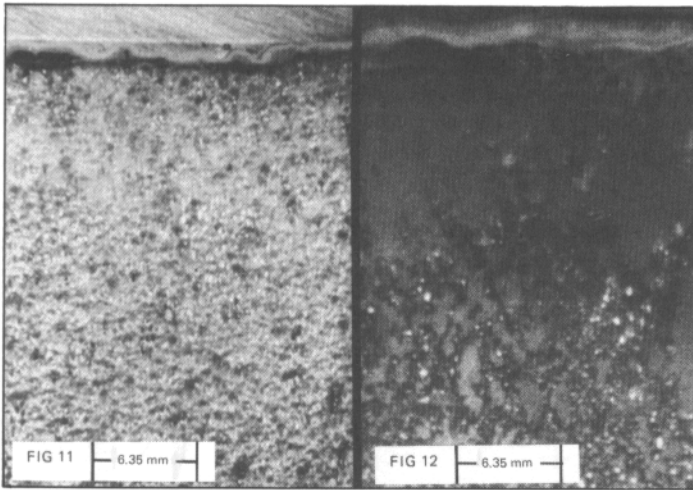
One theory holds that condensed water in the cells formed a shear layer under the coating that expanded with the formation of ice when temperatures dropped below freezing. This ice expansion appears sufficient to cause rupturing of the foam structure (*Figure 11 and 12*).

Figure 11 Urethane rubber coating taken from a project in the Pacific Northwest at the time of installation in 1975

Figure 12 Specimen taken in 1983 from the same area of project shown in Figure 11. Note gray area under coating without foam detail. This volume filled with blue epoxy resin during section preparation indicating an open cell foam structure.

This test supports the need for a vapor barrier in areas with warm and humid interior conditions and seasonal exterior temperatures averaging 20F (6C) or more below interior temperatures.

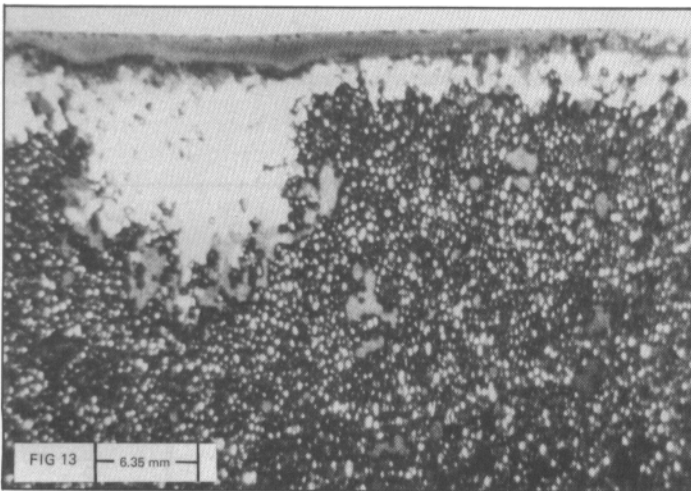
developed, simulating those from field samples (*Figure 13*).

Figure 13 Urethane rubber coating on three-pound foam after water transmission and freeze-thaw testing. Light area under coating filled with blue epoxy resin indicating open cell foam structure which developed after freeze cycles.

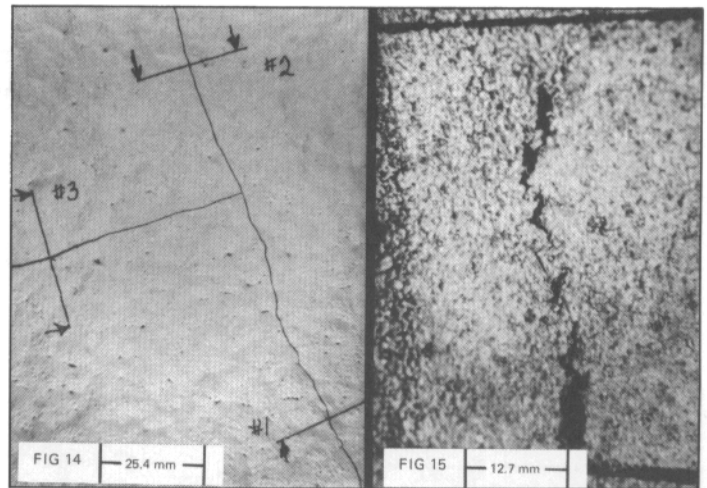
This study indicated that any coating with under 100 percent elongation when tested in accordance with ASTM D-412 in its specific service environment exhibited a risk of cracking. Rapidly dropping temperatures subject the coating to sufficient tensile stress to initiate a crack. Once a crack is started, continued stress concentrations promote crack growth (*Figure 14*).

Coatings which have minimal ability to stretch can develop enough thermal stress to accelerate decomposition or cause cracking. The coating on the surface of a well-insulated substrate is subject to rapid temperature change and must compensate for the thermal expansion or contraction of the substrate by yielding. Without this ability, the coating will crack. Although specific elongations could not be measured from field-collected samples, it is estimated that those coatings with less than 100 percent elongation are likely to develop cracks during the part of each year when maximum temperature changes occur. This was observed in samples from both arctic and temperate climate areas (*Figure 14*).

Field samples also showed that coatings with sufficient elongation can have that property compromised by the inclusion of a mineral granule surface. The granule is often used to increase fire and impact resistance, but also detracts from the ability of the coating to elongate under stress by increasing the surface area to which the coating is adhered. In addition, granulated coatings on flat roofs were observed to provide surface friction where ponds of water freeze. The resulting ice expansion cracks the coating and frequently the foam (*Figure 15*).

Figure 14 Acrylic latex coating on foam after two years exposure in Alberta, Canada. Cracks occurred after second winter and are believed to be the result of a rapid temperature drop. Black lines indicate where cross-sections were taken show a crack depth of $\frac{1}{16}$ to $\frac{1}{4}$ " (1.5 to 3.0 mm) into the foam.

Figure 15 Polyurethane coating with granules on foam after two years exposure in Nova Scotia. Crack is believed to have developed as a result of ponded water freezing on a flat roof. Crack depth into the foam reached a maximum of $\frac{1}{4}$ " (6.4 mm).

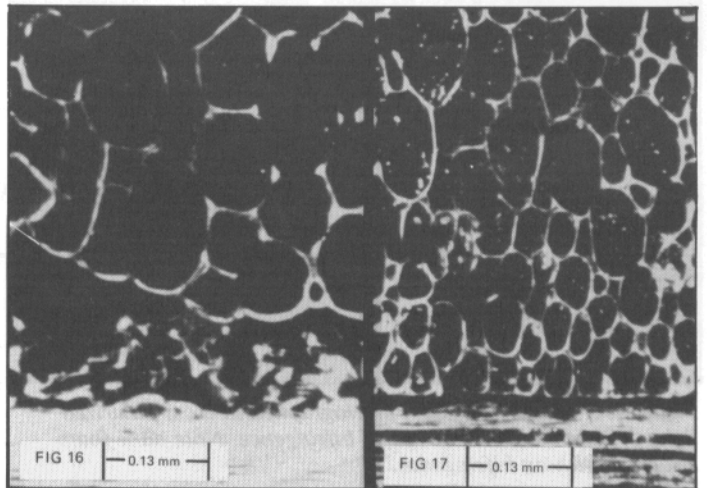
Many of the precautions needed for coatings also apply to the adhesion of polyurethane foam to substrates. The substrates must have cohesive integrity and must be dry. The presence of moisture causes the generation of carbon dioxide during the foam application process. This gas can cause overexpansion of the cell structure to a point where there is delamination or decreased strength of the foam (*Figure 16*). Primers used to inhibit water or water vapor transmission from a substrate were seen to be effective in preventing foam-water reactions and promoting good polyurethane foam cell structure. The primer, of course, must be compatible with the foam and substrate (*Figure 17*).

Figure 16 Cross section of three-pound foam that was applied to damp plywood. Note disrupted foam cell structure adjacent to plywood substrate.

Figure 17 Cross section of three-pound foam applied to primed plywood that had been dampened as substrate in Figure 16. Thin black line on plywood is the primer.

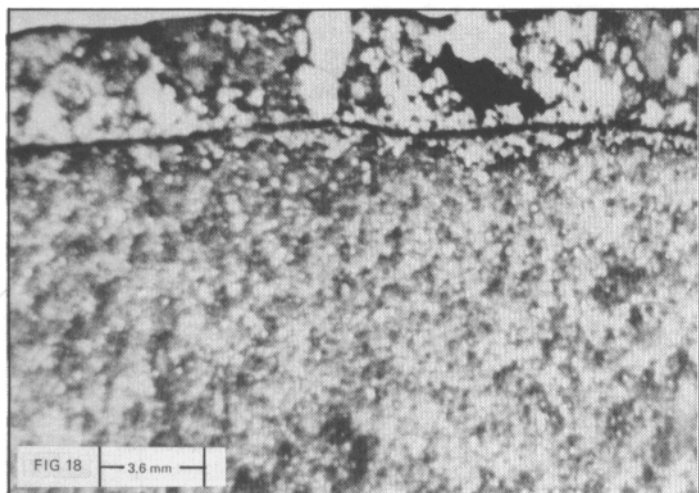
The application techniques used to install polyurethane foam can lead to variations in the foam structure. Several samples observed in this study showed a high degree of open cell structure in areas of thin passes of polyurethane foam. These thin passes lose much of the heat generated by the exothermic reaction between polyol and isocyanate, so that insufficient energy is available to cause the blowing agent to develop a uniform foam structure (*Figure 18*).

Figure 18 Cross section of 2.7-pound foam after three years exposure in central California. Thin foam pass is porous as indicated by light colored area that filled with blue epoxy resin during section preparation. Dark spot is dirt that collected through a coating rupture. Coating is an acrylic latex.

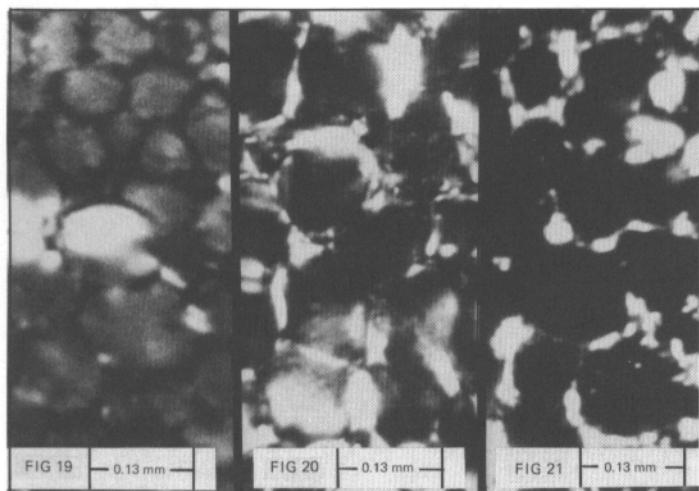
It was also observed that off-ratio foam resulted in decreased physical properties. Polyol-rich foam is frequently soft, with inadequate compressive strength. Isocyanate-rich

foam is often friable and brittle, without adequate structural strength. This study found that as the isocyanate content increased, there was also an increase in optical birefringence. Birefringence is an optical property of some crystalline materials to rotate polarized light. It is believed that either a high crosslink density of an isocyanate-rich foam produces such a crystalline property or that unreacted isocyanate forms urea crystals that in turn provide the birefringent property. The significance of birefringence is that a laboratory procedure could be established to determine the reacted ratio of polyurethane foam. The optical birefringence of foam should be retained regardless of age (*Figures 19, 20 and 21*).

Figure 19 Polyol rich foam photographed in cross polarized light. "Glare" indicates areas of birefringence. Note dark foam structure without birefringence.

Figure 20 Isocyanate rich foam photographed as in Figure 19. Note the increased birefringence (glare).

Figure 21 Normal ratio foam photographed as in Figures 19 and 20. This photo shows an intermediate degree of birefringence.
