A THEORY TO EXPLAIN ROOF SPLITTING BY ICE

ROGER G. RIEDEL

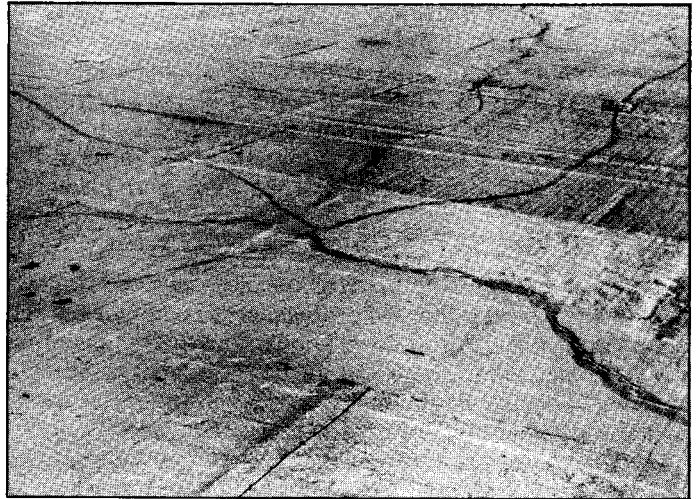
Photograph 3

1. A sprayed urethane roof system on a school in Winnipeg, Manitoba that failed by catastrophic splitting the first winter of its existence. (*Photo 1.*)
2. A similar system, behaving the same way in Elkhart, Ind. (*Photo 2.*)
3. An aluminum foil faced modified bitumen system nailed direct to plywood decking at Plover, Wis. (*Photo 3.*)

The aluminum foil faced system had been mechanically attached to the plywood deck of a new refrigerated warehouse. Batt insulation was located below the deck. Random, wandering stress lines were found in which the embossments in the foil were stretched flat. Where stress exceeded the tensile strength of the foil, it split and the modified bitumen layer also split in places. None of the cracks were linear or related to the structural elements in any way. They seemed

related entirely to the shape of snow drifts on the roof.

Yet another factor appears to be present—color or reflectivity. The superbly reflective aluminum foil system may have prevented much more extensive damage. The roof was repairable. The Elkhart and Winnipeg sprayed urethane systems were coated with grey material. Being less reflective, the coating would promote more thawing.

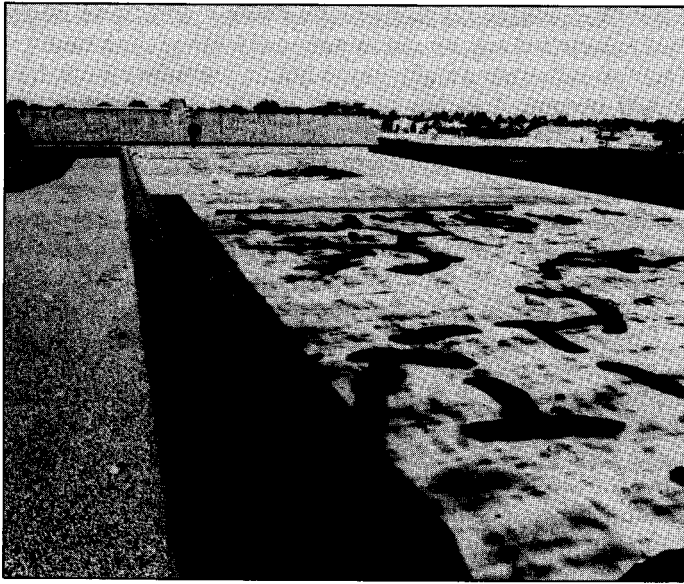
Photograph 1

The urethane roofs had been applied over old insulated flat graveled roofs to overcome leaks and to improve insulation values. In both projects, provision was made in the contract to build in drainage slopes (at considerable expense for the additional urethane foam required) by applying up to 5 inches of foam at perimeters and 1½ inches at drains. This proved to be beyond the skill of the applicators, resulting in the roofs remaining about half ponded.

The coatings of both projects were acrylic latex emulsion claiming 280 percent elongation capability. Application rates were found to vary in thickness from nearly adequate to unacceptable, but in both cases the areas with greater coating thickness fared little better with regard to splitting than those with a thinner coating.

These two failed urethane roofs have been replaced with traditional BURs applied to new flat or tapered preformed foamed insulation of similar R value, and splitting has not occurred. This indicates that good tensile strength, rather than good elongation, should be sought in a roof membrane situated in cold regions.

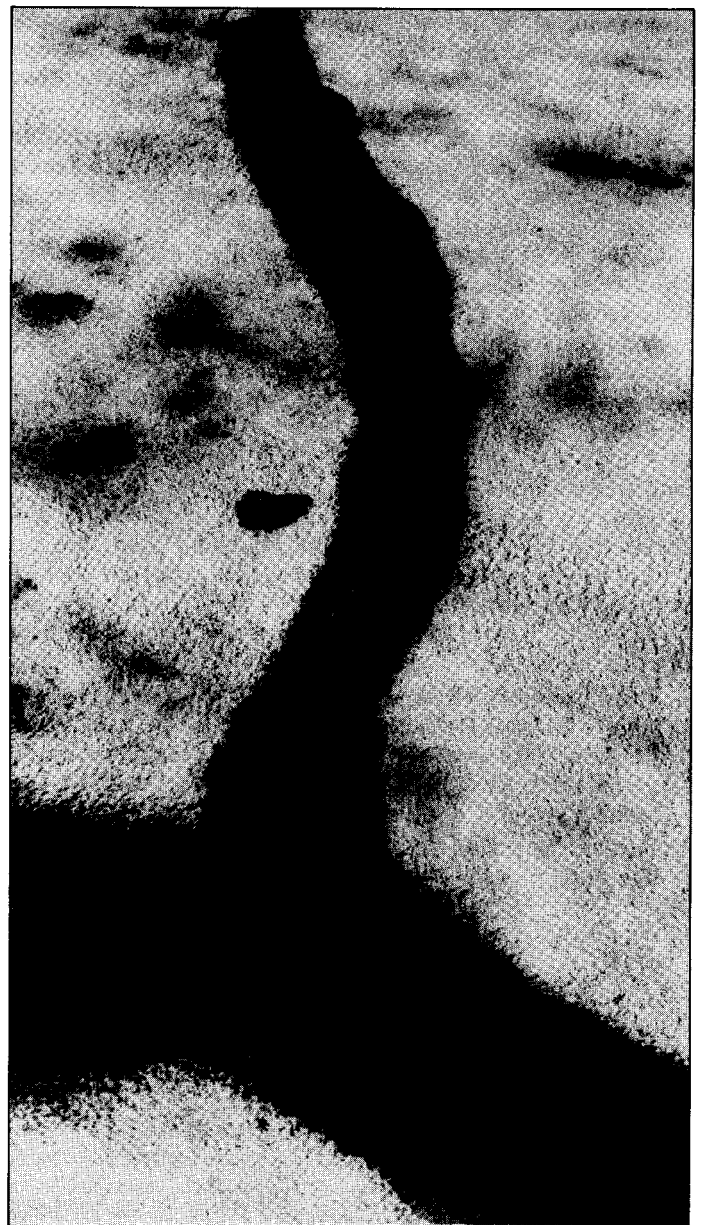
Photograph 4

Although only a few such examples have been investigated directly by the author, splitting failures of sprayed urethane roofs is quite widespread, according to technical discussions in meetings of the urethane contractors during their annual association conventions. Manufacturers have been asked for answers, and tests and surveys of contractors' experiences have been suggested. No recognition of splitting has been published or officially recognized, and an effective repair technique has not been found. (Photo 4.)

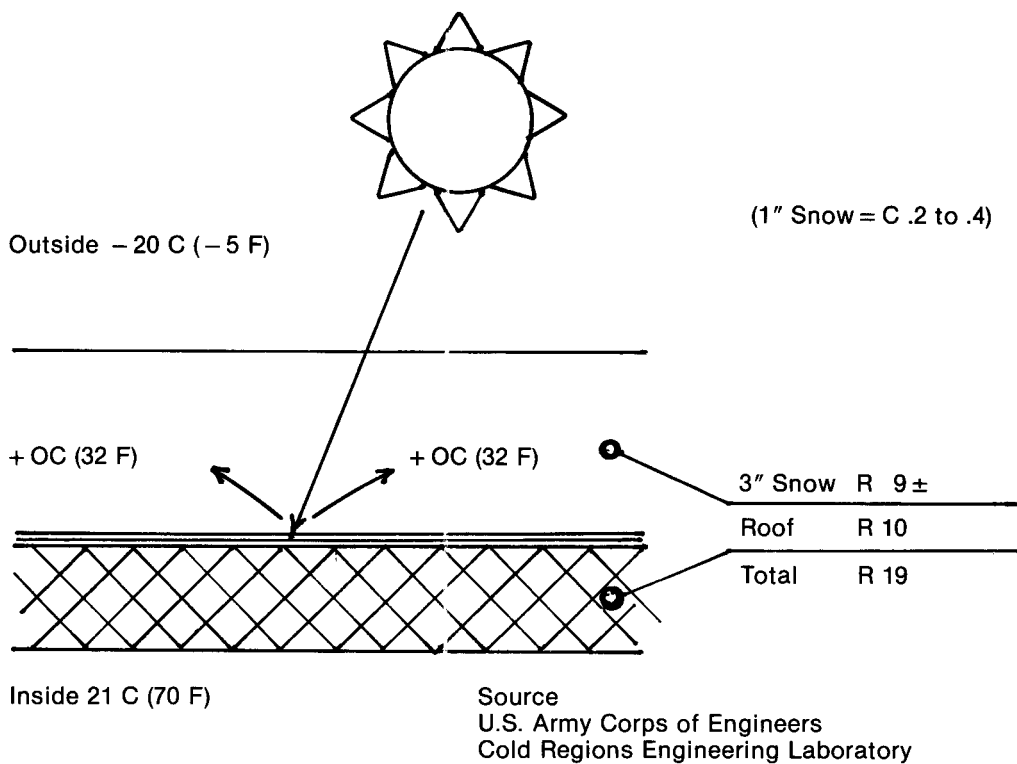
Figure 2

"Snow is a fairly good insulation—hence if a roof has a sufficient snow cover the interface between the membrane and snow can be above freezing. An example: With approximately 2 inches of insulation (R = 10) and 3 inches of snow, the interface melts at an outside temperature of about -5F (inside temperature 70F). If the roof does not have a uniform snow cover the snow can melt in one place and refreeze at others." (Figure 2.)

Actual conditions found in Wisconsin verify this. A school roof having about 1-inch-per-foot slope and better than R-10 insulation was found to have ankle-deep slush under a foot of snow on a cold day without sunshine. That this would become 4 inches of solid ice that evening was not realized at the time.
