SUCCESS AND FAILURE WITH (APP) MODIFIED BITUMEN

NICO A. HENDRIKS

BDA Buro Dakadvies BV
Gorinchem, The Netherlands

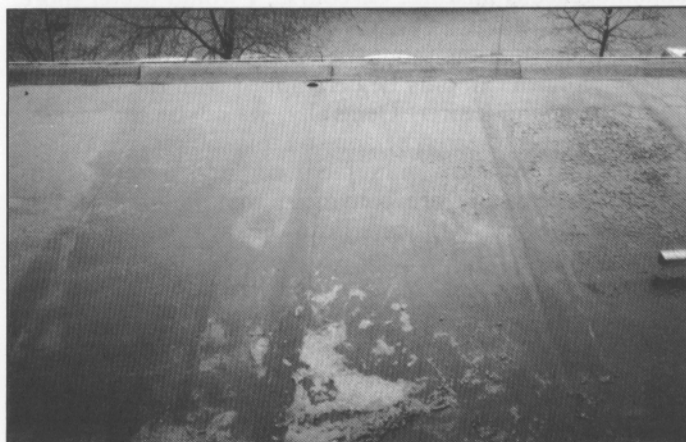
Figure 1 Part of the Case 1 roof

On an important part of the roof the slope was nil or negative, resulting in a lot of ponding. The total surface of the roof showed extreme cracking, which looked like alligator skin in many places. This phenomenon was the worst at ponded areas, but it was also very serious in dry areas. The polyester reinforcement was easily visible through the craquele-cracks.

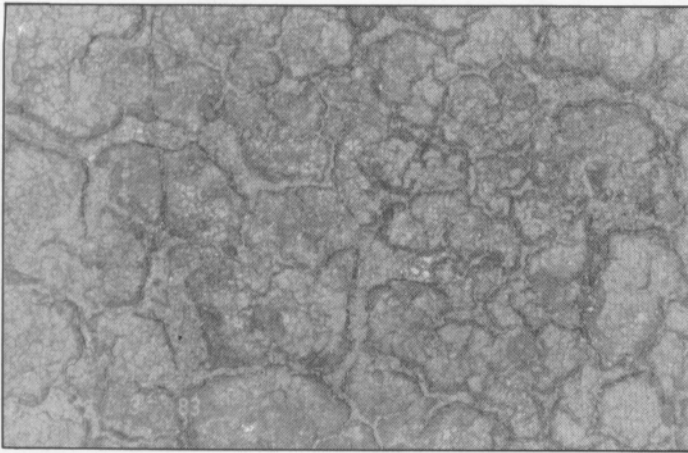
Samples of the roof were investigated in our laboratory. We found a ring and ball temperature of 112C (234F), which is very low for an APP mixture. As far as it was possible the low temperature flexibility test showed that the product did not even pass at 10C (50F), although the manufacturer stated -15C (5F) in its specification. We also found a relatively high, 15.7 percent filler content.

Figure 2 Case 1: Deterioration resulting in alligator skin

the amount of APP was less than 15 percent and/or the APP and base bitumen were not properly mixed during the production. Furthermore APP mixtures contain a certain amount of oxidizing components that can dissolve in water. This caused a brownish discoloration, which is typical for APP roofs. Good quality APP roofings show this only moderately, and after about a year the discoloration washes away.

In this case there must have been far more oxidized, soluble components than normal, combined with, for instance, nonhomogeneous mixture. Of course, I would prefer more definite conclusions, based on sound technical facts. However, information about the mixing and the quality of the base bitumen can only be determined with the cooperation of the manufacturer. Generally, we advise that extensive comparative research be done on this subject, with close collaboration between manufacturers and research institutes. Anyway, we are convinced that failures of this nature, which are very rare, can be avoided by good manufacturing quality control.

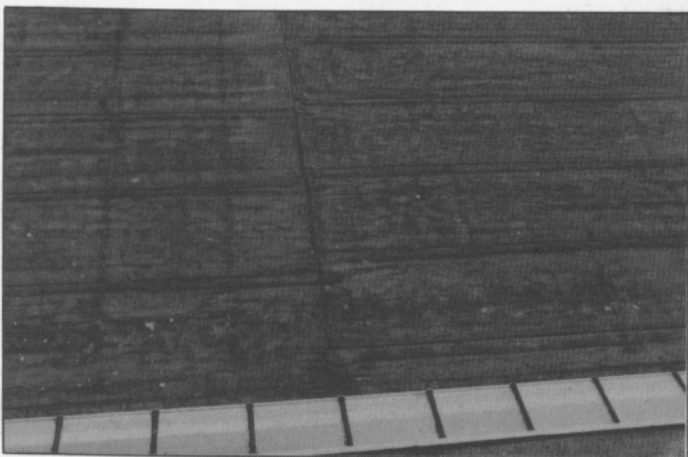
Figure 3 Part of the Case 2 roof.

Contrary to our advice, the top layer was applied with hot bitumen (oxidized bitumen 110/30). Our advice is based upon the fact that there is not much difference between the 150C (302F) softening point of APP and the 180 to 200C (356 to 392F) application temperature of the adhesive bitumen. This may result in poor adhesion. The roofing company preferred pouring with hot bitumen rather than the more normal torching. Their reason was production speed is substantially higher with pouring.

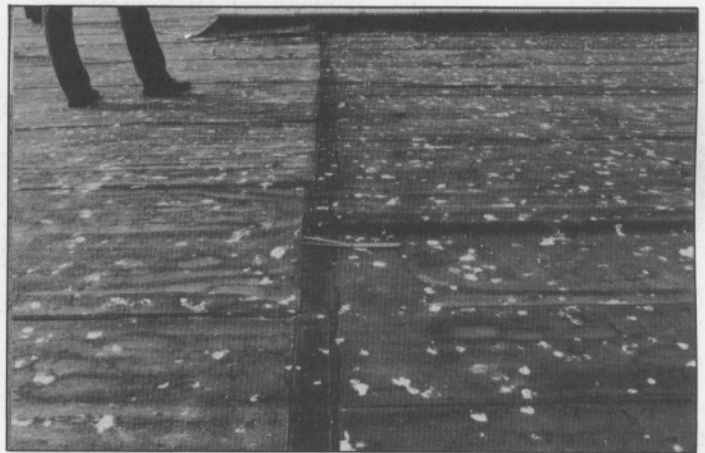
One year later the roofing showed strong longitudinal shrinkage and transverse wrinkling over about one-third of the total 25,000 square meters (approximately 2700 squares) roof area. We cut several samples from the roof and found that free shrinkage at 80C (176F) was 0 to 0.2 percent. The shrinkage on the roof, which was easily measured at the transverse overlaps, showed a total shrinkage of just under 0.7 percent. This meant that the product itself met the specified quality requirement of 0.7 percent maximum. In other words, there was not enough resistance against shrinkage forces in the polyester mat.

Figure 4 Shrinkage and wrinkling of the Case 2 top layer

We found that the APP product was good quality. However, application with hot bitumen is very risky because of the excellent chance for poor adhesion. It allows the polyester mat to revert to its original form before being coated with APP bitumen. This causes longitudinal shrinkage and transverse wrinkles. APP modified roofing, applied by torching, very seldom shows marked shrinkage.

We concluded that this failure could have been avoided by using the right application technique.

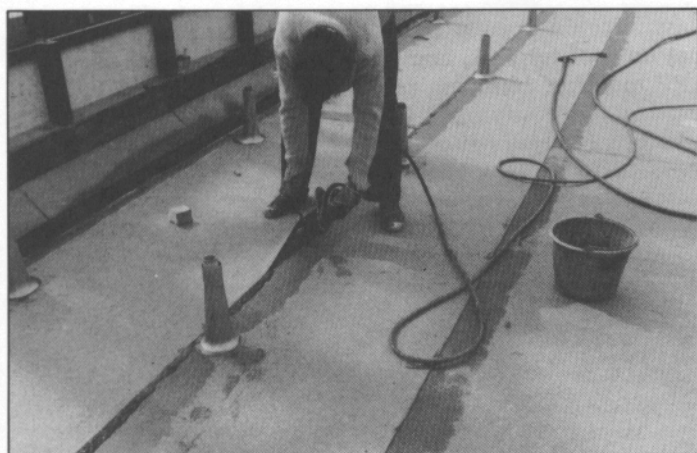
Figure 5 Separate torching of the Case 3 overlaps

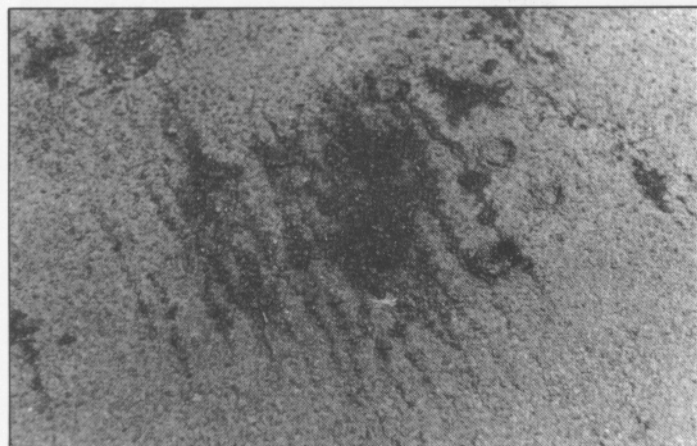
Shortly after application, while the majority of the project was unfinished, it was noticed that the roofing surface showed several extremely soft, brownish "bleeding" spots. This was rather alarming, because on a warm day it was almost impossible to walk on the roof without damaging it. As it was only single-ply roofing, and the showrooms underneath contained valuable goods, the owner was very worried, despite the fact that no leaks had yet occurred.

Figure 6 Case 3 "bleeding" spots

From our observations it was quite clear that the APP bitumen mixture was desintegrated by the cold mastic solvent. It caused segregation, which actually resulted in a soft bitumen phase, containing APP particles. However, the method of application with a sprayed-on cold mastic was identical to that employed on many other roofs that perform well. The amount of applied cold mastic was between 500 and 1000 g/m² (1 to 2 lbs/sq ft). At places where the spraying machine had started, we found substantially more, but that is normal.

In fact, the only property of the APP bitumen on the new rolls that was *not* normal was the penetration, 43.10⁻¹mm. Values between 20 and 30.10⁻¹mm are more usual. This gave us the idea to test the viscosity of the mixture at a certain temperature and compare this with the literature. Here we got a really important difference. Using a Haake viscosity meter we found a value of about 1600 MPa.s at 161C.

According to the literature viscosity at this temperature should vary between 6,000 and 10,000 MPa.s. Apparently the manufacturer had used a low molecular weight APP. Mixtures with this type of APP are much more sensitive to separation by solvents than blends with high molecular weight APP which have a much higher viscosity. However, this requires more research.

Other factors that may have influenced the failure to a certain extent are the amount of cold mastic and the mineralized surface. This may have limited the evaporation of the solvent.

We recommend care with the use of cold mastic as an adhesive for APP modified bitumen, particularly if the penetration of that bitumen is higher than 30.10⁻¹mm. One can easily test in the laboratory whether or not the proposed product is extremely sensitive to the solvent in the cold mastic.

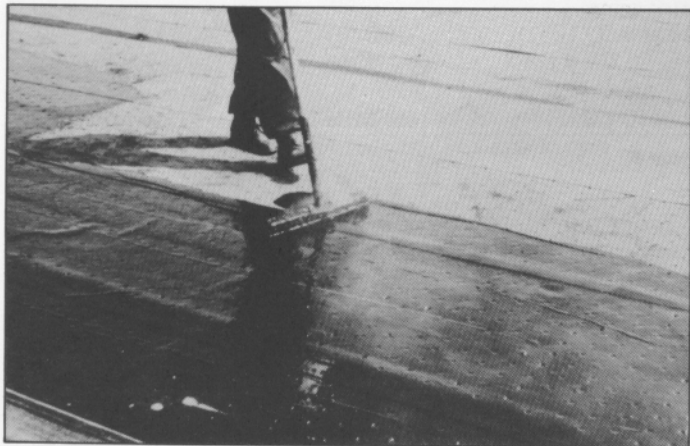
Figure 7 Installation of Case 4 floating coat

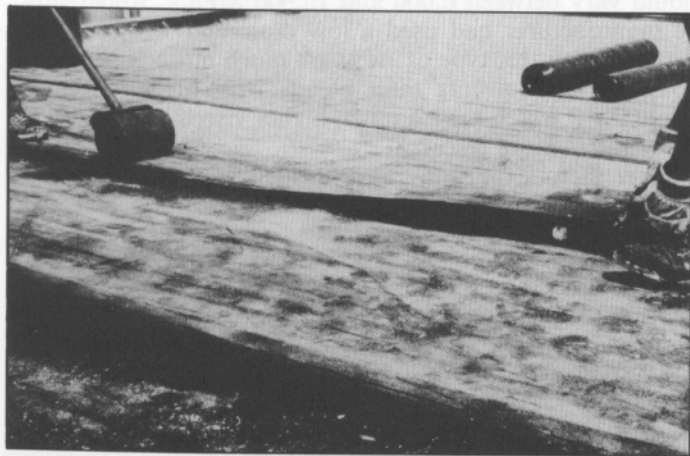
Figure 8 Case 4: Pressing the overlaps after torching

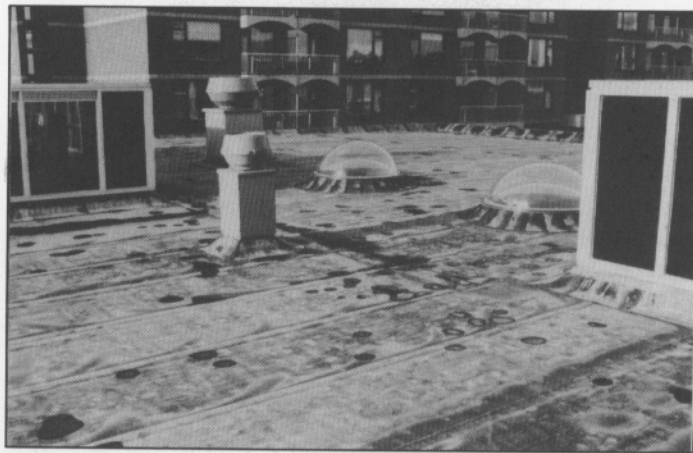
glassfleece on normal flat roofs and bituminized polyester mat on roof terraces, and a top layer of 4mm (0.16 inches) APP modified bitumen, reinforced with a 170 g/m² (0.035 lbs/sq ft) polyester mat. The materials were selected on the basis of good experiences and the project is now performing very satisfactorily.

Figure 9 One of the Case 5 roofs

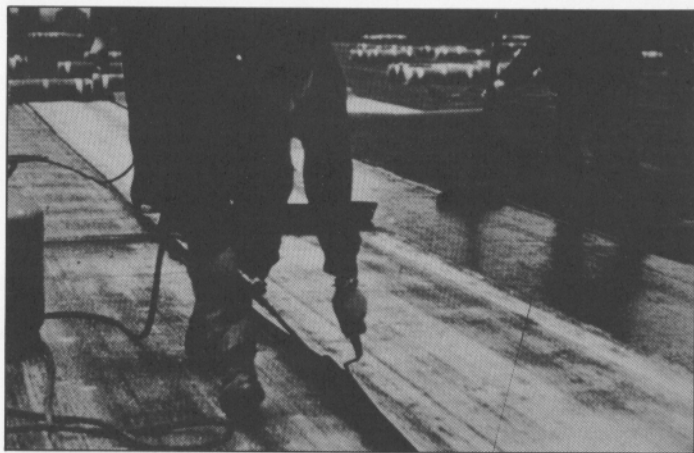
Figure 10 Application of the APP modified bitumen rolls with cold mastic in Case 6

We inspected this roof in 1983 because we were specifically interested in examining adhesion between the top layer and the old roofing. We found the roof still in excellent condition. Only at the expansion joints were some cracks evident. The samples, which we tested in our laboratory, showed an
