# A STUDY OF THE BEHAVIOR OF LOOSE-LAID, BALLASTED SINGLE-PLY ROOFING SYSTEMS SUBJECTED TO VIOLENT WINDS

KENNETH G. SCHNEIDER, JR.

Schneider & Associates  
Nashville, Tenn.

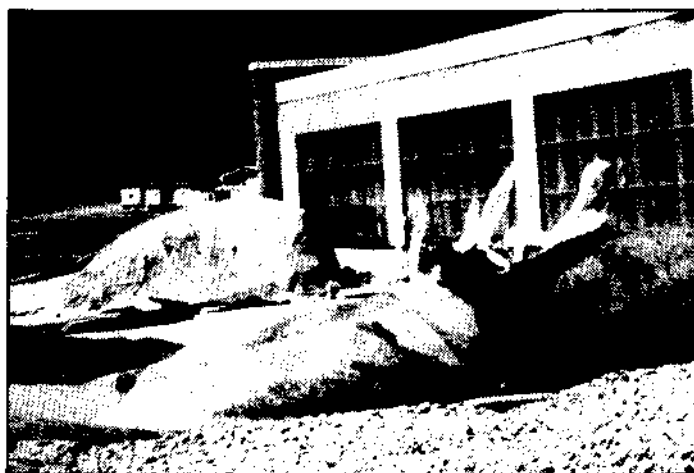
*Figure 3* Taken during fatal wind, photo above shows critical configurations of ballasted EPDM. Far balloon is 5'4" high as wind speed increases from 147 mph. Note ballast dam in foreground.

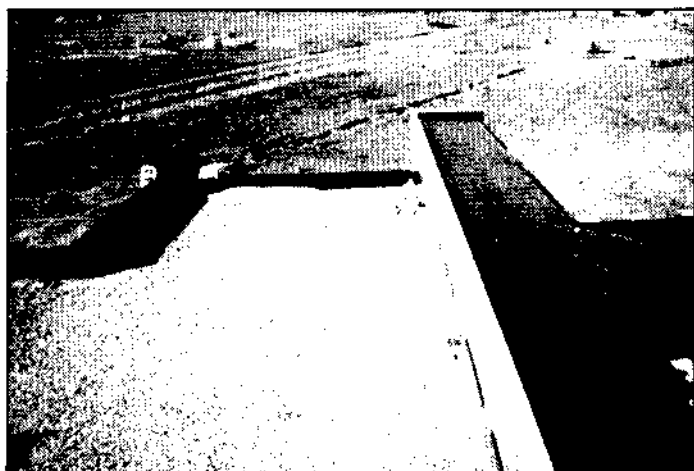
*Figure 4* Overall view of USDOE roofs show typical scouring of ballasted EPDM vortex at interior corner. Long, thin upper roof is fully adhered EPDM. Note pavers added around perimeters and at base of clerestory wall.

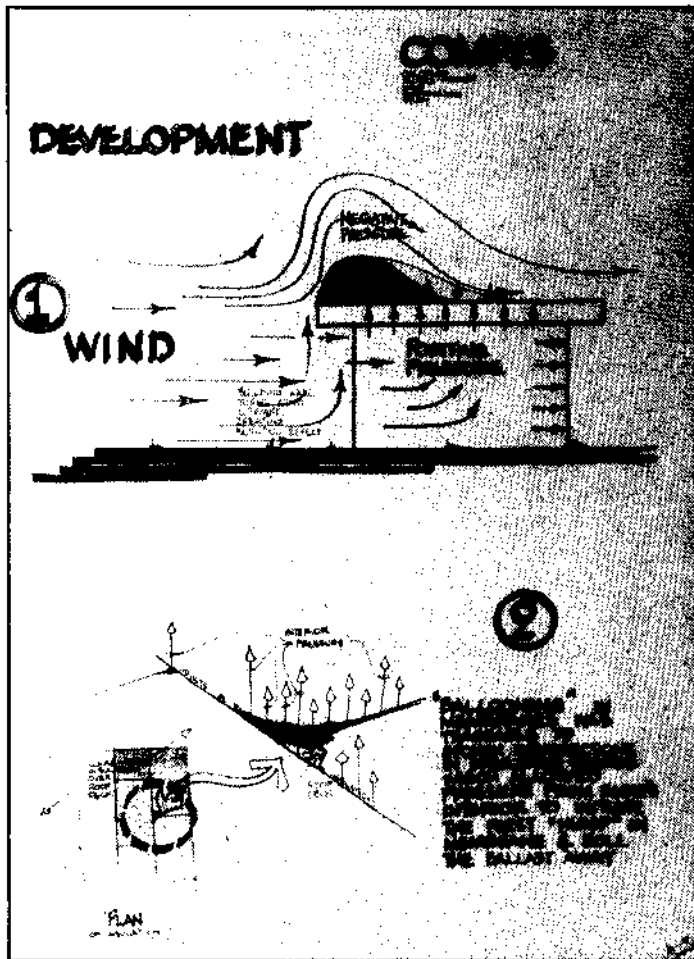
Figure 5 1. Wind is turned upward at vertical building walls creating Bernoulli effect on roof surfaces and cracks around windows and doors allow interior pressurization of building envelope. 2. Interior pressure penetrates spaces between decks, roofing insulation boards, etc. and ballooning begins from a combination of interior pressure and exterior suction. Ballooning in membranes was traceable to broken intersections in insulation boards which permitted the first "hump" in membrane and rolling away of the ballast.

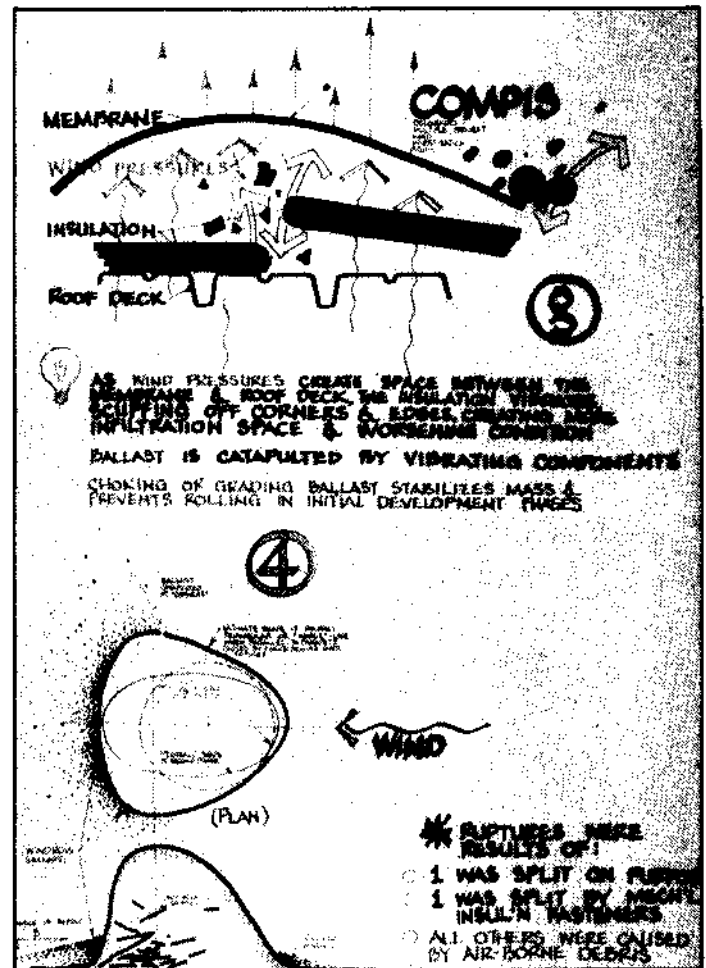
Figure 6 3. As wind pressures separate the membrane from the deck the insulation begins to vibrate in the space created between the membrane and roof deck, scuffing off corners and edges, thus creating more infiltration of space and worsening the condition. An "air valve" is created by vibrating components and ballast is catapulted by undulating action. Choking and grading of ballast stabilizes the mass and prevents rolling in initial development phases.

4. Ultimate shape of the mature balloon is roughly rounded, triangular or "whale-like"; when parallel to parapets, configuration conforms to corkscrewing pattern over copings.

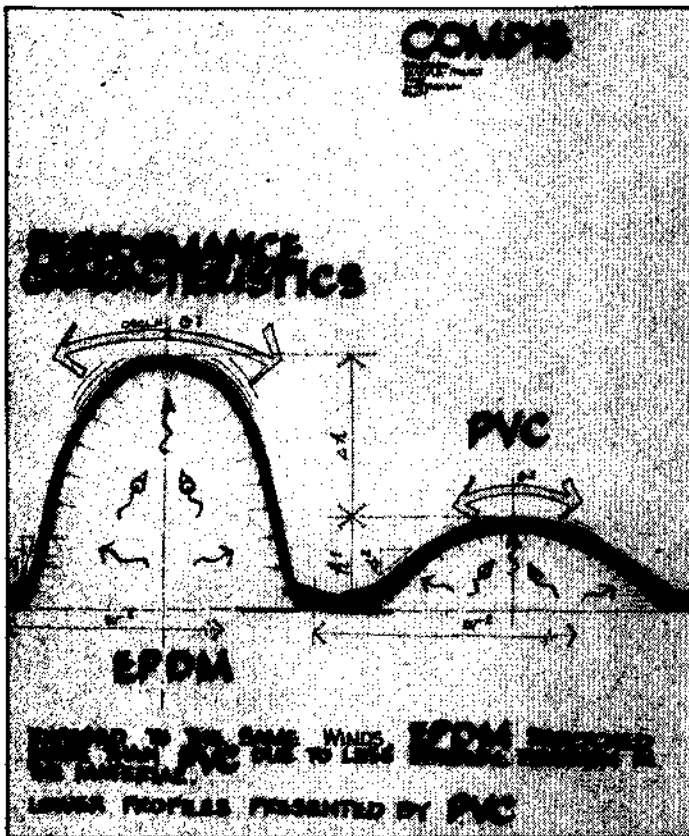
Figure 7 Exposed to the same winds, ballasted EPDM stretched more than the PVC due to less internal friction of the material. Lower profiles by PVC presented smaller targets for flying debris.
