EPDM AND PUF ROOFING LONG-TERM FIELD TEST RESULTS

DAVID M. BAILEY, STUART D. FOLTZ and MYER J. ROSENFELD

U.S. Army Construction Engineering Research Laboratory
Champaign, Ill.

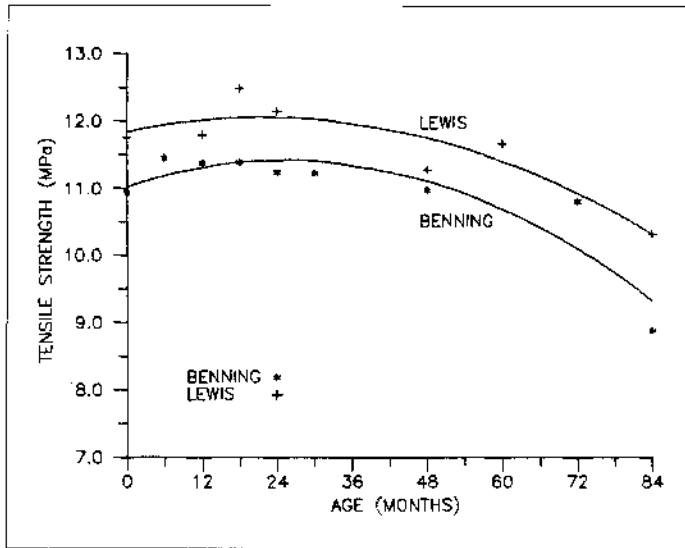
Tests by others⁵ indicate that the EPDM roof materials display increased tensile strength, reduced elongation properties and increased hardness after accelerated aging. Results of the field test (Figures 3, 4 and 5) indicate similar effects of natural aging. There was an initial increase in tensile properties (Figure 3) after exposure of six months at Fort Benning, but the succeeding tests indicate a gradual return to just below the original value after six years. At Fort Lewis, an increase was evident up to 18 months with a steady

Figure 3 EPDM tensile strength.

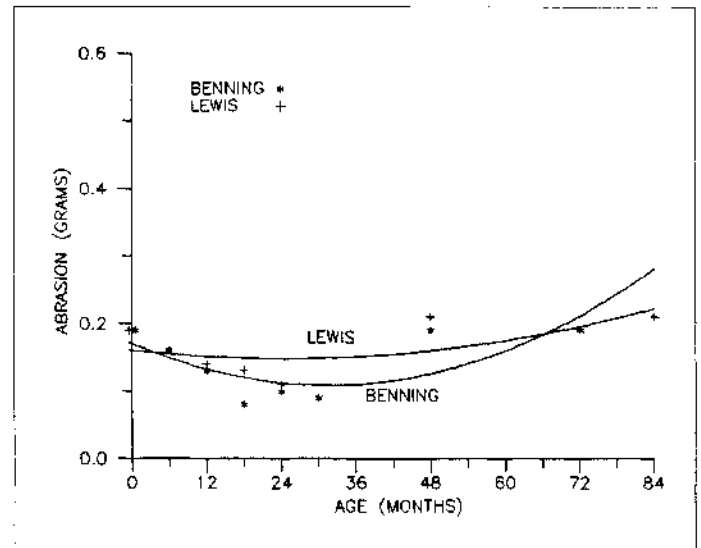
drop to just below the original value after five years. Decreases in elongation (Figure 4) and increases in hardness (Figure 5) indicate long-term hardening of the EPDM at both locations. The abrasion loss (Figure 6) showed steady increases after declining during the first three years. Water absorption (Figure 7) of the membrane at Forts Benning and Lewis steadily increased over time.

Figure 6 EPDM abrasion loss.

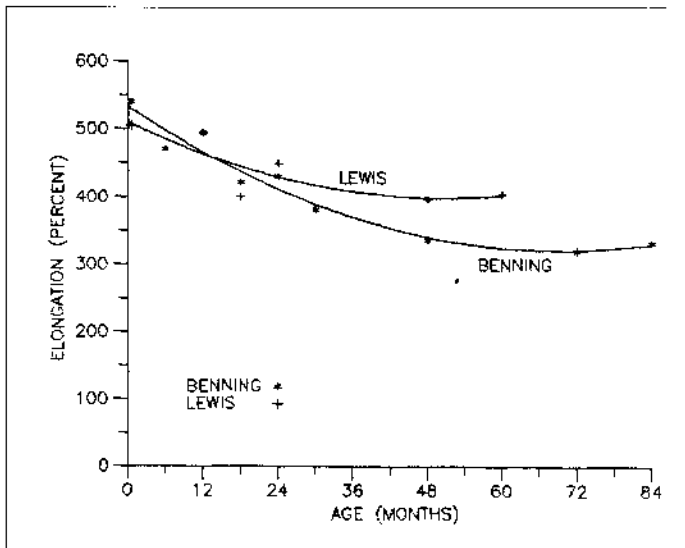
Figure 4 EPDM elongation.

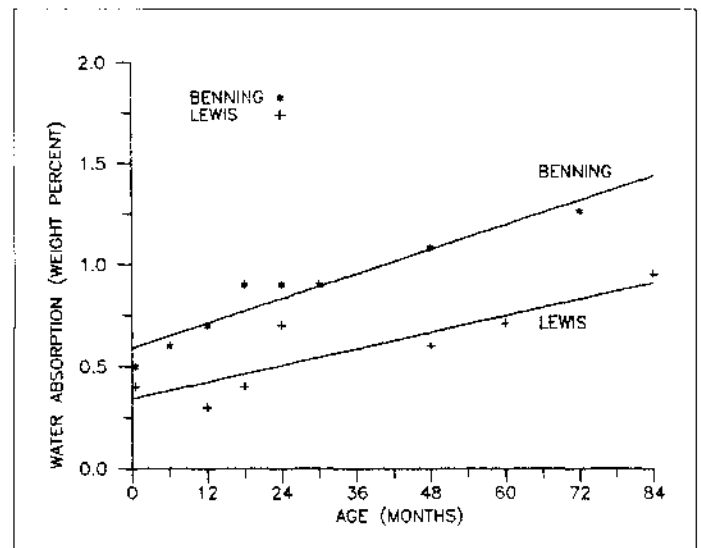
Figure 7 EPDM water absorption.

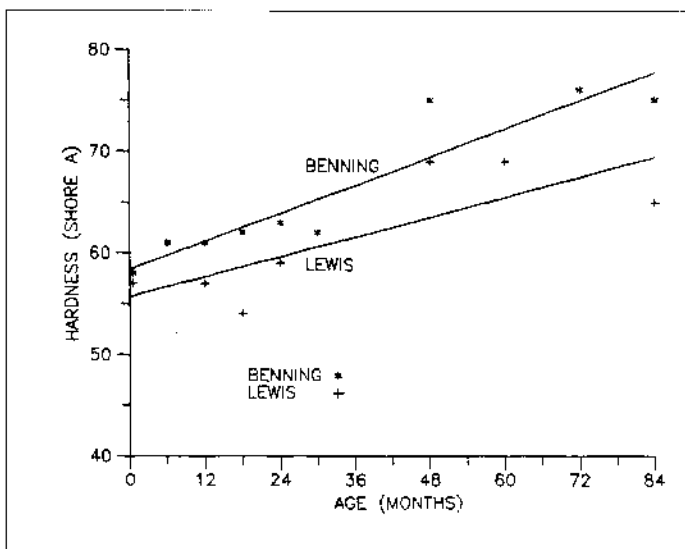
Figure 5 EPDM hardness.

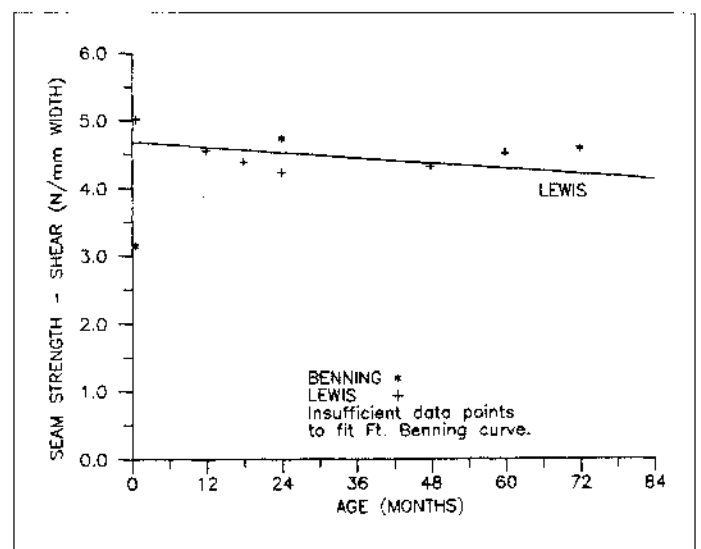
Seam strength testing was performed as scheduled for the EPDM at Fort Lewis, but not at Fort Benning due to poor sample conditions. Some of the Fort Benning samples did not include seams and other samples were not large enough to cut all of the necessary test specimens. The shear strength of the seam at Fort Lewis (Figure 8) decreased to a low of 4.2 N/mm (24 lb./in.) after two years and stabilized. The T-peel strength (Figure 9) dropped from an initial value of 0.44 N/mm (2.5 lb./in.) to 0.33 N/mm (1.9 lb./in.) after two years and stabilized. The seams lost 16 percent of their initial strength in shear and up to 24 percent of their initial strength in peel. The drop in peel strength at Fort Lewis apparently did not affect the performance of the seams. The seams at Fort Benning were initially very weak, but show a substantial increase in both peel and shear strengths with time. At both locations, the system is fully adhered, so the strength of the seams is not as important as it would be if the membrane were either loose laid or mechanically fastened. An important finding of these field tests was that the original seams at both locations maintained their watertight integrity, despite the aging of the membrane surfaces, except for one seam at Fort Benning.

Figure 8 EPDM seam strength—shear.

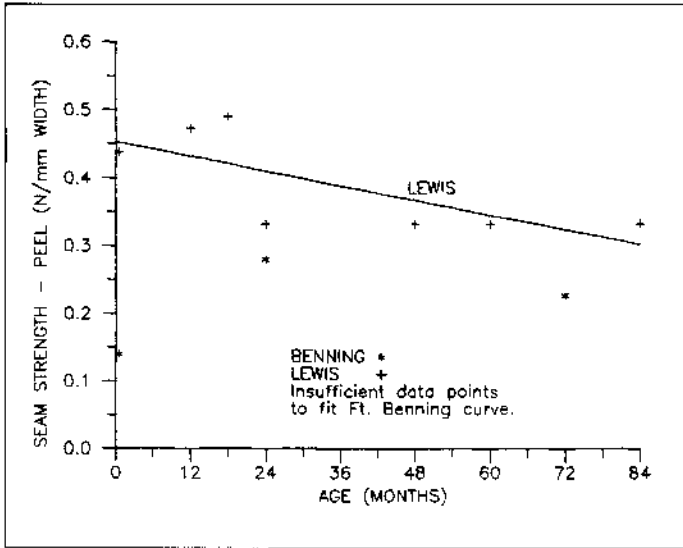
Figure 9 EPDM seam strength—peel.

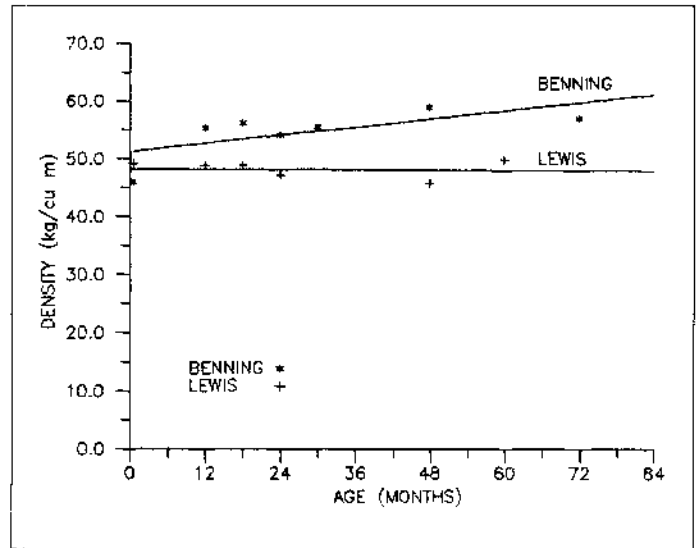
Figure 12 shows the densities of foam samples. Recommended minimum density is 40 kg/m^3 (2.5 lb./ft.^3). This is to ensure minimum compressive strength requirements of a properly mixed spray. The foam density at Fort Lewis has remained relatively unchanged. However, at Fort Benning, the density has shown a 28 percent increase after the initial sampling.

Figure 12 PUF density.

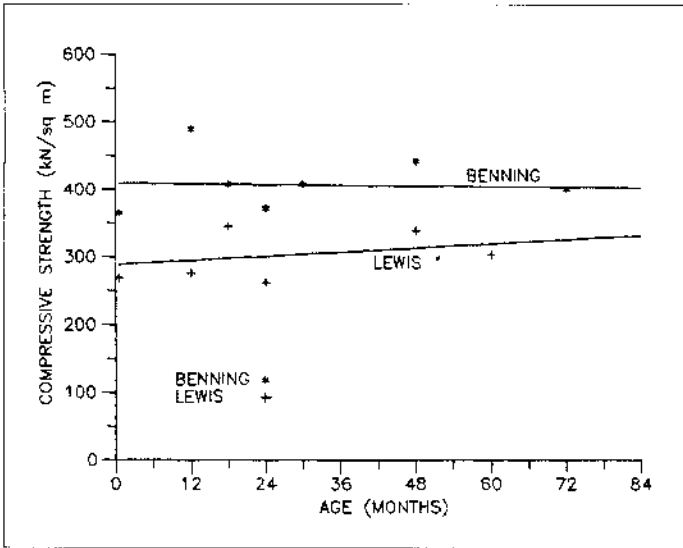
The compressive strength (Figure 10) has shown a slight increase with time from the initial value at both locations, each staying near or above the required minimum of 276 KN/m^2 (40 lb./in.^2). Compressive strength is an important property of the foam, as it is the one property which most resists traffic on the roof. The foam should be capable of bearing all anticipated traffic loads throughout its life. Tensile interlaminar strength decreased at both sites (Figure 11). The loss of tensile strength in the foam at Fort Lewis was more rapid, indicating that the specific foam used there lost its ability to adhere to itself, leading to the possibility of future separation of the layers.

Figure 10 PUF compressive strength.

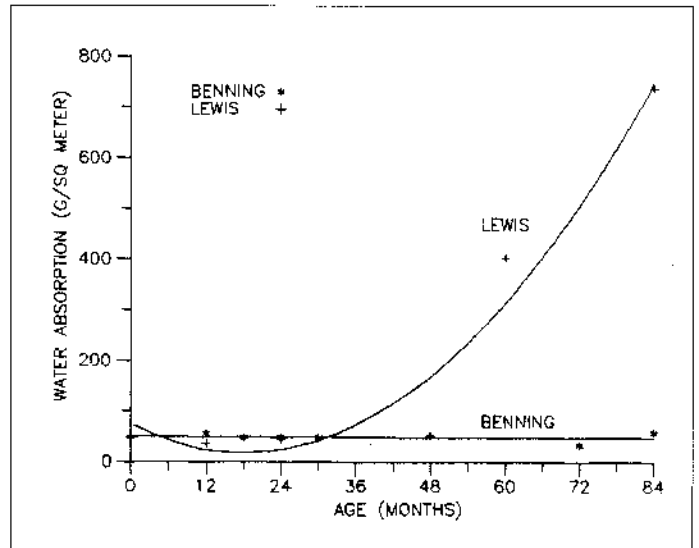
Water absorption of the foam at Fort Benning (Figure 13) remained steady, staying below 60 g/m^2 (0.0123 lb./ft.^2) through seven years. At Fort Lewis the water absorption remained at approximately its initial value for four years and then showed a significant increase during the last two years.

Figure 13 PUF water absorption.

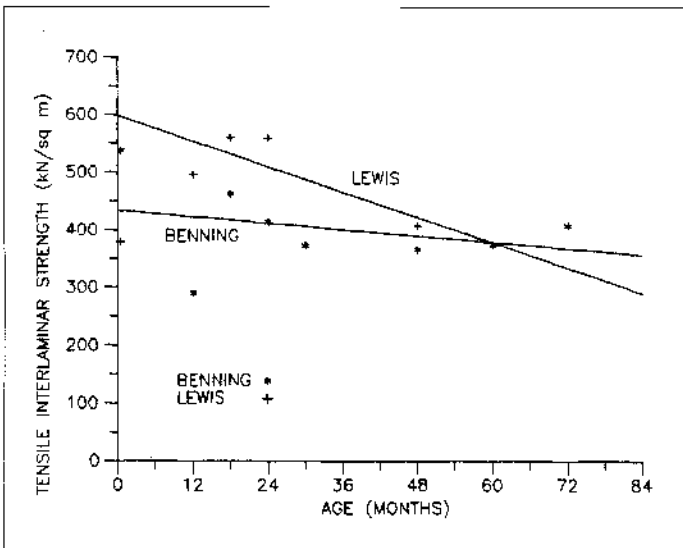
Figure 11 PUF tensile strength—interlaminar.

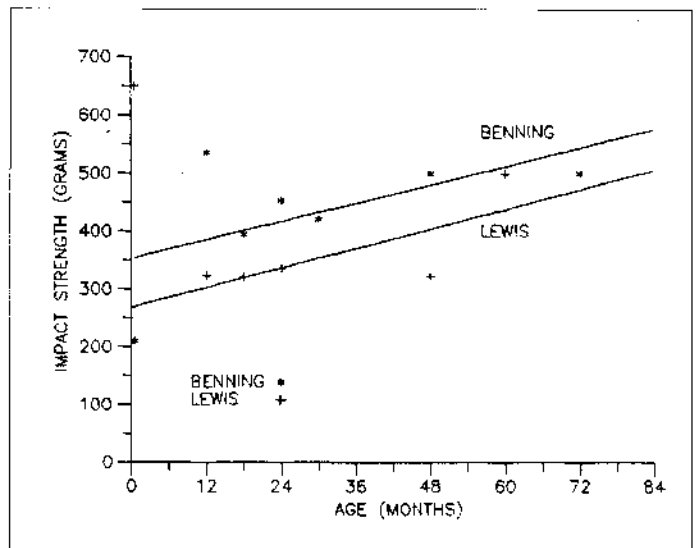
Figures 14 through 16 outline changes of foam and coating assembly properties. Impact and indentation properties improved over time as coating adhesion declined. Impact strength increased at about the same rate at Fort Benning and Fort Lewis. The rate of increase in indentation strength was slightly greater at Fort Lewis. At both sites, the coating adhesion has shown a large decrease. Despite this degradation, visual inspections have not shown any significant occurrences of blisters within the foam/coating interface or peeling of the coating.

Figure 14 PUF impact strength.
