THE EFFECTS OF HAIL ON RESIDENTIAL ROOFING PRODUCTS

JIM D. KOONTZ

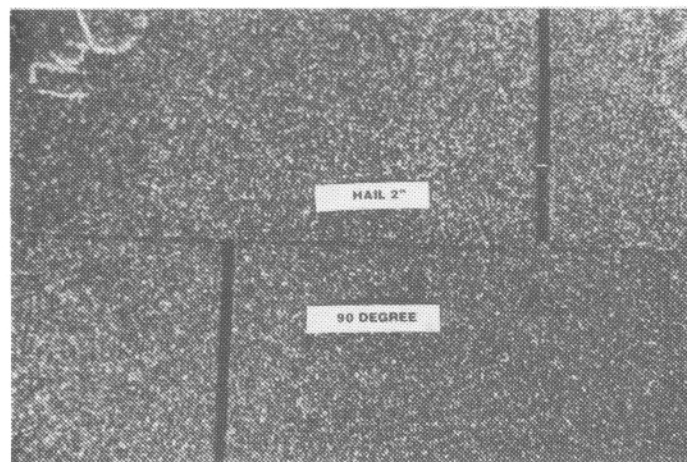
Indentations in the bulk of these areas were superficial, with just minor granule loss. It was observed in some shingles, such as Target #1, that indentations would occur (hail size 2 in./51mm, angle 90°) as illustrated in Photo 5. At this point, the shingles were desaturated with hot solvent, and

fractures were observed in the shingle mat. These fractures were not readily detected by visual observation.

Photo 5 Target 1—impact area of 2 in. hail at 90° angle.

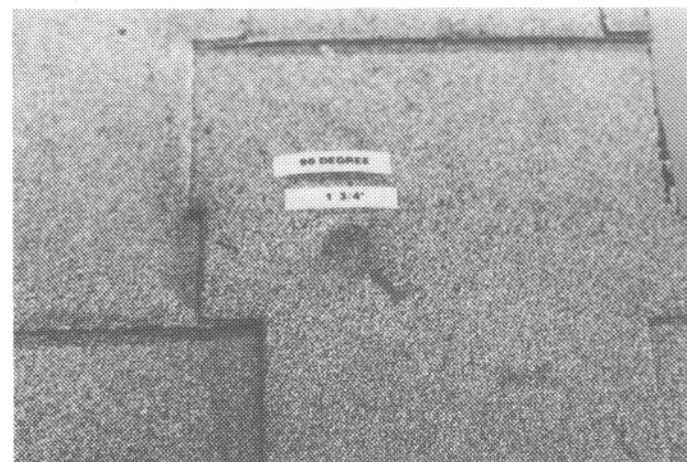
There did not appear to be a visible difference in hail resistance between organic and fiberglass three-tab products. The three-tab, assembly-type shingles, however, did have a higher hailstone resistance than T-lock shingles (Photo 6). This increased hail resistance appears to be a result of the smoother, flatter installation of the three-tab shingles. Although color does not affect the resulting damage or indentations, damage tends to be less visible with darker colored shingles.

Photo 6 1 3/4 in. hailstone impact/90° angle/Flock shingle.

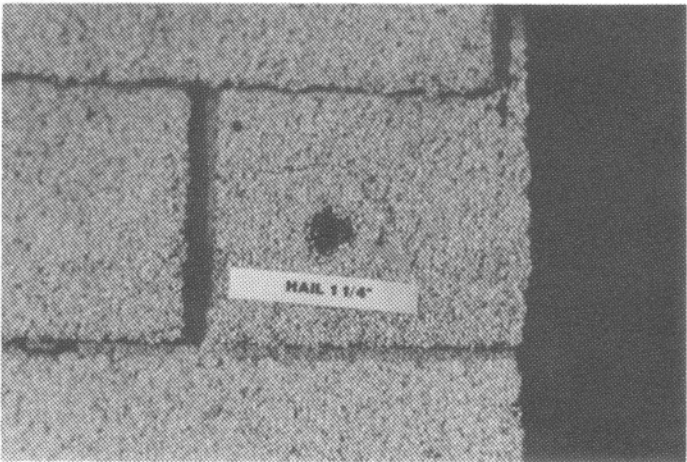
The older, organic three-tab and T-lock shingles exhibited a very low threshold of hail resistance (Photo 7). As shingles age, asphalt within the shingle obviously hardens and becomes somewhat more brittle. This creates a situation in which two residences could be next door to one another, and one residence could sustain damage to a slightly older roof, while the other residence could have virtually no damage with a new roofing system.

Photo 7 1 1/4 in. hailstone impact/older, three-tab shingle.

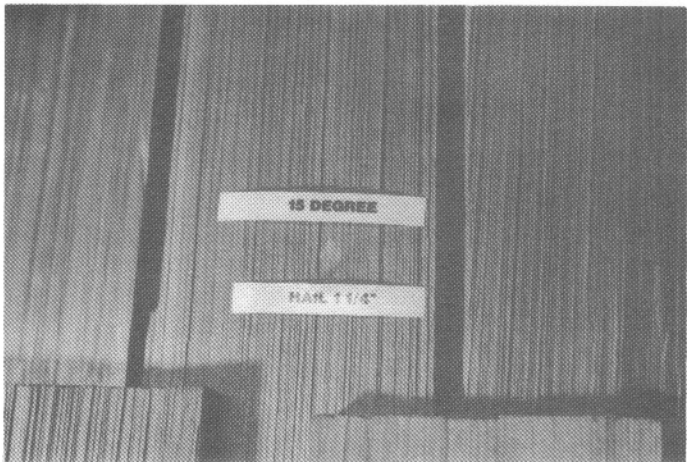
The three wood shingles impacted all exhibited various degrees of indentation, which occurred at very low thresholds of kinetic energy. When the wood shingles were impacted with hailstones from 3/4 in./19mm to 1 1/4 in./44mm in diameter, fairly uniform indentations occurred (Photo

10). The indentations, depending upon angle of impact, were either circular or somewhat elliptical. Damage in this particular area, for the most part, was superficial and would not affect the overall performance of the roofing system.

Photo 10 Impact of wood shingle/1 1/4 in. hailstone/90° angle.

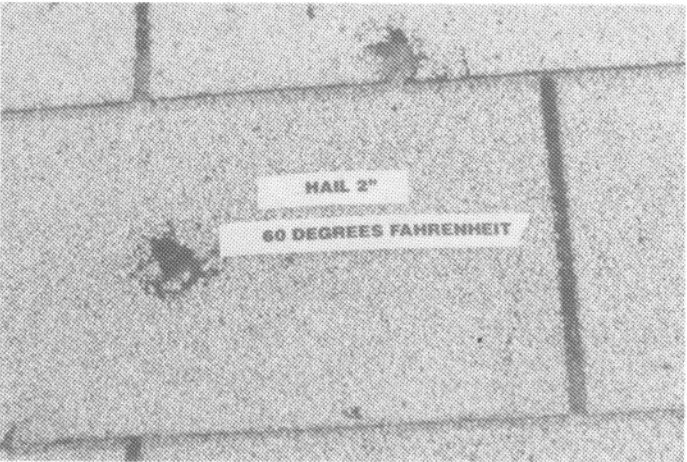
Temperature of the roof assembly surface is a definite factor in hail damage (Target #14). Lower-temperated surfaces (60°F/15.6°C) are much more prone to fracture than higher-temperated surfaces (Photos 8 and 9). The situation may occur in which a rain just prior to a hailstorm lowers the shingle surface temperature. This produces a lower threshold for damage. The asphalt into which the granules are imbedded appears to shatter more readily at colder temperatures. When the surface temperature of the shingle is somewhat higher, at 120°F/49°C, the surface is somewhat softer and, although easily indented, does not readily fracture.

Photo 8 2 in. hailstone impact/surface temperature of shingle 60°F.

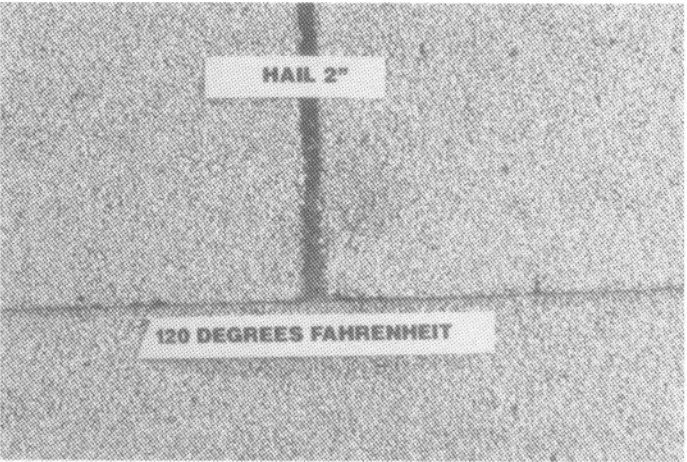
Photo 9 2 in. hailstone impact/surface temperature of shingle 120°F.

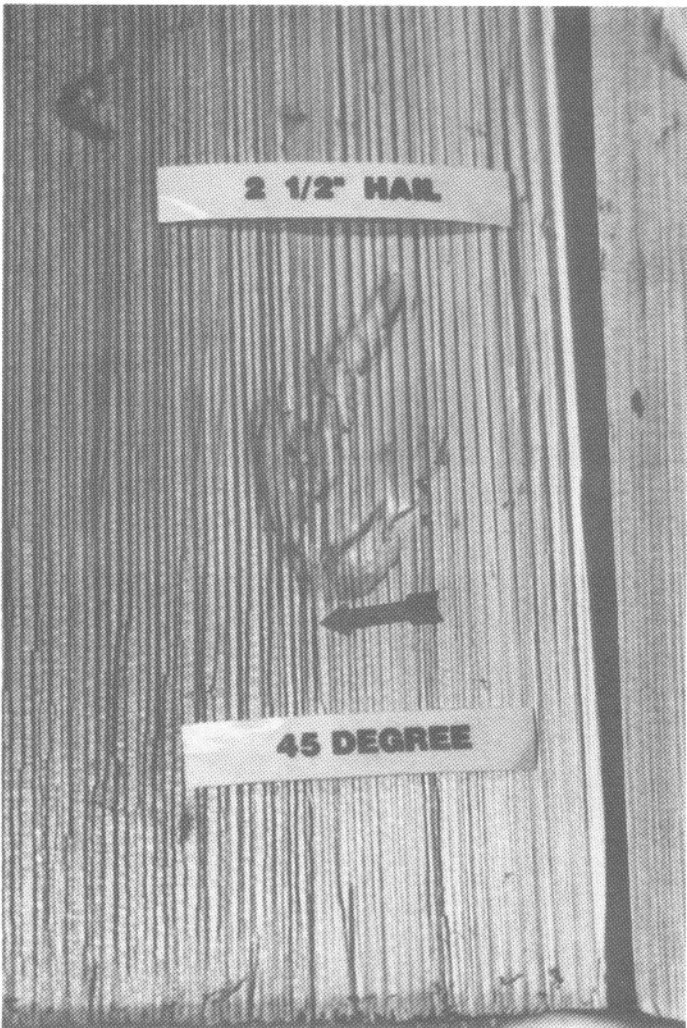
When the wood shingles (Targets #15 and #16) were impacted with hailstones 1 1/4 in./44mm or larger, the shape of the indentation was not uniform (Photo 11). This was due to two factors. One, the hail tends to crush and rotate somewhat as it impacts the shingle. Two, since the surface of the wood shingle is irregular, the indentation becomes erratic.

Photo 11 Irregular indentation of hailstone impact on wood shingle.

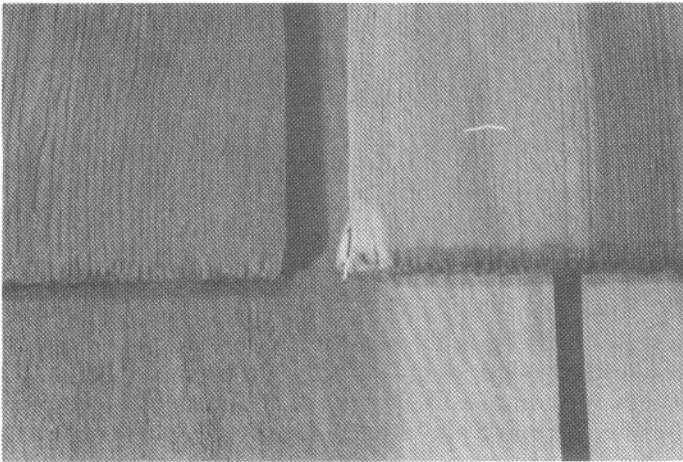
Some indentation of the wood shingles did occur at the leading butt edge and at the joints of the shingles. The bulk of this damage is somewhat superficial, and began at a fairly low threshold of kinetic energy (Photos 12 and 13).

Photo 12 Wood shingle indentation at butt edge.

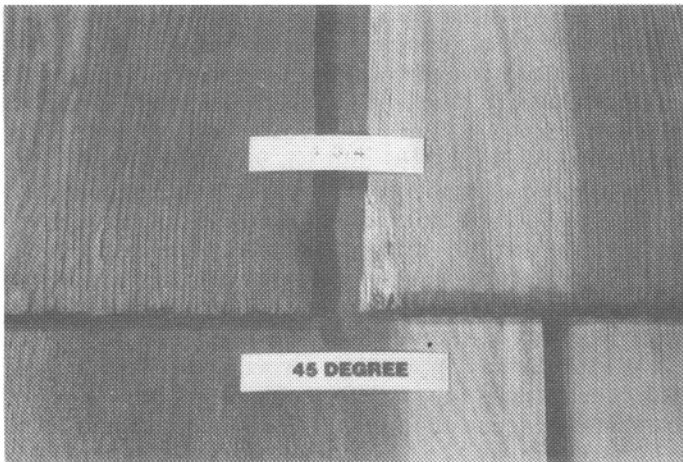
Photo 13 Wood shingle indentation.

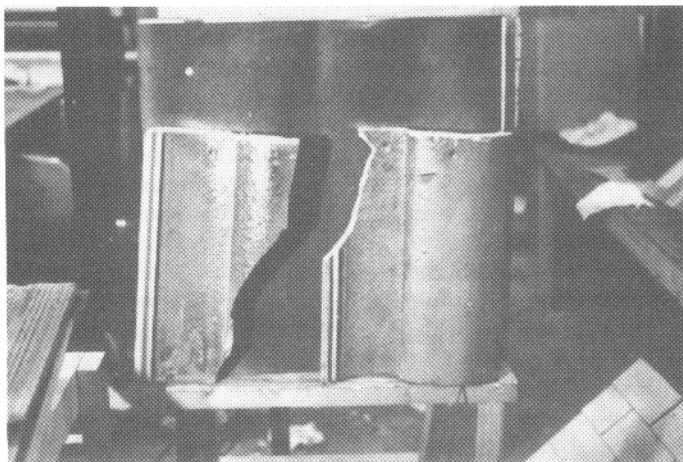
The three concrete tile targets all exhibited fairly high degrees of hail resistance. Fracture/breakage did not occur with the 2 1/4 in./64mm hail/90° angle. Fracture/breakage did occur, however, when the velocity was increased to 131 ft./sec., 40 meters/sec., or 89 mph, resulting in kinetic energy of 71.49 ft./sec./96.9 joules (Photo 14). The flatter concrete tile shingle was the most hail resistant concrete tile product tested. Multiple impacts with a 2 1/4 in./64mm hailstone were required before fracture/breakage occurred.

Photo 14 Fracture of concrete tile.
