AN INVESTIGATION OF THE ROLE OF DIFFERENTIAL STRUCTURAL MOTION AS THE CAUSE OF FLASHING PROBLEMS

JAMES R. WELLS and JEFFREY A. TILTON

Owens-Corning Fiberglas
Granville, Ohio

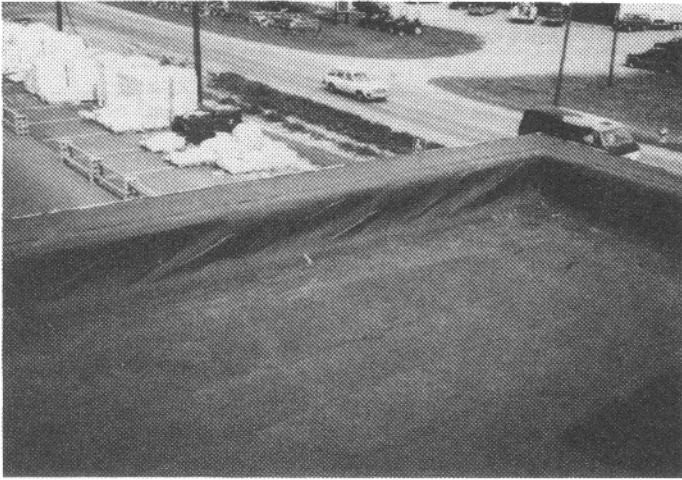
During late 1988 and early 1989, a small fraction of a national retailer's roofs were experiencing problems with wrinkling and/or tearing of base flashings near the corners of the buildings with raised parapet walls. A typical example is shown in Figure 1, with the wrinkles highlighted with white chalk. The roof membranes were of standard construction, three plies of premium glass built-up roofing (BUR), without gravel over fibrous glass roof insulation. All of the buildings had steel decks and concrete block walls. Approximately 10 to 15 percent of their newly constructed buildings were experiencing the problems. The retailer had recently changed engineering firms for their building designs, and the problems were much more frequent on the new larger stores, which were designed by the new engineering firm. The owner of the engineering firm had inspected

- The flashing wrinkles occurred primarily on the front wall near the side walls. The wrinkling is worst at the front corners and diminishes toward the center of the building. There are no wrinkles at distances greater than 30 to 60 feet from the corners, depending on the roof. There is little or no wrinkling of the side wall flashings. If present, it is much less pronounced than that of the front wall.

- On the front walls, the directions of the flashing wrinkles form diagonals with lower end toward the center of the building and upper end toward the outer walls (see Figure 1).

Figure 1 Wrinkling and/or tearing of base flashings (wrinkles highlighted with white chalk).

- The observed differential motion correlates most closely with the plenum air temperature.
- The proposed solution of adding curbs and counterflashings around the perimeter of the roof should work. The work could be postponed until the flashings develop leaks and are in need of repairs.

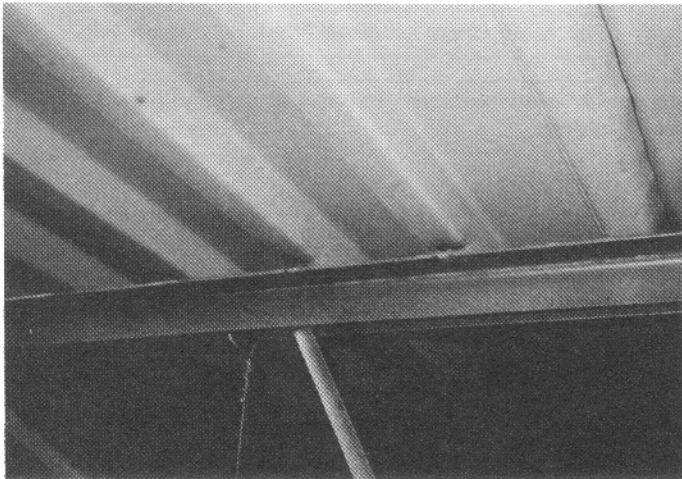
- The front wall flashings were wrinkled near the right and left corners, as was typical of the other roofs. The right side was worse than the left. The right side of the building is not obstructed; the left side abuts a strip of stores. The front of the stores faces west.
- The roof trusses are resting on plates on the front wall but are not grouted into place.
- Along the front wall, for at least 36 feet from the right side corner, the steel deck sections that were adjacent to the front wall were no longer attached to the joists. The

welds between the deck and joists had been sheared from the front wall to the first line of bridging. Also, the joists had all moved to the north and were visibly deflected from the wall to the first line of bridging.

- The deck sections could be easily lifted by hand from the under side. Broken deck/truss welds were visible, and the deck had clearly moved on the trusses at some point (see Figure 2).
- The suspended ceiling is $\frac{3}{4}$ inch fibrous glass with no back-loading (see Figure 3).

Figure 2 Broken deck/truss welds and depicts deck movement on the trusses.

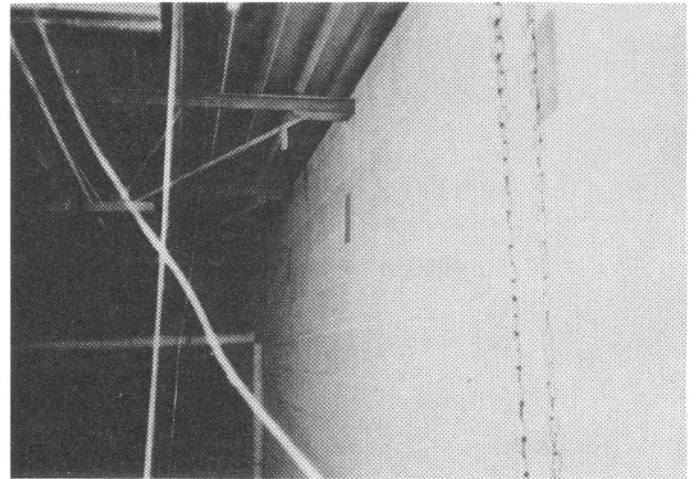
Figure 3 Suspended ceiling is $\frac{3}{4}$ inch fibrous glass with no back-loading.

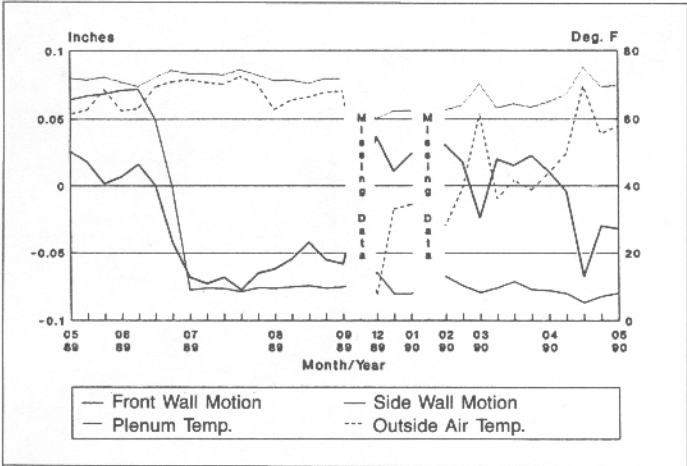
Figure 8 Front and side wall average positions with reference temperatures weekly average.

In Figure 8, the weekly average of the position of the roof deck relative to the front and side walls is given; the plenum

um and outside air temperatures are given for reference. It is clear that a significant, permanent change of approximately -0.15 inch occurred in the deck position relative to the side wall during June 1989. A permanent change of perhaps -0.05 inch occurred in the position relative to the front wall. The sign of these changes indicates the walls have "outgrown" the deck by the indicated amount. However, the fluctuating changes that are seen on a weekly basis are normally larger than the permanent ones.

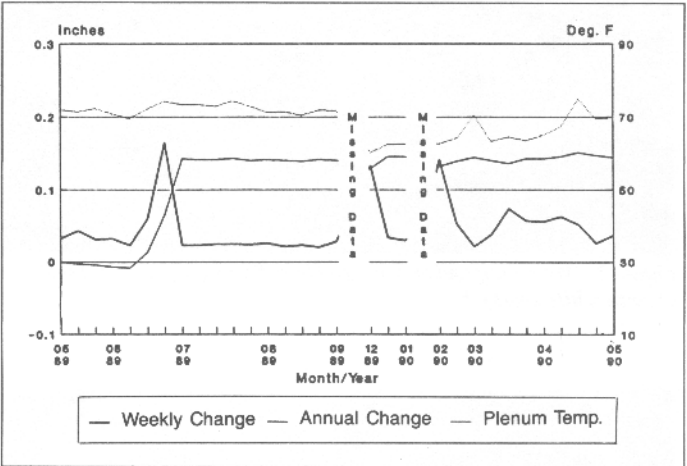
Figure 10 Maximum weekly and total annual side wall to deck motion weekly average.

Figures 9 and 10 compare the maximum motions during each week to the cumulative annual motion to date relative to the front and side walls, respectively. The plenum temperature is included for reference. Notice that the weekly fluctuations are significantly larger than the cumulative ones, except for the one-time, large movement relative to the side wall mentioned previously and seen clearly in Figure 10.
