ROOFING CONSTRUCTION MAY IMPACT EXISTING INTERIOR BUILDING ASBESTOS

JOSEPH F. HALE, PHIL H. DAWSON and LYNN EICHHORN

HDH Associates, P.C.

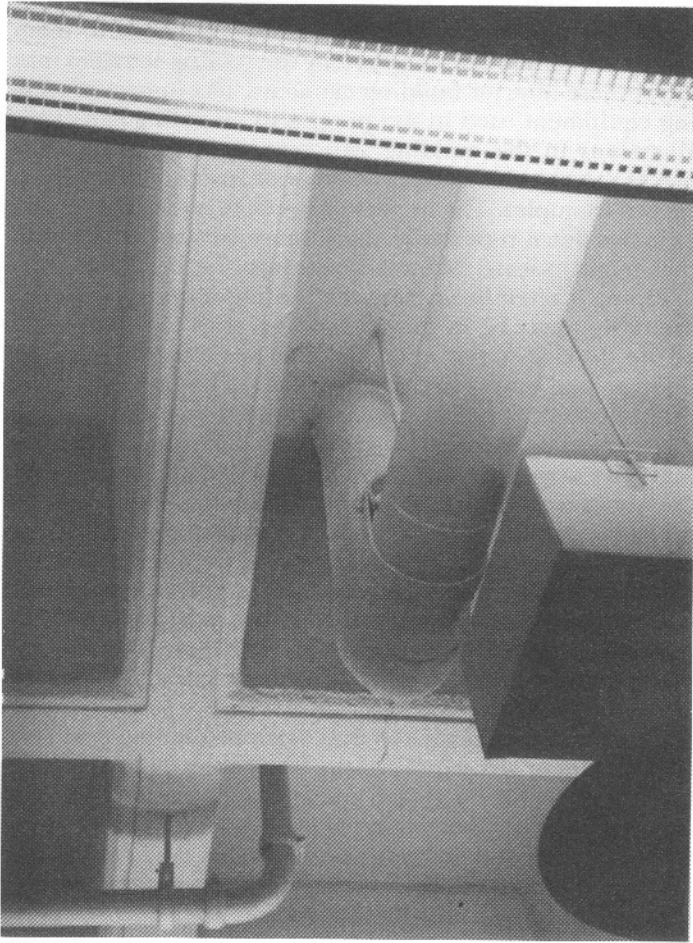
Photo 1

piping, piping joints, structural members and duct work which has asbestos containing materials attached to them (see Photo 1). Vibrations caused by the roofing activities may affect these interior building elements. The impact of roofing equipment used in the process of reroofing can cause vibrations in the building structure. Cutting equipment, power driven removal equipment or dropable removal buckets are examples. The impact of the debris-removal bucket as it sets down repeatedly could cause structural vibration that might release asbestos fibers into the building.
