IMPROVING WIND PERFORMANCE OF ASPHALT SHINGLES: LESSONS FROM HURRICANE ANDREW

THOMAS L. SMITH

National Roofing Contractors Association
Rosemont, Ill.

Hurricane Andrew caused very extensive roof covering damage in south Florida. This paper describes asphalt shingle roof covering damage, wind loading, failure modes, life safety and property damage, workmanship, perimeter metal flashings, deck influences, testing, code requirements, and design guides. Finally, it provides conclusions and recommendations for enhanced performance in hurricane-prone and other high-wind regions.

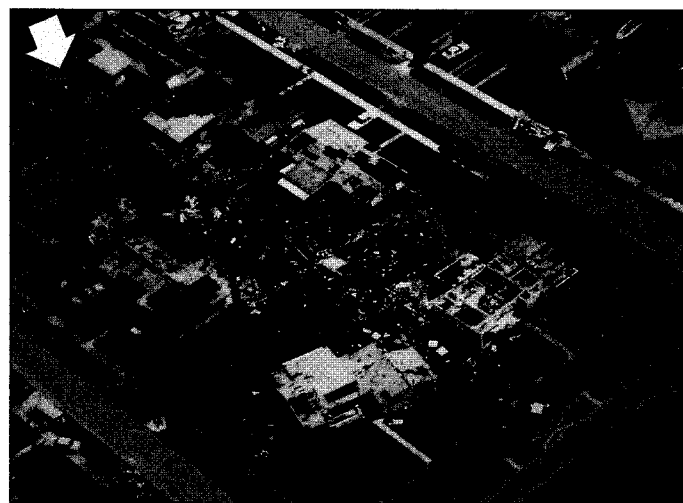
Photo 1. The structure from the house on the middle-right of the photo landed near the upper left of the photo (see arrow).

Photo 1 illustrates the great variability in performance. Ten houses are shown, all of which have asphalt shingles. One house experienced significant structural damage (loss of the roof deck and framing). One house exhibited very

minor shingle loss. One house lost several shingles over various areas of the roof. Two houses lost most of their shingles, but the underlayment remained. Four houses lost large areas of shingles (one of these lost a small area of underlayment). One house lost a moderate number of shingles in four areas, with loss of underlayment at three of these areas.

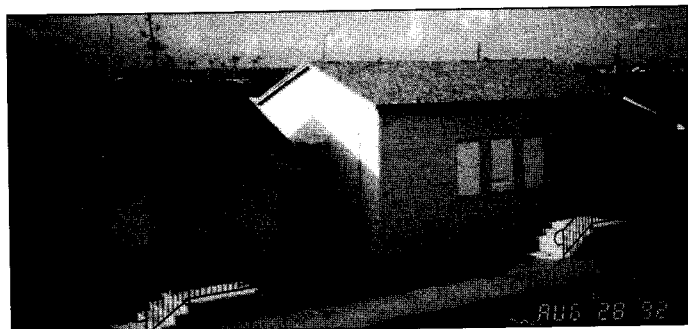
Photo 2.

Photo 2 also illustrates the performance variability. One portable classroom lost only a few ridge shingles while the adjacent classroom was stripped of almost all of its shingles (several pieces of shingles still remained along the rake). Another nearby portable classroom, which is not shown, lost several ridge shingles. Detailed investigation was not performed; hence, the reason(s) for this variability is unknown. The estimated peak gust wind speed was 145 mph (65 m/s).

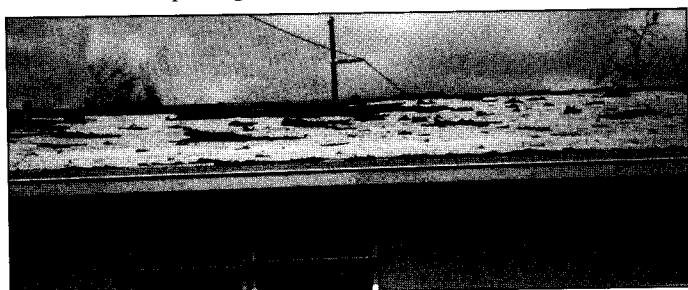
Photo 3.

At the building shown in Photo 3, essentially all of the underlayment was lost on one side of the roof. The underlayment was fastened with thin metal disks ("tin caps") though it appeared that only a few of these fasteners were used. A few tabs remained along the eave. The perimeter metal flashing (metal drip edge) did not appear to be damaged. The estimated peak gust wind speed was 170 mph (76 m/s).

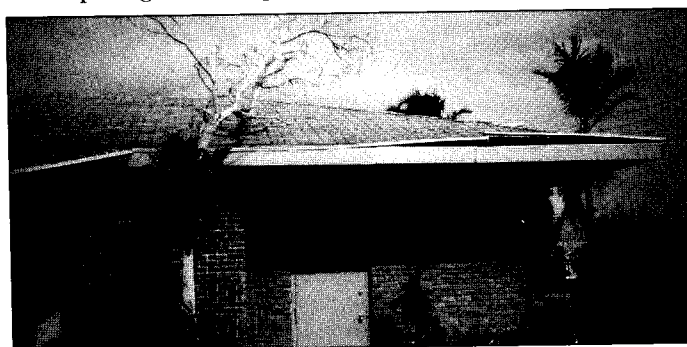
Photo 4. The tree on the roof was stripped of its leaves, but other nearby vegetation was not stripped. It appeared that some shelter was provided by nearby buildings; however, the wind was sufficient to break and knock down some trees.

Photo 4 shows an older roof that lost only a few tabs. Some of the built-in gutter flashing was also lifted up. The estimated peak gust wind speed was 145 mph (65 m/s).

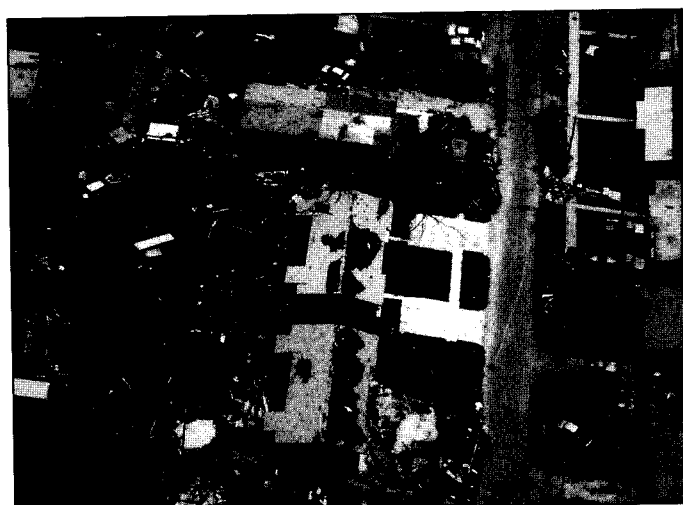
Photo 5. Wind appears to have blown parallel to the street, from the bottom of the photo toward the top.

Five houses are shown running up the middle of Photo 5. All lost a large number of shingles, but only the two houses at the top lost large areas of underlayment. The other three houses lost very small areas of underlayment though the house at the bottom had at least five of these small areas. The house at the bottom right side of the photo had some damage near the ridge/rake; however, it may not have had asphalt shingles. The next house lost shingles in two large areas. The next two houses lost the right side of the roof covering, but the underlayment remained. The house at the top lost most of its roof covering and part of the underlayment. These last three houses may not have had asphalt shingles.

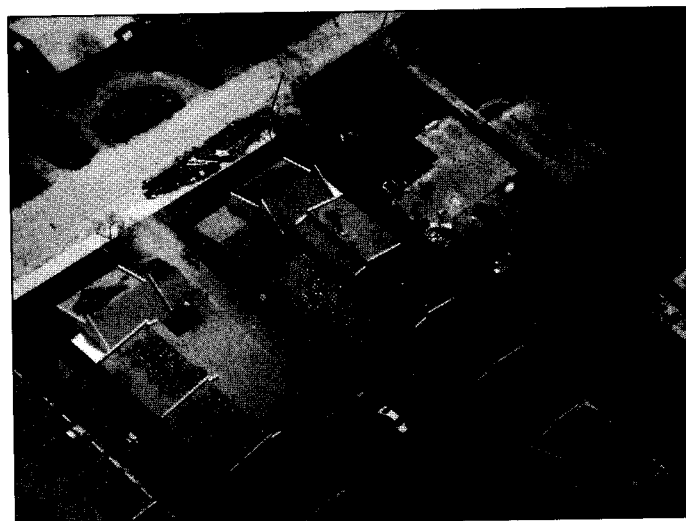
Photo 6.

Photo 6 shows an apartment or condominium complex. Although most of the roofs lost a large number of shingles, the underlayment remained. The underlayment was fastened with a large number of closely spaced fasteners (which were probably metal disks).

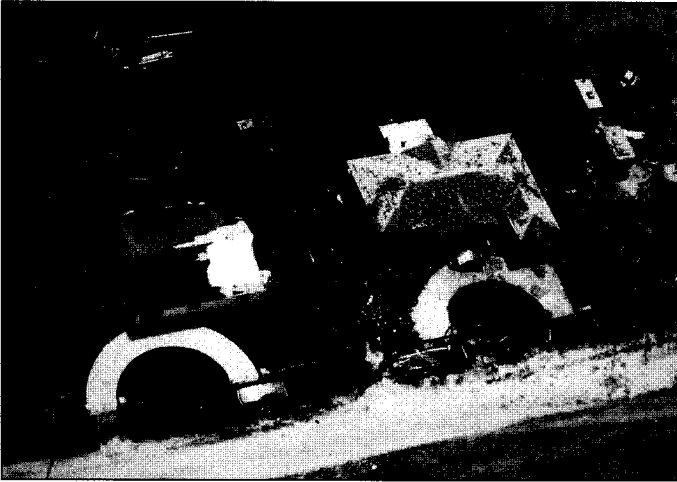
Photo 7. The wind blew in two primary directions: from the left to the right of the photo and from the top to the bottom. The house on the right has a tile roof.

The asphalt shingle roof on the left in Photo 7 lost a large number of shingles and the underlayment along the rake/ridge/eave. It also lost several shingles over various areas on the side of the roof that is towards the top of the photo. The other house has a mortar-set tile roof. It lost many tiles, but the underlying built-up membrane was not blown off.

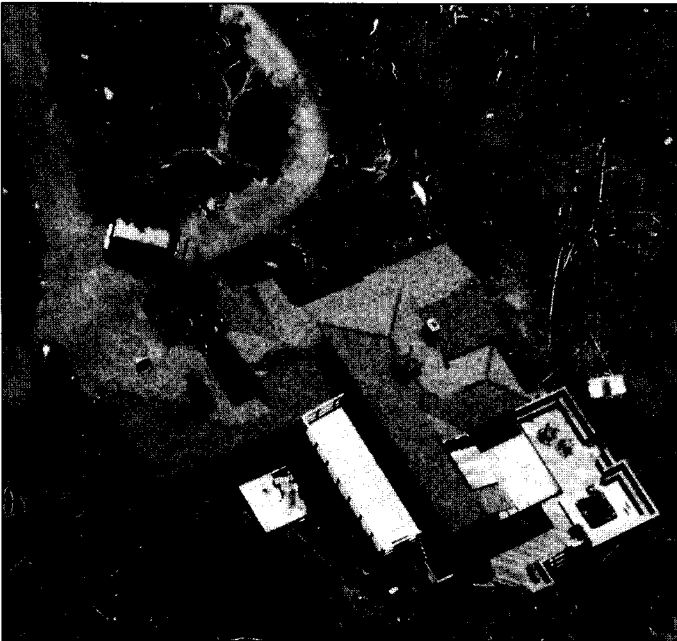
Photo 8 shows a house of complex shape in a very high wind area. It lost most of the hip and ridge shingles, as well as shingles near three of the ridges, but the underlayment remained.

Photo 8. The wind appears to have come from three directions: bottom left to upper right of the photo, bottom to top and top to bottom (or top left to bottom right).

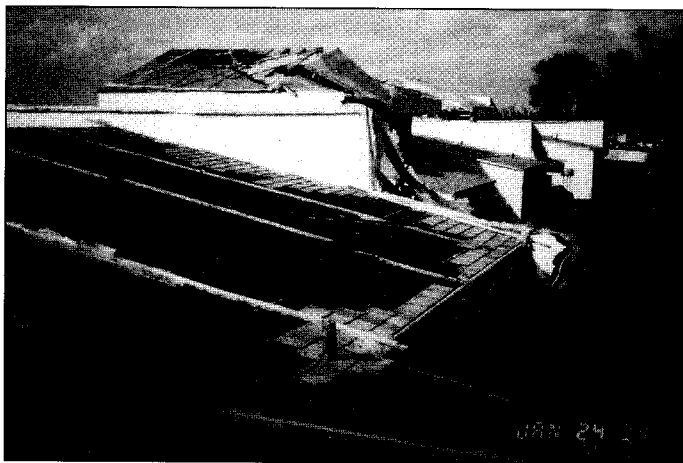
Photos 11 to 13 show a roof on a building of an apartment or condominium complex. The fiberglass-reinforced shingles were attached with four staples per shingle. The staples were typically installed in the correct location and orientation (i.e., parallel to the sealant strip) except that the end fasteners were about $\frac{1}{4}$ to $\frac{1}{2}$ of an inch (6 to 13 mm) from the end rather than 1 inch (25 mm). The underlayment was attached with metal disks and staples. The disks were in rows that were approximately 18 inches (460 mm) apart. Along the row, they were placed from about 6 to 12 inches (150 to 300 mm) on center. At one rake (Photo 12), there was a metal edge flashing that had a vertical flange that projected up above the shingle about 1 inch (25 mm). The first fastener of these rake shingles was placed 8 inches (200 mm) from the upturned flange. Asphalt roof (plastic) cement was placed

Photo 11. Some underlayment was lost (bottom center of the photo). The wood strips running up the roof had been placed to hold down polyethylene sheeting, which was no longer in place when this roof was observed in January 1993. On one of the other roof areas of this building, it appeared that wind-blown debris may have initiated the shingle failure.

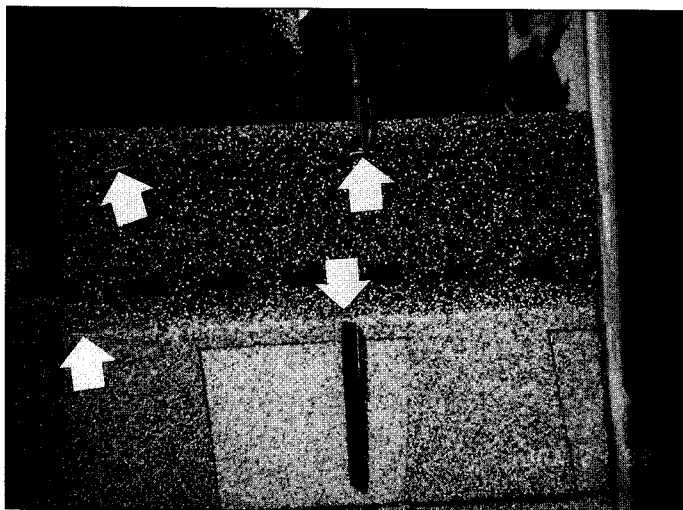
Photo 12. Close-up of Photo 11. Arrows show the fasteners. This metal edge flashing has an upturned flange.

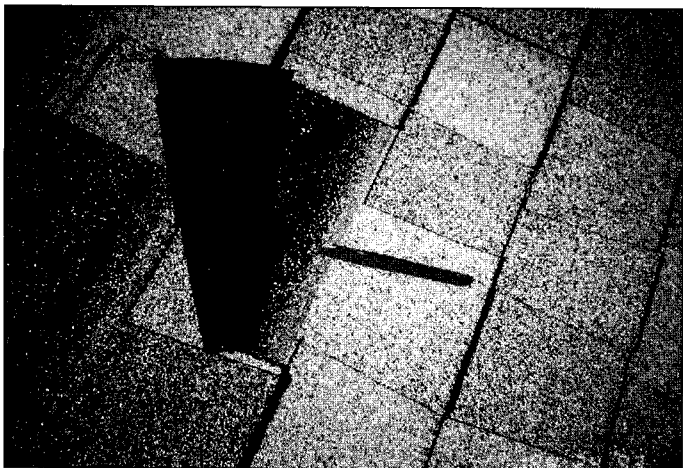
Photo 13. A staple (near the end of the pen) drove all of the way through the shingle.

between the metal flange and the shingles. Most of these rake shingles remained on the roof. Photo 13 shows a tab that was pulled up during the investigation to evaluate the sealant bond. The bond strength seemed to be very good—the failure occurred within the shingle rather than within the sealant or between the sealant and the shingle. Under this tab, the staple drove all of the way through the shingle. The estimated peak gust wind speed was 170 mph (76 m/s).

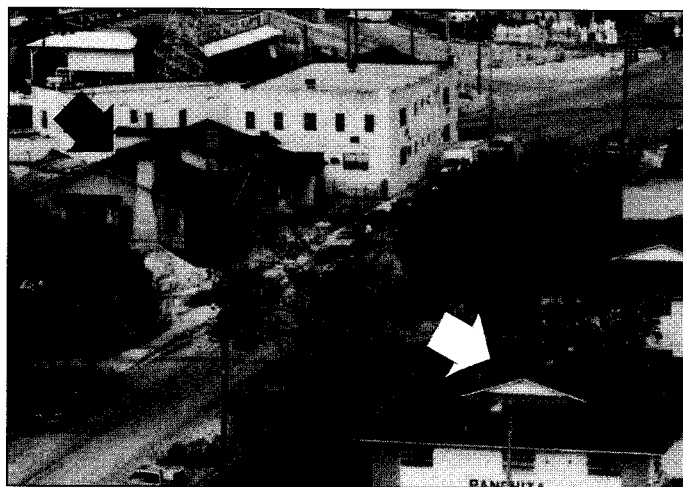
Photo 14. These two damaged asphalt shingle roofs (see arrows) are located near downtown Miami. The estimated peak gust wind speed was 125 mph (56 m/s).

Although most of the damaged roofs in Dade County experienced wind speeds that were above the ANSI/ASCE 7 design wind speed for this area (i.e., 130 mph [58 m/s] peak gust), many shingle roofs that experienced winds below the design wind speed were also damaged, as shown in Photo 14.

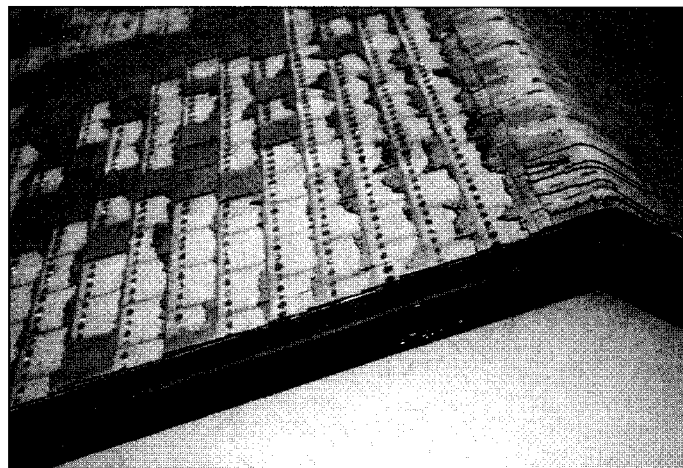
Photo 15. These shingles were each attached with four nails, which were located in the self-seal strip. In this corner area, many of the tabs were lifted and broken off. On the right side of the roof, several tabs were lost along the eave, a few were lost along the rakes, and several were lost in the field of the roof, starting about 5 feet (1,500 mm) up from the eave. The estimated peak gust wind speed was 160 mph (72 m/s).

A large number of workmanship deficiencies were observed. These were primarily related to the incorrect location of fasteners, and in the case of staples, incorrect orientation. The fasteners in Photos 10, 15, 16 and 17 were incorrectly located. All of these fasteners are too high—they are located in or above the self-seal strip rather than below it. The end staples in Photo 12 are located too close to the end. With staples, not only is the correct location important, but the staple should also be correctly oriented (i.e., parallel with the sealant strip). Photo 16 shows the progressive misorientation of staples. The first staple is close to the correct orientation, but the last staple was turned 90 degrees. This was caused by the natural tendency of the mechanic to rotate the staple gun as staples were driven along the shingle.

This additional research should provide guidance on the enhancement of both the mechanical properties of shingles and the fastening requirements necessary to minimize shingle blow-off in the event of sealant bond failure. Ideally, if a bond failure is experienced, the worst case scenario would be loss of tabs (Photo 15) rather than blow-off of entire shingles.

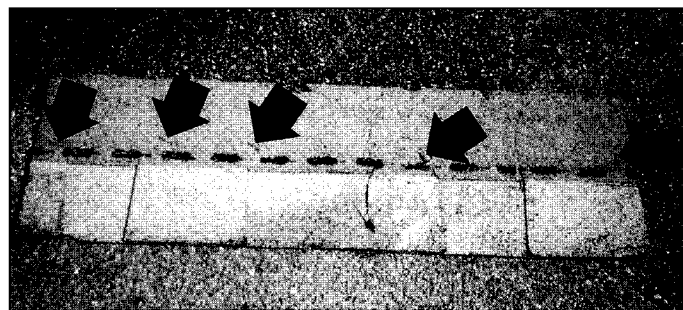
Photo 16. Progressive misorientation of staples (see arrows). Also, the staples are located above the self-seal strip rather than below it. The estimated peak gust wind speed was 145 mph (65 m/s).

Several Hurricane Andrew damage investigation reports stated that stapled shingles did not perform as well as nailed shingles.^{13, 18, 19} However, these reports lack documentation to support what may be overly generalized conclusions. With proper deck engagement, either fastener type has sufficient strength to resist the small uplift load on the shingle provided the tabs remain sealed. The blow-off potential develops if the tab becomes unbonded, in which case, the fastener pull-through resistance of the shingle and the number and orientation of fasteners govern performance. If nails are superior to staples, their superiority in preventing blow-off after sealant failure is minimal. However, nails do have the advantage of not having orientation problems. If staples are mis-oriented, as shown in Photo 16, the reduction in pull-through resistance appears to be significant.
