SHRINKAGE OF EPDM ROOF MEMBRANES: PHENOMENON, CAUSES, PREVENTION AND REMEDIATION

RALPH M. PAROLI, ANA H. DELGADO and OM DUTT

THOMAS L. SMITH and TERRANCE SIMMONS

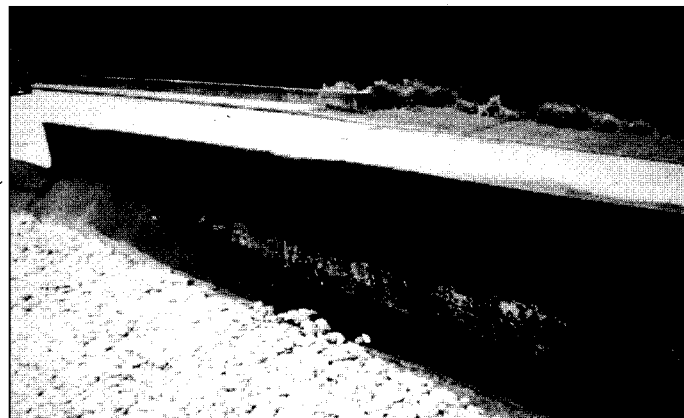
Photo 1. After the field sheet was torn at the metal batten, the originally uncured flashing over the batten stretched and tore. (Georgia)

Fortunately, this type of problem is typically not catastrophic. (An exception would be a long tear extending from an equipment curb into a ponded area, which happened in another area of the roof shown in Photo 1). In many instances, if flashings have become damaged, the roof life can be extended by their replacement/repair.²³

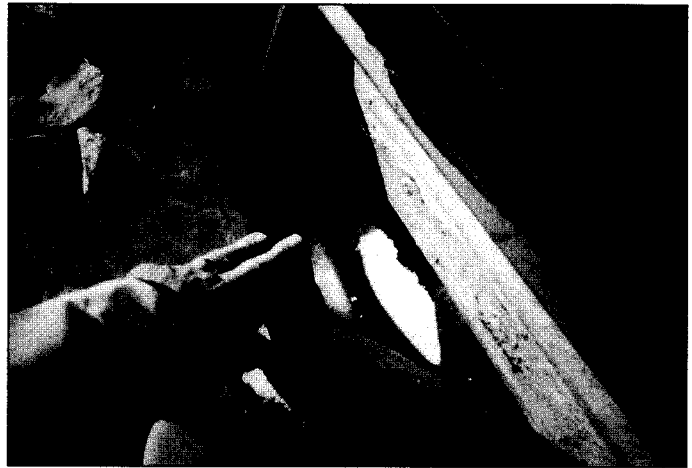
Photo 2. Roof S5: The field sheet was attached to a CMU wall with wood battens that were fastened with plastic sleeves/drive pins, spaced at 12 in., 11½ in. and 9½ in. (305, 290 and 240 mm). The field sheet tore and pulled out from under the batten at the fastener locations. The originally uncured flashing over the batten was then stretched and torn. At other locations, the fasteners pulled out of the wall and the batten moved inward approximately 6 in. (150 mm).

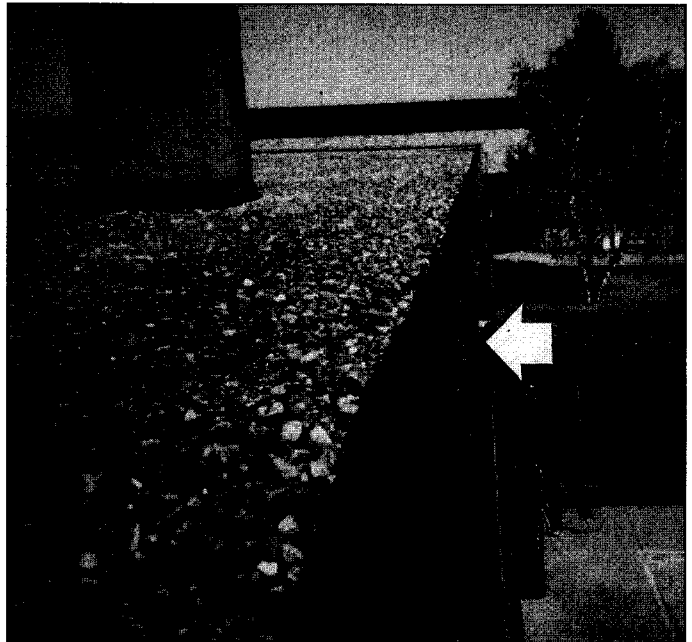
Photo 3. Roof S7: Membrane contraction caused the top of this weak metal parapet to move to the left. The parapet rested on the field sheet and the sheet was attached with roofing nails spaced at 18 in. and 18 in. (455 and 455 mm). It may have also had other securement. Water can now enter the top of the parapet (see arrow).

- S-7: Contraction of the membrane caused parapet damage (Photo 3). Membrane securement was as noted on the photo. The originally uncured flashing was very deteriorated. Minor water infiltration was possible.

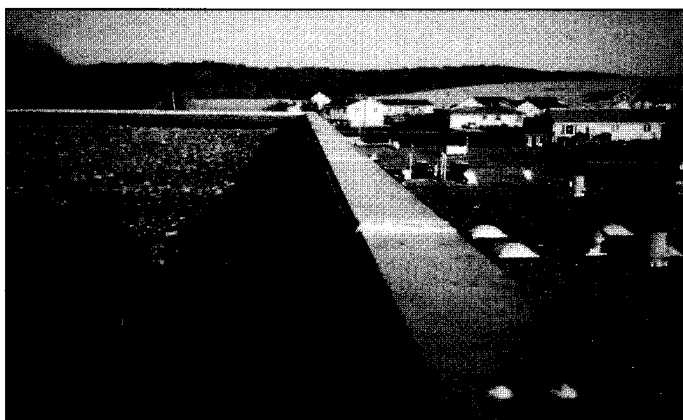
Photo 4. Roof S9: Along most of this parapet, the wood batten fasteners pulled out of the brick. In some locations, patches had been placed where the ends of the battens had punctured the flashing.

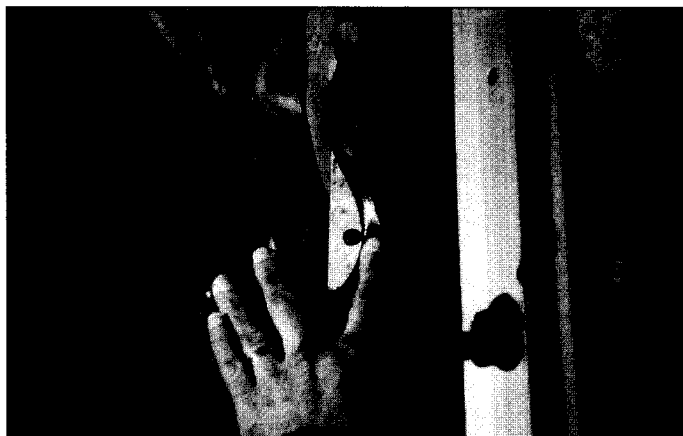
Photo 5. Roof S10: Looking down at a vertical transition between a new and old roof. The field sheet on the left was attached with a 1 in. (25 mm) wide aluminum batten that was fastened with screws at 12 in. (305 mm) on center. The field sheet tore at the fasteners and the originally uncured flashing over the batten was stretched until it tore.

- Membrane shrinkage does not appear to be the cause of the flashing problems on Roof S10 (Photo 5). The damage may be related to temperature-induced loads, however, since it was installed directly over an unreinforced PVC membrane that had shattered, perhaps the flashing damage was related to EPDM movement associated with subsequent shrinkage of the unreinforced PVC membrane. To avoid this later possibility, rather than recovering a membrane that may be susceptible to further shrinkage, the existing membrane could be removed. However, with conservative base securement details (which was not the case with this roof), flashing problems will probably not be experienced even if the old membrane remains.

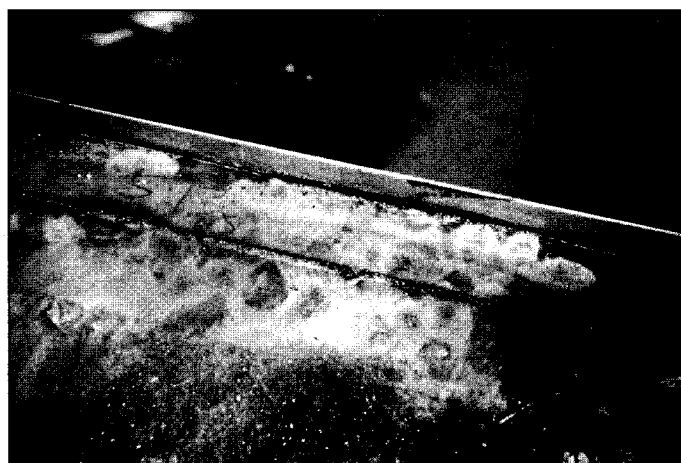
Photo 7. Roof S13: The field sheet is fastened with roofing nails that were also used to attach the metal edge flashing. The nails were spaced at 5 in., 5 in. and 4 in. (125, 125 and 100 mm). The field sheet turned down at the wall and was fastened by the continuous cleat fasteners. As the field sheet moved inward, the originally uncured flashing was stretched and torn.

(1985 and 1989) of *The NRCA Roofing and Waterproofing Manual* show batten strips near the base of parapets and curbs, and most of the details indicate a fastener spacing of 12 in. (300 mm), but the type of fastener is not indicated. The *Manual* also has a metal edge flashing detail that is similar to that shown in Photo 7.

For metal edge flashings, securement of non-reinforced sheets may be successful if the sheet is turned down at the outside face of the wall and fastened with capped-head nails which are closely spaced (e.g., 4 in. [100 mm] on center), and the membrane is additionally secured with a continuous metal cleat. The 90° angle change reduces the tearing stresses at the holes around these fasteners. However, some tearing/elongation of holes around the fasteners securing the horizontal flange of the edge flashing may still occur. Periodic observation and repair of the flashing may be required (Photo 7), as is commonly the case with similar details in built-up roofs.

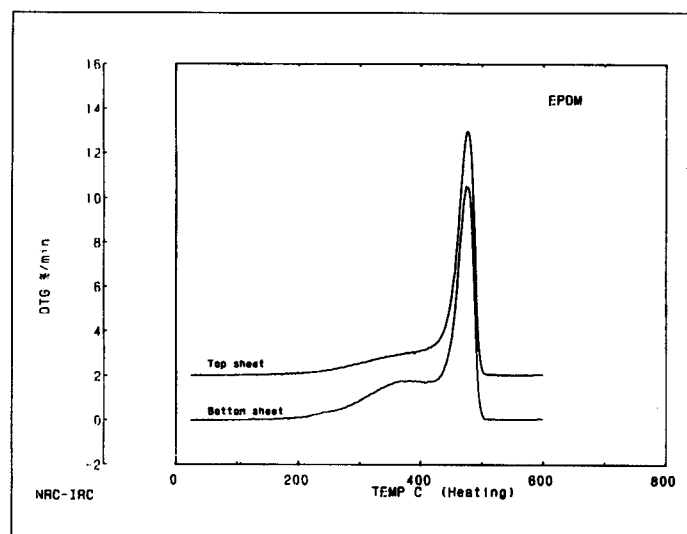
Figure 1. DTG plot for the SG1 EPDM roof membrane.

The amount of oil loss for the top sheets for S3A, S5-A, S7, S5-B, S13-B and SG1 is at least 3 percent (Appendix 5). For instance, the total weight loss below 930°F (500°C) for the top sheet of sample SG1 was 52.9 percent while for the bottom sheet, the weight loss was 60.9 percent. This indicates that the top sheet has lost some oil (~8 percent) during exposure to natural weather conditions. Results obtained for sample S13-B could indicate that the two bottom layers that have been naturally aged, but protected by the top layer, are losing oil at a slower rate. As can be seen from the results, the total weight loss for the oil and polymer region of the middle sheet is 2.6 percent higher than the top sheet, but 2 percent lower than the bottom sheet (i.e., the retained oil content is greatest for the bottom sheet).

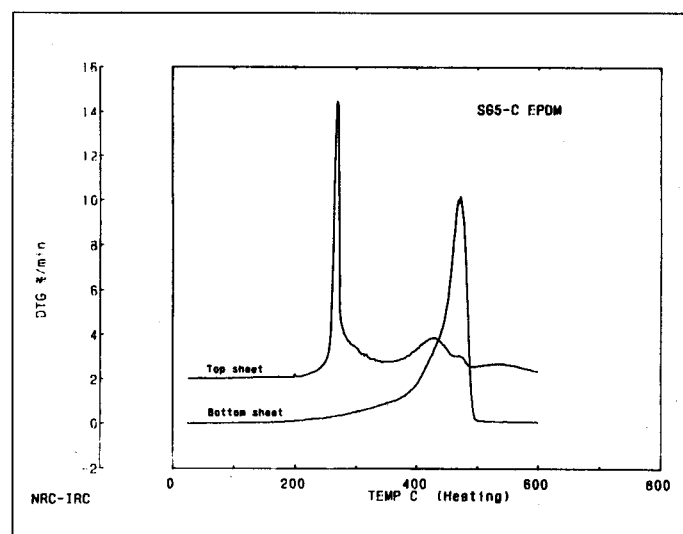
One sheet from SG5-C exhibits a weight loss between 480°F (250°C) and 700°F (370°C) which is not observed in a typical EPDM membrane (Figure 2). This sample, which was taken near a flashing, is an originally uncured sheet. It is interesting to note how the TG and DMA techniques can easily be used to differentiate between the various membranes on this roof. Using other chemical techniques such as Fourier-transform infrared (FTIR) spectroscopy, one can determine if the originally uncured flashing is either butyl- or neoprene-based. In this case, it is neoprene-based.

Figure 2. DTG plot for the SG5-C flashing.

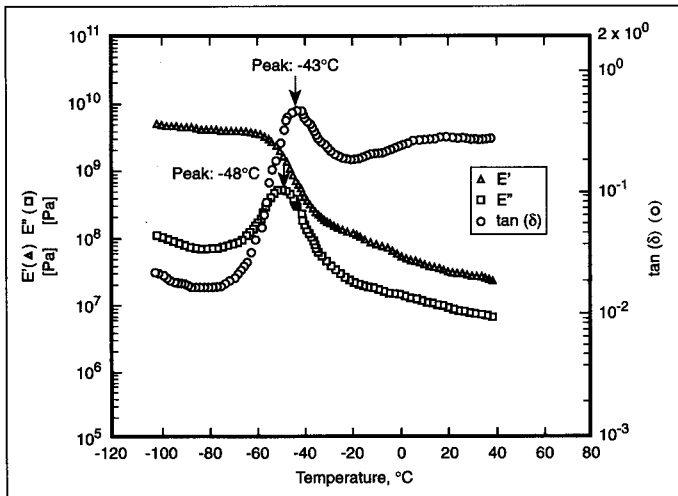
A typical DMA plot showing the storage modulus (E''), loss modulus (E') and damping factor ($\tan\delta$) is shown in Figure 3. The data are summarized in Appendix 5. In general, the T_g values did not change substantially. The ΔT_g (T_g [top sheet or "exposed"] - T_g [bottom sheet or "unexposed"] was as low as 0°F (0°C) to a high of 16°F (+9°C). A change in T_g to warmer temperatures can be attributed to various factors such as crosslinking, loss of oils (or plasticizers) or other molecular rearrangements. The only EPDM samples to show a change in T_g greater than 5°F (3°C) were S5-A, S13-B and SG1. This implies that although oil loss was detected in other samples, the amount was not sufficient to affect the T_g .⁴ On average, the T_g values ranged from -54°F (-48°C) to -72°F (-58°C). Only one sample, the originally uncured neoprene-based flashing in SG5-C, had a T_g value as high as -36°F (-33°C).

Figure 3. DMA plot for the S3-B EPDM roof membrane. (Note: E' is the storage modulus, E'' is the loss modulus and $\tan\delta$ is the damping factor.)

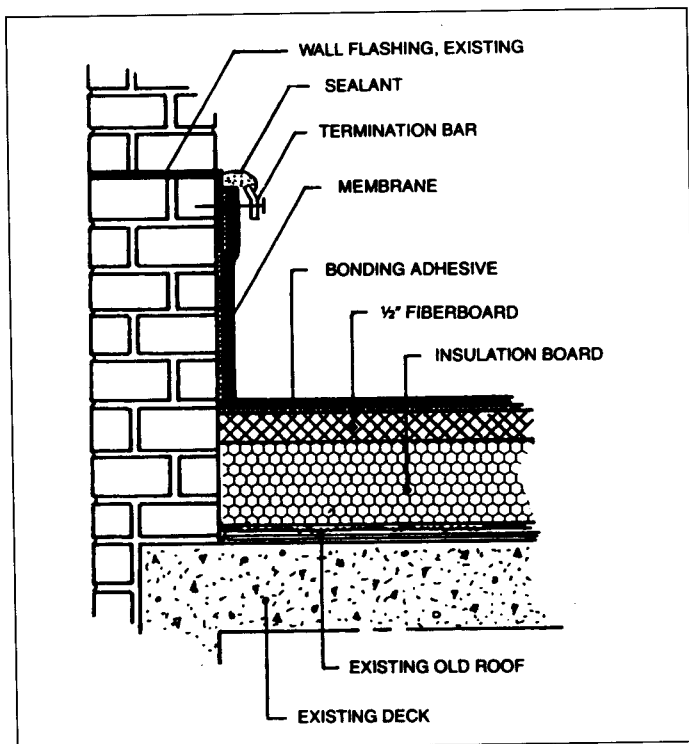
Figure 4. A 1980 detail from a manufacturer that did not recommend mechanical attachment near the base of the parapet. (This manufacturer no longer supplies EPDM sheets in North America.)

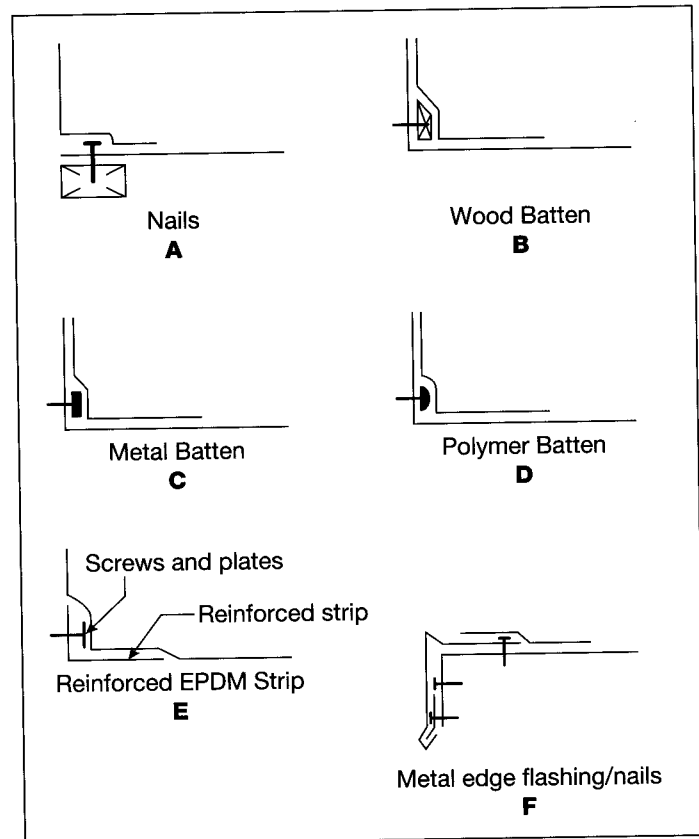
For non-reinforced membranes, all of the base securement details that use battens rely upon batten compression. If the batten does not provide sufficient compression and if the non-reinforced membrane contracts, then the membrane begins to tear around the strip's fasteners (Photo 2 and 5). As the field sheet becomes unrestrained, the originally uncured flashing is stretched. If stretched sufficiently, it can tear (Photo 1 and 7). (When stretched, originally uncured flashing can tear more easily than stretched field sheet.)

Figure 5. Common base securement details that have been or are still being used. (Typically, fastening strips may be installed on the vertical or horizontal plane.)

To enhance the probability of maintaining sufficient compression during the design service life of the roof, batten fasteners could be specified to be spaced more closely together (e.g., 6 in. [150 mm]), rather than the common 12 in. (300 mm). Also, it is of critical importance to specify a fastener, such as a screw, that is capable of pulling the batten snugly to the substrate and maintaining it there. Attention by the sheet manufacturer to the type of batten fasteners that they recommend for various substrates is also vital. The substrate under the EPDM should be firm and capable of maintaining the compression load. Bending characteristics of the battens are also important, although the batten needs to be flexible enough to conform to common substrate irregularities.
