FIELD AND LABORATORY ASSESSMENT OF SPF ROOF SYSTEMS

RENE M. DUPUIS

Structural Research, Inc.
Middleton, Wisconsin

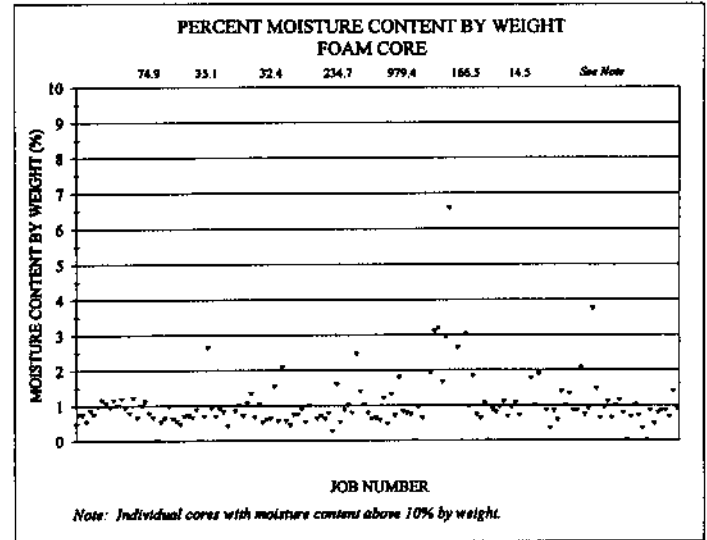
Figure 6. Foam core moisture content, by weight.

Moisture content values were determined by oven drying the samples at 50°C (122°F); no further weight change was observed. The average moisture content was 1.02 percent by weight (for 155 specimens with moisture contents less than 10 percent by weight) as shown by the plot in Figure 6. Also shown at the top of the graph are the moisture content results for eight samples that were beyond the maximum scale of the graph (10 percent by weight). These higher moisture contents range from 14.5 percent to 979 percent. It is interesting to note that five of these eight high moisture content values were taken from roofs that were aggregate surfaced. The highest moisture content of 979 percent by weight

came from an aggregate surfaced foam roof that had an air conditioned office space immediately below with a suspended ceiling installed below the roof deck. Ponded water was noted to occur near the sample area on this New Jersey SPF roof when it was surveyed in June 1996.

The three other roofs having a high moisture content in the foam core was a SPF roof located in Texas and recoated with silicone in 1993. Another high moisture content (35.1 percent by weight) was found on a church roof in southern California that used an acrylic coating and was installed in 1989. The roof was surveyed in January 1996. A silicone coated restaurant roof was inspected in northwestern Wisconsin in August 1996. This roof was installed in 1978 and recoated in 1992. A deep core sample (87.5 mm [3½ in.] thick) was taken in the kitchen area. The top half of the core sample had a moisture content of 0.72 percent by weight; the bottom half of the core sample had a moisture content of 166.5 percent by weight. Upon further inspection, it was determined that a built-in freezer was immediately below this area and that a moisture vapor drive condition existed due to the presence of the freezer. The silicone coating (while performing adequately) could not resist the passage of water vapor due to the cold conditions at the deck level.

A large manufacturing complex in New Jersey (inspected in June 1996) had nine aggregate surfaced SPF roofs of various ages with moisture contents ranging from 1.67 percent to 6.58 percent by weight in 8 of the 10 core samples taken. The other two core samples from this complex had moisture contents of 234.7 percent and 979.4 percent.

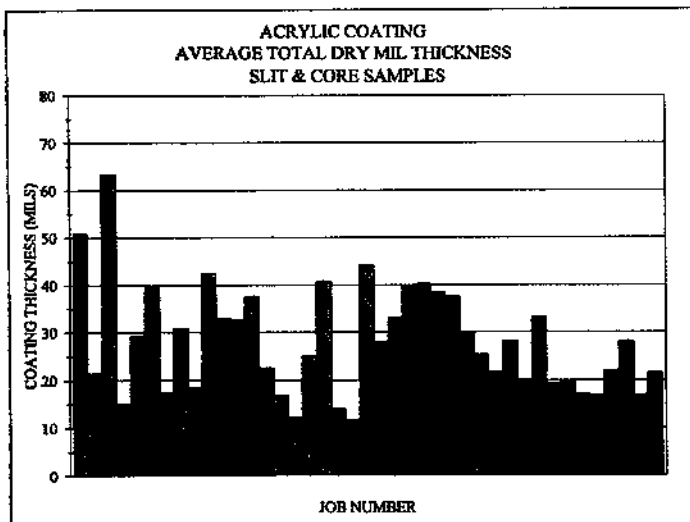
Figure 7. Average total dry mil thickness for acrylic coatings.

The total dry mil thicknesses of the coated SPF roofs were determined from core samples and slit samples taken during the survey. The average coating thickness for each acrylic roof is shown in Figure 7. These values include recoated systems as well as original acrylic coatings. The acrylic coating thicknesses ranged from a high of 63.4 mils to a low of 11.7 mils. The SPF roof with 63.4 mils was originally installed in 1981 and recoated in 1995. The SPF roof with 11.7 mils of acrylic coating was installed in 1995.

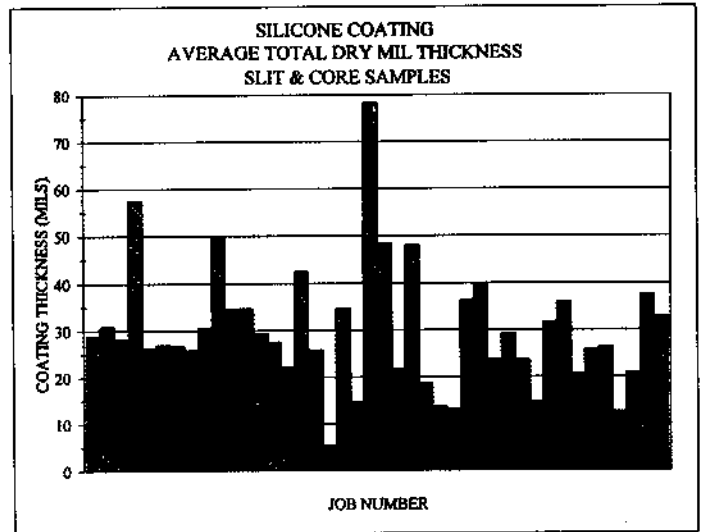
Figure 8. Average total dry mil thickness for silicone coatings.

The average coating thickness for each silicone SPF roof surveyed is shown in Figure 8. The silicone coating thicknesses ranged from a high of 78.3 mils to a low of 5.4 mils. The SPF roof with 78.3 mils of silicone was installed in 1978 and recoated in 1990. The SPF roof with 5.4 mils of silicone was installed in 1969 and has never been recoated.

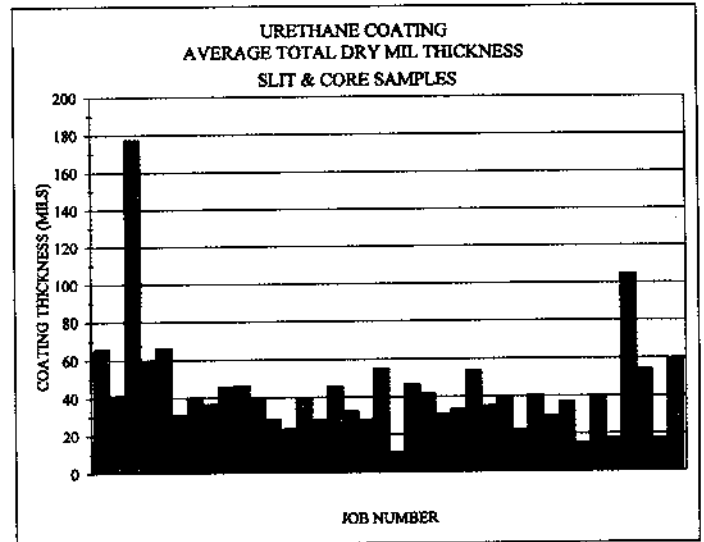
Figure 9. Average total dry mil thickness for urethane coatings.

The average coating thickness for each urethane SPF roof is shown in Figure 9. The urethane coating thicknesses ranged from a high of 177.5 mils to a low of 10.8 mils. The SPF roof with 177.5 mils of urethane was installed in 1976 and recoated in 1995 after a severe hailstorm with baseball size hail damaged the roof. The SPF roof with 10.8 mils of urethane was recoated in 1984.
