INFLUENCE OF NAIL LOCATIONS ON WIND RESISTANCE OF UNSEALED ASPHALT SHINGLES

THOMAS L. SMITH, AIA, RRC

MATT MILLEN

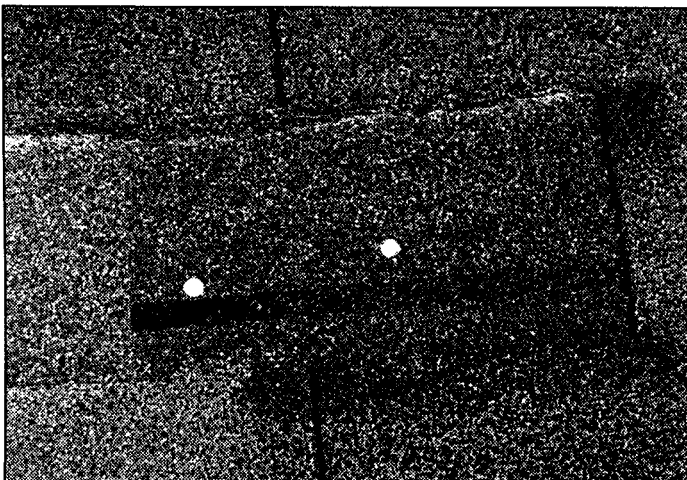
The influence of substantially offset fasteners on the wind performance of sealed shingles is not documented in the literature. However, as illustrated by Photo 1, it is likely that relatively large offsets are not problematic as long as the tabs remain sealed.

Photo 1. This roof lost a few tabs during a storm. These fasteners were substantially offset from the specified locations. However, tab blow-off was related to inadequate bonding of the sealant, rather than fastener location.

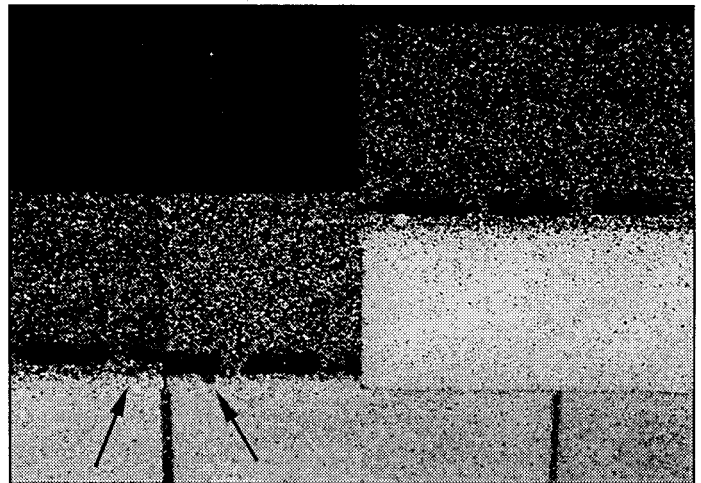
Photo 2. This roof is under construction. The end nail at the lower left corner was located as specified. However, the end fastener at the adjacent shingle was placed lower than specified in order to avoid placing the nail in the sealant (the sealant strip is lower on this shingle).

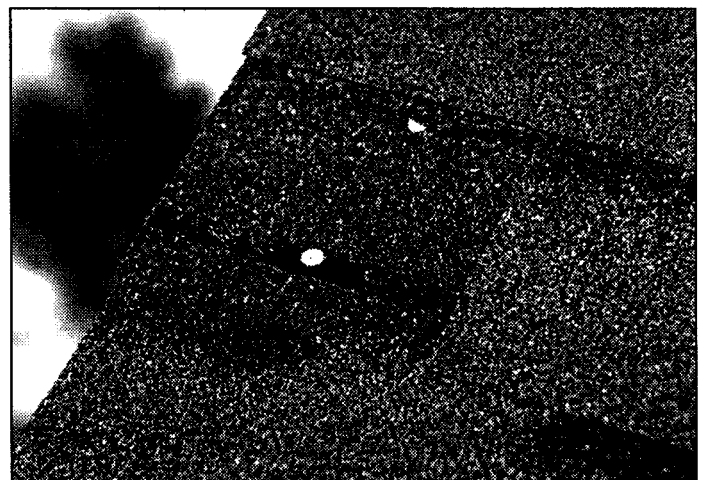
Photo 3. This roof lost a rake tab during a storm. Because the shingle extended past the edge of the deck, the nail was located inward of the typical location for end fasteners.

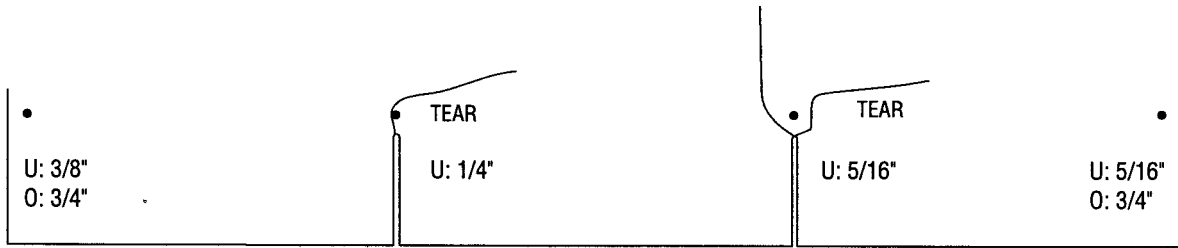
B1 E1 35° RUN 79 DAMAGE INDEX: 52

B1E3 had two small tears at the cutouts, whereas B1E1 had large tears at the cutouts. Although the damage was quite different, the nails above the cutouts in each of these runs were almost identically located. Each run had one nail that was $\frac{3}{8}$ inch (9.5 mm) below the specified location. B1E2 had one nail that was $\frac{1}{8}$ inch (3.2 mm) below the specified location, yet it, too, had a large tear at the cutout.

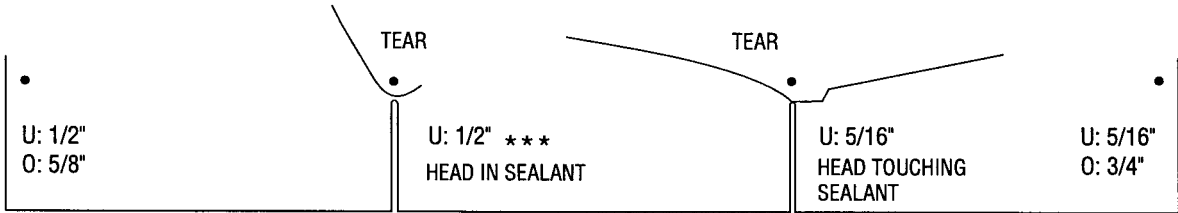
B1 E2 35° RUN 70 DAMAGE INDEX: 48

product B1, in some instances, the nail head engaged the sealant even though the nail was located 1/8 inch (3.2 mm) below the specified location (see B1E2 in the Appendix). Photo 2 (from a job under construction) also shows sealant strip location variability.

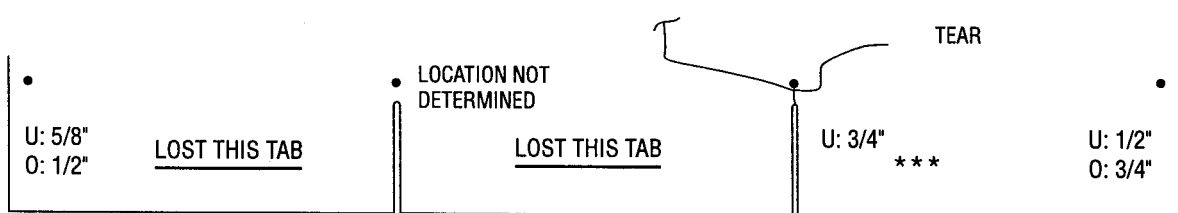
B1 G4 35° RUN 93 DAMAGE INDEX: 86

Although the greatest distance from the specified location occurred with end fasteners, tears only occurred at four end fasteners (decks B1A3, B1G3, B1G4 [tab blew off] and B2C7). A severe crack also occurred at one end fastener (B1A1). Hence, while only 5 percent of the shingles had damage at their ends, 68 percent of the end nails were greater than ¼ inch (3.2 mm) from their specified location.⁵
