INFLUENCE OF NAIL LOCATIONS ON WIND RESISTANCE OF UNSEALED ASPHALT SHINGLES

THOMAS L. SMITH, AIA, RRC

MATT MILLEN

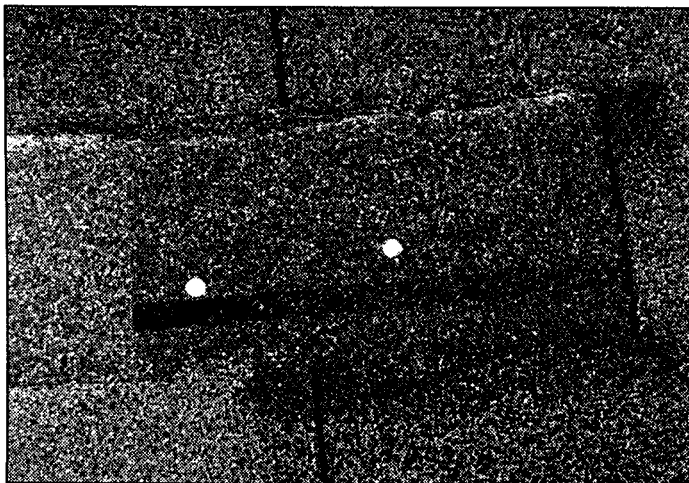
The influence of substantially offset fasteners on the wind performance of sealed shingles is not documented in the literature. However, as illustrated by Photo 1, it is likely that relatively large offsets are not problematic as long as the tabs remain sealed.

Photo 1. This roof lost a few tabs during a storm. These fasteners were substantially offset from the specified locations. However, tab blow-off was related to inadequate bonding of the sealant, rather than fastener location.

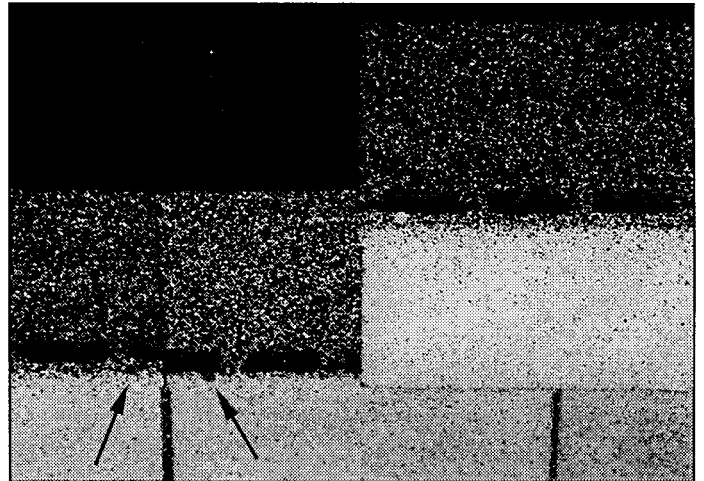
Photo 2. This roof is under construction. The end nail at the lower left corner was located as specified. However, the end fastener at the adjacent shingle was placed lower than specified in order to avoid placing the nail in the sealant (the sealant strip is lower on this shingle).

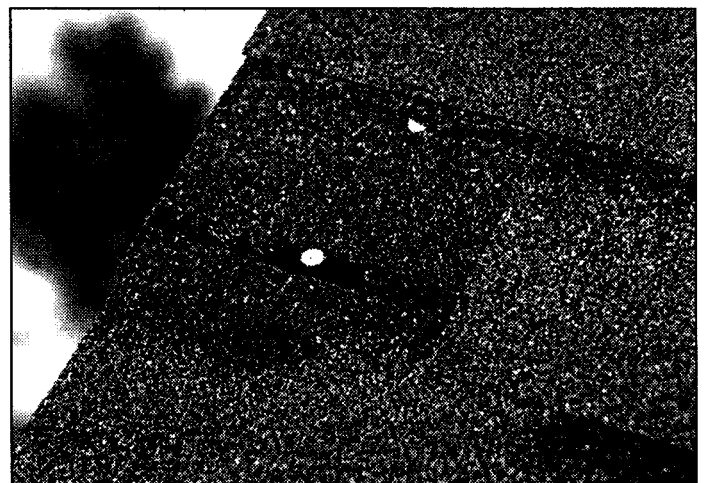
Photo 3. This roof lost a rake tab during a storm. Because the shingle extended past the edge of the deck, the nail was located inward of the typical location for end fasteners.

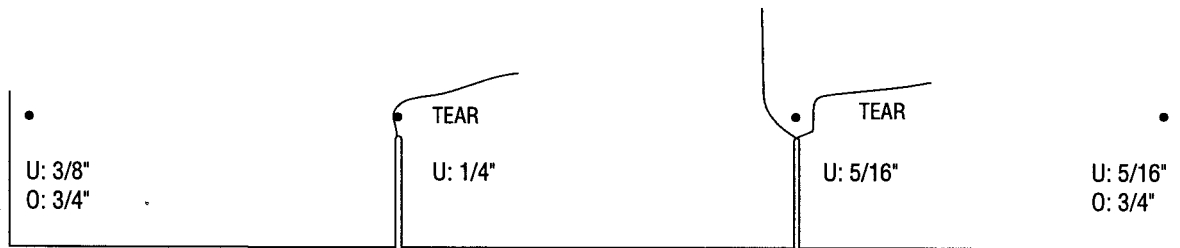
B1 E1 35° RUN 79 DAMAGE INDEX: 52

B1E3 had two small tears at the cutouts, whereas B1E1 had large tears at the cutouts. Although the damage was quite different, the nails above the cutouts in each of these runs were almost identically located. Each run had one nail that was $\frac{3}{8}$ inch (9.5 mm) below the specified location. B1E2 had one nail that was $\frac{1}{8}$ inch (3.2 mm) below the specified location, yet it, too, had a large tear at the cutout.

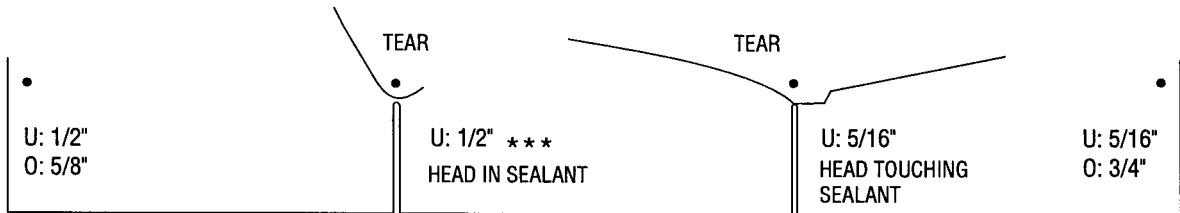
B1 E2 35° RUN 70 DAMAGE INDEX: 48

product B1, in some instances, the nail head engaged the sealant even though the nail was located $\frac{1}{8}$ inch (3.2 mm) below the specified location (see B1E2 in the Appendix). Photo 2 (from a job under construction) also shows sealant strip location variability.

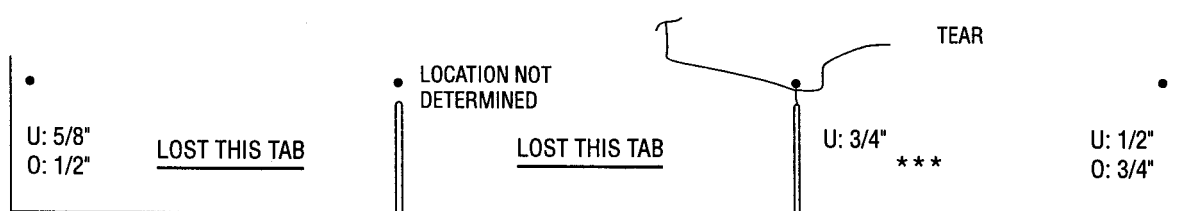
B1 G3 35° RUN 87 DAMAGE INDEX: 62

B1G3, which was in the same replicate set as the B1E runs, had one nail at a cutout that was $\frac{1}{16}$ inch (1.6 mm) below the specified location. At the other cutout, the nail was $\frac{1}{8}$ inch (3.2 mm) below the specified location. Although these nails were more accurately located than those at B1E1, B1E2 and B1E3, the tab was blown off between the cutouts and there were large tears extending from each cutout of B1G3.

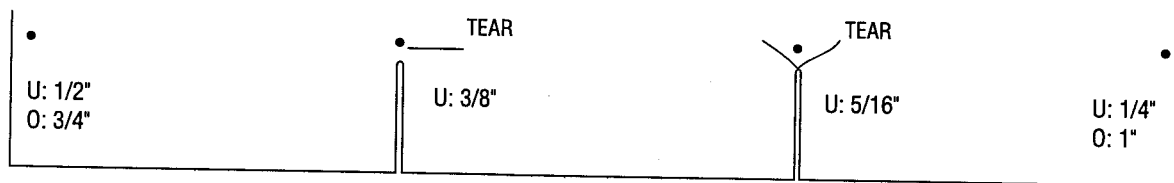
B1 C3 70° RUN 34 DAMAGE INDEX: 84

B1C3, which was in the same set as B1C6, also had a V-shaped tear at a cutout. The nail at this location was ¼ inch (7.9 mm) below the specified location. As with B1C6, the nails at both cutouts at B1C7 were ¼ inch (1.6 mm) below the specified location. However, rather than small V-shaped tears, B1C7 had large vertical tears extending up from the top of each cutout.

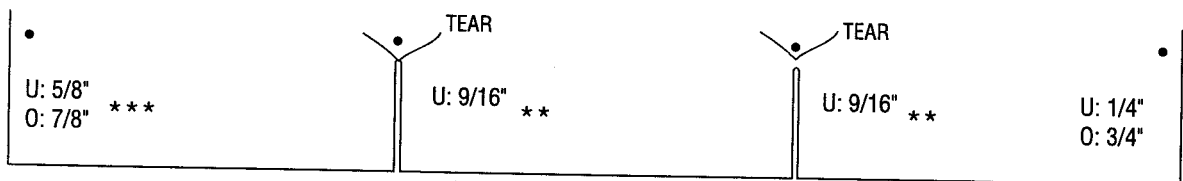
B1 C6 70° RUN 50 DAMAGE INDEX: 70

B1C6 had a V-shaped tear at each cutout. The nails at both cutouts were ¼ inch (1.6 mm) below the specified location. This is in contrast to B1A3, where the nails at the cutouts were ¼ inch (1.6 mm) high. B1C was a normal duration run, whereas B1A was a long duration run.
