THE SACRED CONVENT AND THE BASILICA OF ST. FRANCIS OF ASSISI

COSTANTINO CENTRONI

Soprintendente per i Beni Ambientali Architettonici Artistici e
Storici dell'Umbria

The emergency sites

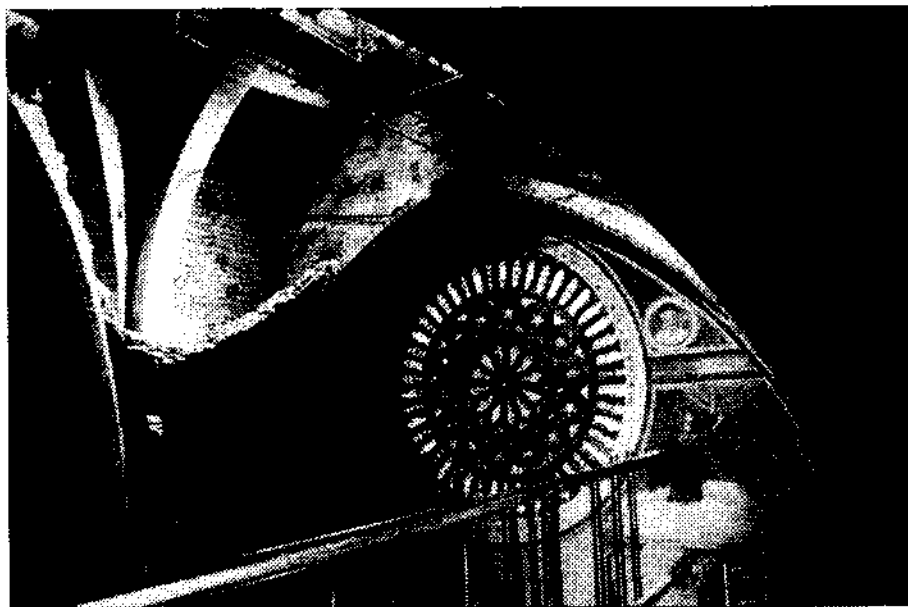
Figure 4: Portion of the fallen vault near the entrance.

Then the fact that the two vaults next to the transept (fig. 3) and to the facade (fig. 4) yielded is due to another phenomenon: these elements (the transept and the facade) represent the most rigid points in respect to the nave (which is more deformable) and it is precisely in this transition zone that the supplementary strains are produced which are then added to the previous ones.
