Failure Mechanisms in Liquid-Applied Waterproofing Systems

Kami Farahmandpour, PE, RRC, CCA, CCCA

Case History: Cincinnati Museum Center Plaza Fountain

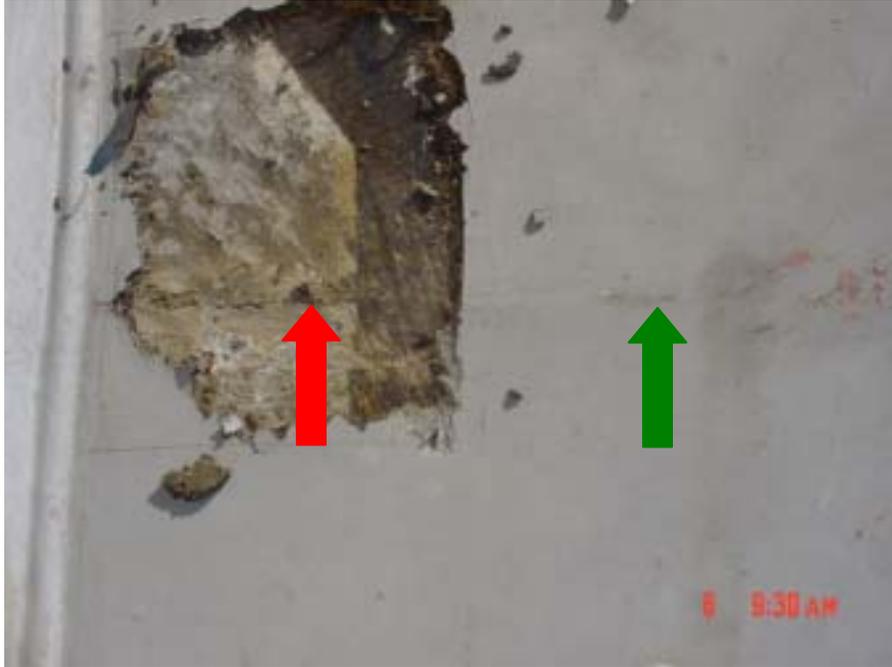
LAMs depend on substrate integrity to perform properly. Although in some cases the membranes are reinforced with some type of fabric/scrim reinforcement, most LAMs are applied directly over a substrate without the use of reinforcing fabric/skrims. Reinforcing fabric/skrims can help distribute crack movements over a wider area. This will help reduce stresses on the membrane over the crack region. However, when reinforcing fabrics/skrims are not present, crack movements will typically cause high stress concentrations on the membrane over the crack, resulting in localized tearing of the membrane (Figure 1). This phenomenon is called crack reflection.

Figure 1 – Crack (tear) in a reinforced liquid-applied membrane (left arrow) coincides with substrate crack (right arrow).

In the author's opinion, better guidelines for application of LAMs over substrate cracks should also be developed. At a minimum, routing and sealing of cracks that are greater than 0.05 inches (1.27 mm) wide should be required. Narrower cracks may also have to be repaired in a similar manner. Regardless of the width of a crack, all moving cracks should be treated carefully to provide for distribution of stresses over the crack.

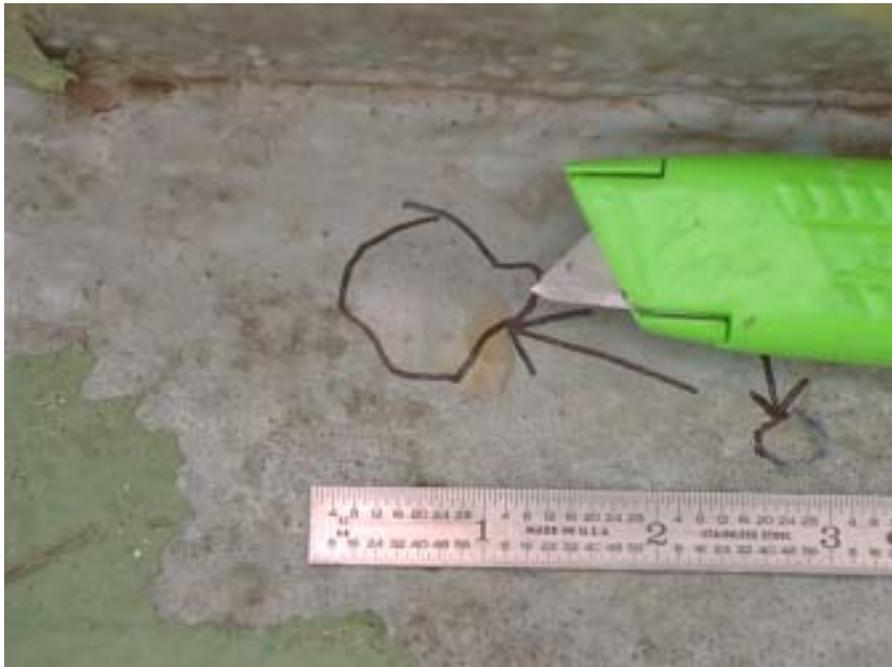
When a LAM is applied to the surface of concrete, it acts as a vapor retarder at the concrete surface, preventing evaporation or moisture emission. Water vapor moving to the surface of the membrane cannot escape, thus causing a buildup of water vapor pressure between the membrane and concrete surface. This phenomenon can occur within minutes of applying a LAM to a concrete surface. Because most LAMs are chemically cured and require several hours to cure and establish bond to substrates, buildup of water vapor pressure shortly after application can inhibit development of a proper bond between the membrane and concrete substrate. Zones of weakened bond can manifest quickly as blisters filled with water and can ultimately cause failure of the membrane (Figures 2 and 3).

Figure 2 – Water-filled blister in a liquid-applied membrane.

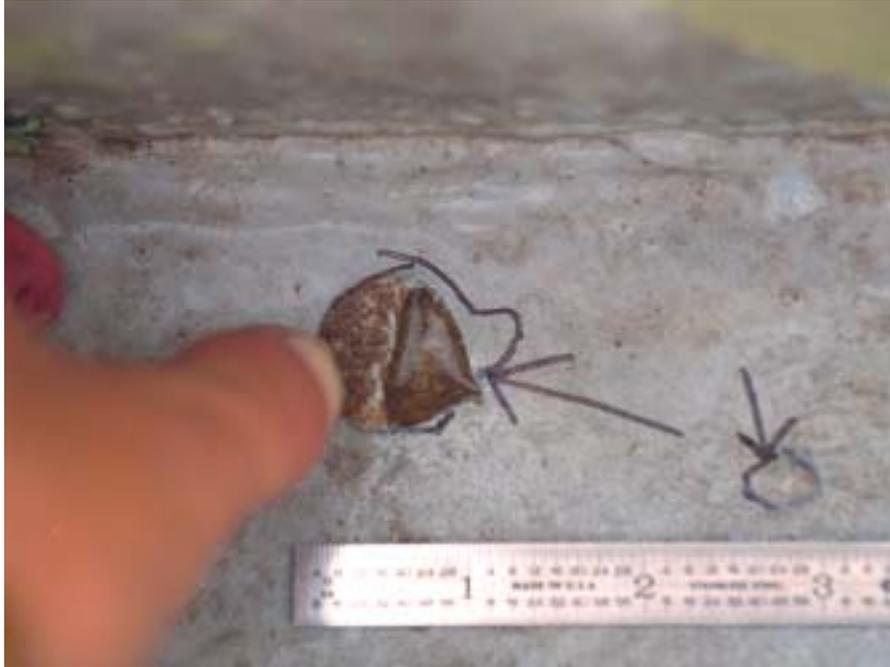
Figure 3 – Water entrapped in the blister shown in Figure 2.

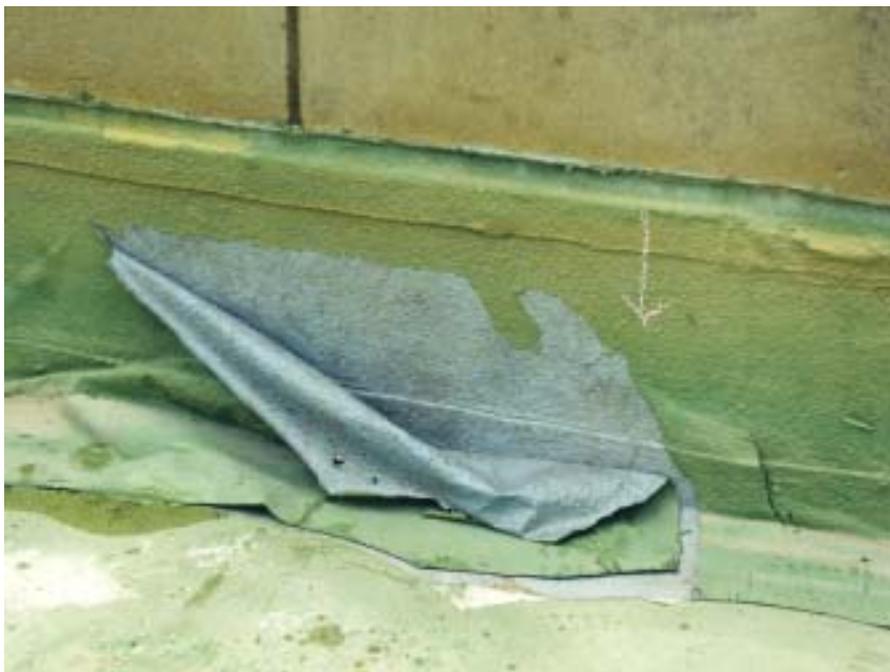
The waterproofing membrane had debonded (separated from the substrate) and delaminated (separated from its underlying layers) in many areas of the fountain (Figures 6 and 7). Large sheets of membrane and color coat peeled away easily in some areas. In general, second and third applications of the membrane (previous repairs) were poorly bonded and could be separated readily. In a few cases, individual layers of the first application of membrane and color coat exhibited interlayer delamination. In most cases, the primer (identified by its red color) appeared to be well-adhered to the concrete.

Figure 6 – Large interlayer delaminations of the membrane.

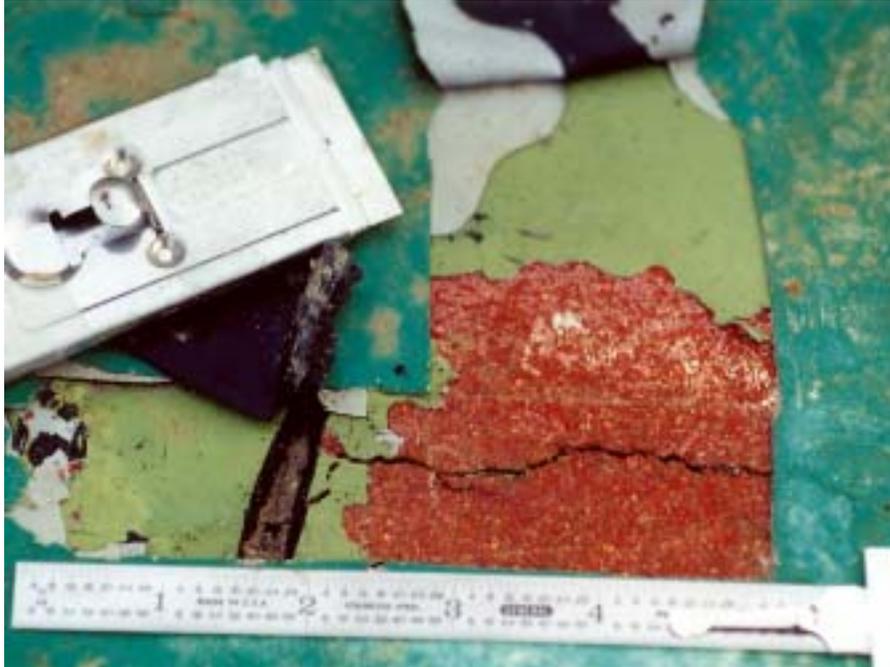
Figure 7 – Interlayer membrane delaminations at various interfaces. Note the substrate crack reflecting through the first light green application of the membrane.

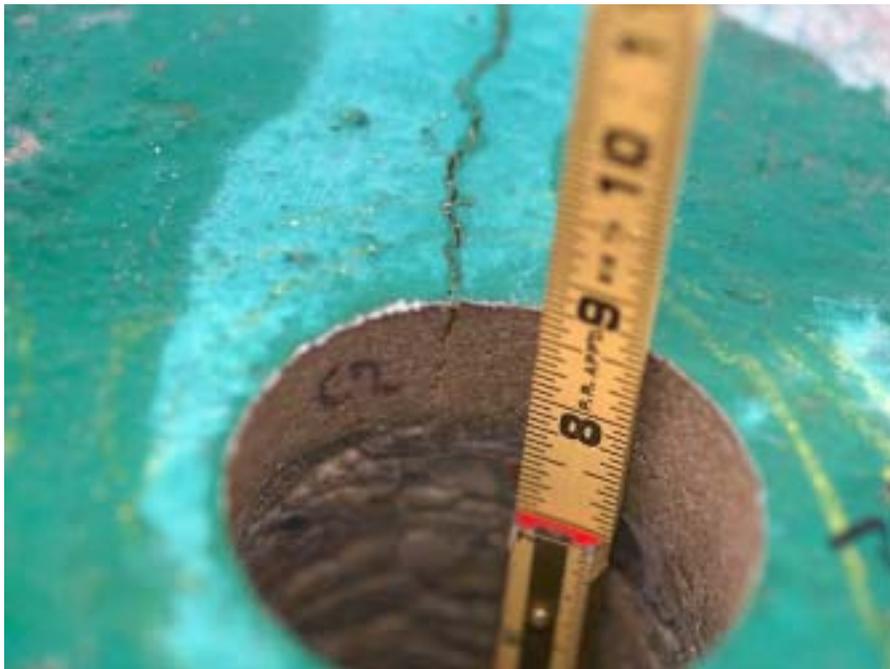
In several areas, cracking of the substrate concrete had reflected through the membrane directly over the crack (Figure 8).

Cracks observed within the membrane lined up with cracks in the substrate. These cracks were attributed to deterioration of repair patches, as well as cracking and deterioration of the original concrete within the fountain. Because the original fountain concrete was not air-entrained and did not have a topside waterproofing membrane for many years, it was susceptible to freeze-thaw deterioration. Also, a drainage layer was not provided at the level of the lead pan. Therefore, water penetrated and saturated the concrete above the lead pan. During winter months, the trapped water froze and cracked the saturated concrete. This deterioration likely began shortly after construction and has continued through the life of the fountain.

Figure 8 – Substrate crack reflecting through the membrane.

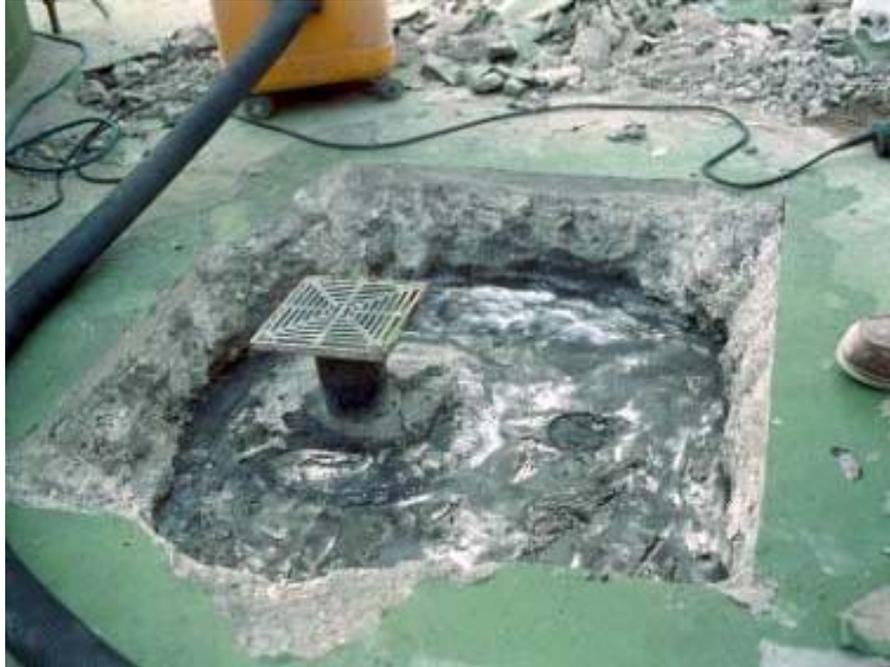
At the lower exploratory opening (Figure 11), water was observed running into the opening at the level of the lead pan, indicating water had migrated to and was ponding on the lead pan. Water continued to enter the exploratory opening for the duration of the field investigation. The drain within the exploratory opening did not appear to be original. The existing 3-inch (75-mm) drain line was placed in an 8-inch (400 mm) diameter hole in the structural slab, presumably from the previous drain line. Backer rod was placed in the annular space between the 3-inch (75 mm) drain line and the concrete, and approximately 1 inch (25 mm) of grout was poured on top of the backer rod. The lead pan overlapped the original drain flange (still in place) but was not attached to the new drain. Therefore, the waterproofing system was not continuous and did not protect the structural slab around the drain.

A portion of the lead pan and bituminous waterproofing membrane was removed. The surface of the underlying structural deck was damp. A partial-depth concrete core (taken from Exploratory Opening No. 1 to evaluate the condition of the structural slab) indicated severe cracking and delamination.

Figure 11 – Overall view of Opening 1 showing the original lead pan and a retrofit drain.

Based on the findings of this investigation, it was concluded that the only viable, long-term solution for rehabilitation of the fountain was a complete reconstruction of the fountain above the lead pan. It was recommended that the lead pan be left in place and repaired as a redundant waterproofing membrane.

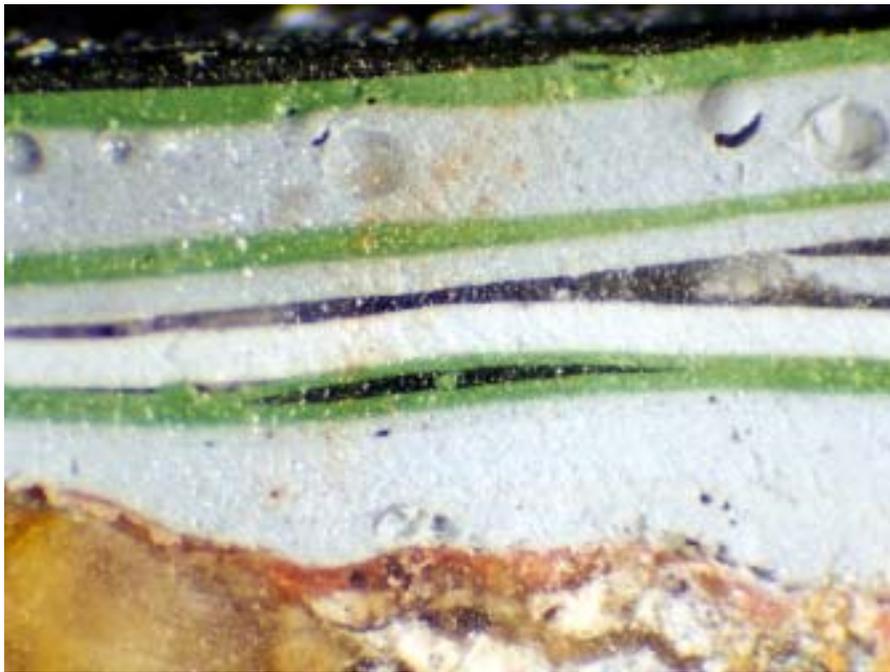
Microscopic examination of samples obtained in the field indicated the first application of the waterproofing membrane consisted of a red primer applied directly to the concrete/repair mortar substrate, followed by multiple coats of a light gray membrane and topped with multiple coats of a green color coat. In some areas, the membrane contained embedded aggregate up to 52 mils (1.321 mm) in diameter while the membrane did not contain any aggregate in other areas. The first application of the waterproofing membrane thickness was highly variable. Primer thickness ranged from 1 mil to 5 mils (0.025 mm to 0.127 mm). Membrane thickness ranged from 1 mil to 57 mils (0.025 mm to 1.448 mm), and color coat thickness ranged from 1 mil to 20 mils (0.025 mm to 0.508 mm). The coating system on sidewalls and sloped surfaces typically was thinner. Figures 12 through 14 depict various membrane configurations that were observed.

Reapplication of the membrane had failed in numerous areas, primarily because of lack of proper bond between the first membrane application and subsequent applications. Bond failure was typically caused by inadequate surface preparation techniques. The lack of interlayer bond provided voids that collected water and created blisters. The water collecting in these voids penetrated through pinholes and other deficiencies in the membrane.

Figure 12 – Photomicrograph of the membrane in an area with three membrane applications. Note interlayer delaminations at various layers.

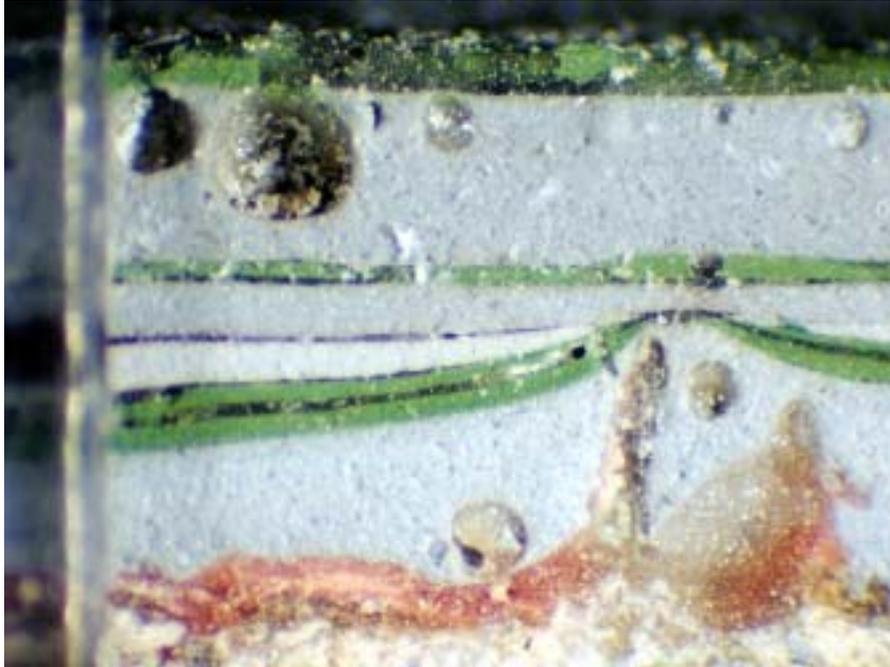
In some areas of the fountain, sand particles had been broadcast into the membrane during installation. The tips of the sand particles typically were exposed, creating pinholes within the membrane. These pinholes could allow water penetration under hydrostatic head, filling voids and creating interlayer blisters. The inclusion of sand particles was not specified by the membrane manufacturer and is not common to waterproofing systems designed for this service condition. The sizes of sand particles placed in the first membrane application were large enough that their tips were typically exposed through subsequent membrane applications.

Figure 13 – Photomicrograph of the membrane in an area with three membrane applications. Note bridging of the bottom layer by a sand particle.

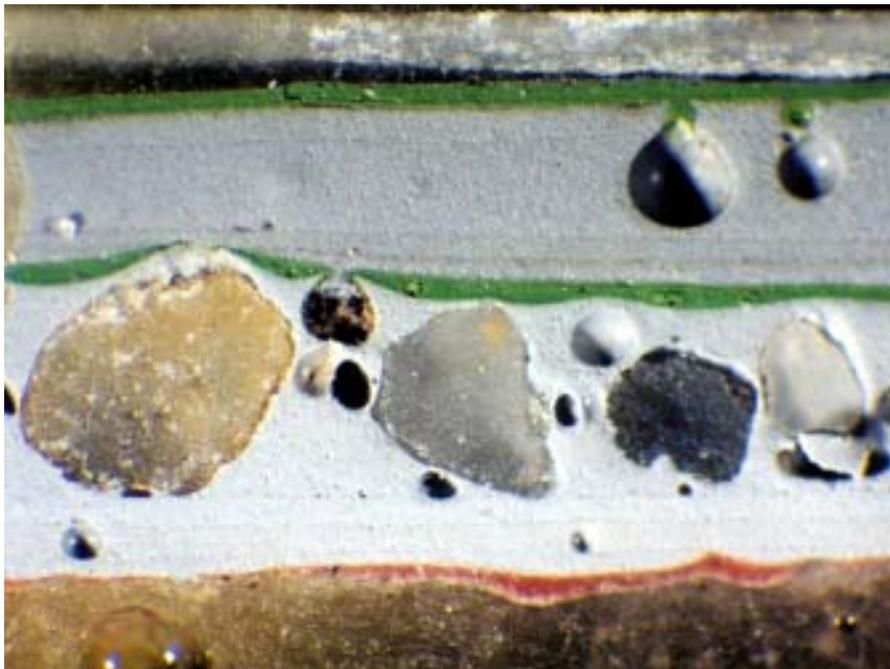
In some areas, the membrane contained embedded sand (aggregate) within the first application of membrane. In these areas, the coating exhibited a rough surface texture with the tips of the aggregate commonly exposed. A second application of coating did not completely cover the exposed aggregate. When this coating was peeled away, it contained numerous pinholes.

Figure 14 – Photomicrograph of a membrane area with sand particles broadcast into the bottom layer.

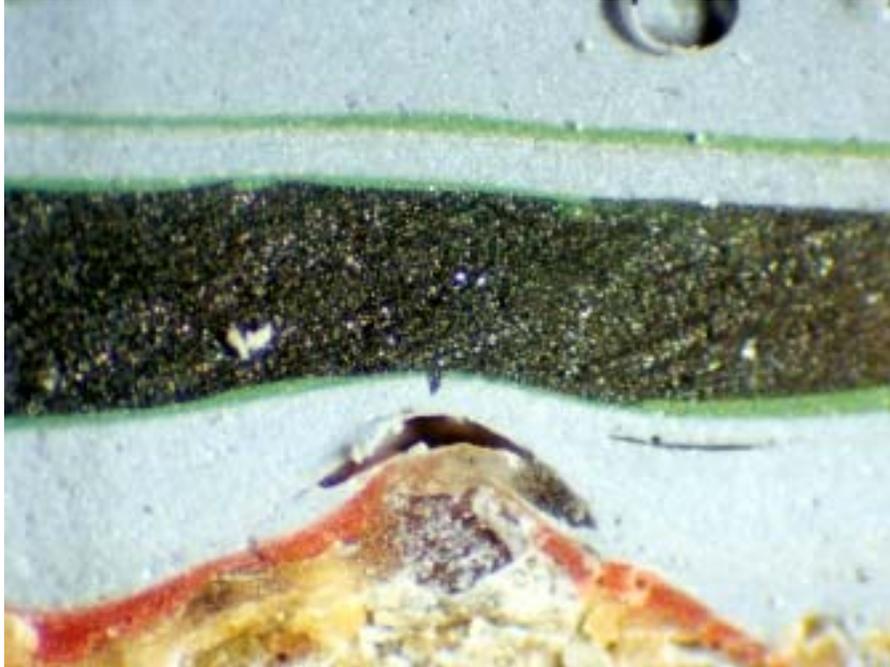
Examination of the waterproofing membrane revealed numerous small pinholes in the primer and water-filled blisters at the primer/membrane interface (Figure 15). Interlayer debonding of the membrane was common. In general, second and third applications of the membrane were poorly bonded and could be separated readily. In a few cases, individual layers of the first application of membrane and color coat exhibited interlayer delamination. In most cases, the primer appeared to be well-adhered to the concrete. Tears and breaches of the membrane were typically reflections of cracks in the substrate.

Numerous small pinholes and blisters in the first application of the primer and membrane were observed. There was no record of water vapor emission tests having been performed before application of the LAM. Therefore, it was concluded that the concrete substrate was saturated and exhibited high water vapor emission rates during and immediately after application of the membrane system. This high water vapor pressure resulted in the formation of pinholes in the primer. These pinholes facilitated the formation of blisters.

Figure 15 – Photomicrograph of a membrane blister directly over a substrate peak. The peak appears to have caused a breach in the primer (red material).
