# Refurbishing Roof System and Roof Terraces on a Major Residential Building Complex

NRCA, Washington

2011-09-08

Tommy Bunch-Nielsen , Danish Roofing Advisory Board

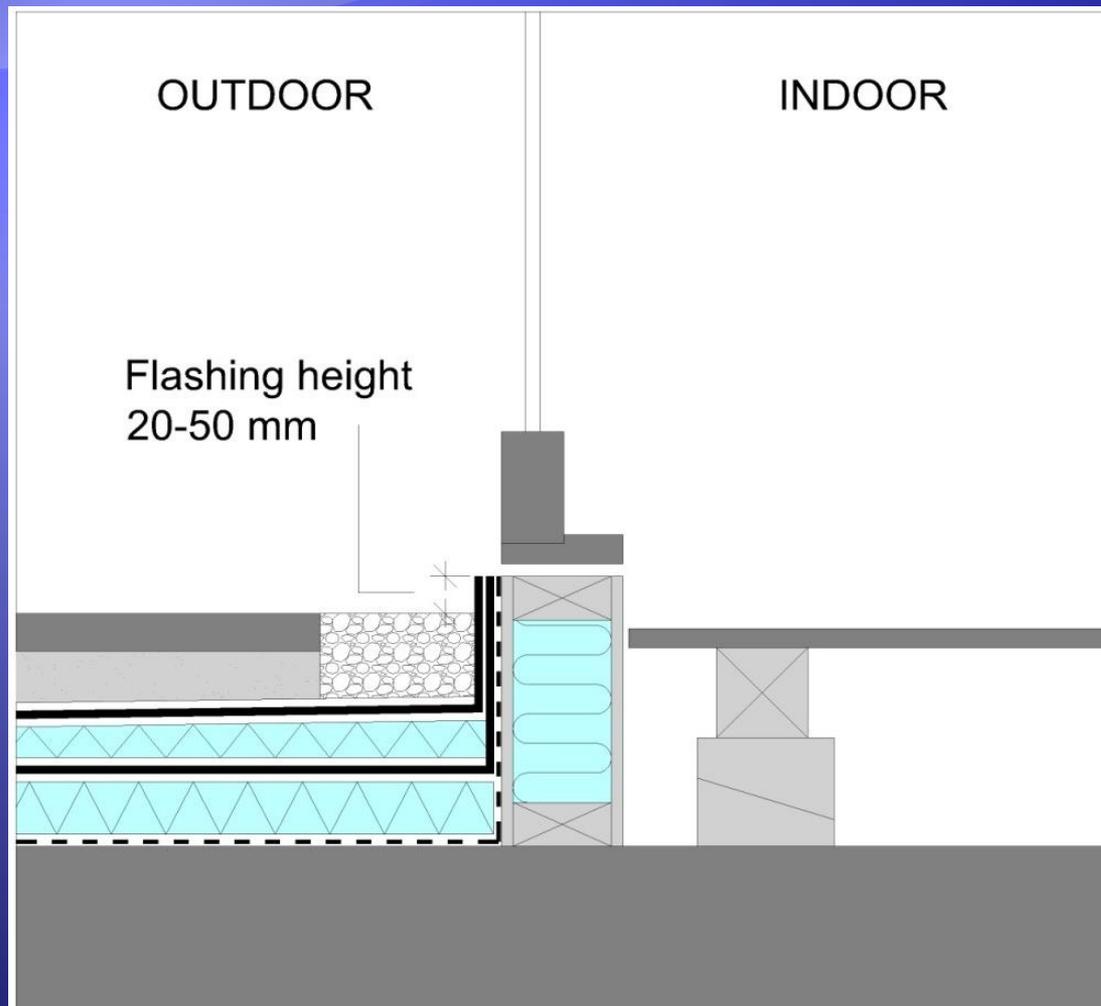
- ◆ Tapered insulation and PVC membrane
- ◆ Slope 1:100 or 1 %
- ◆ Height of up stands unchanged
- ◆ Flashing height lower due to extra insulation

# Lower height of flashings

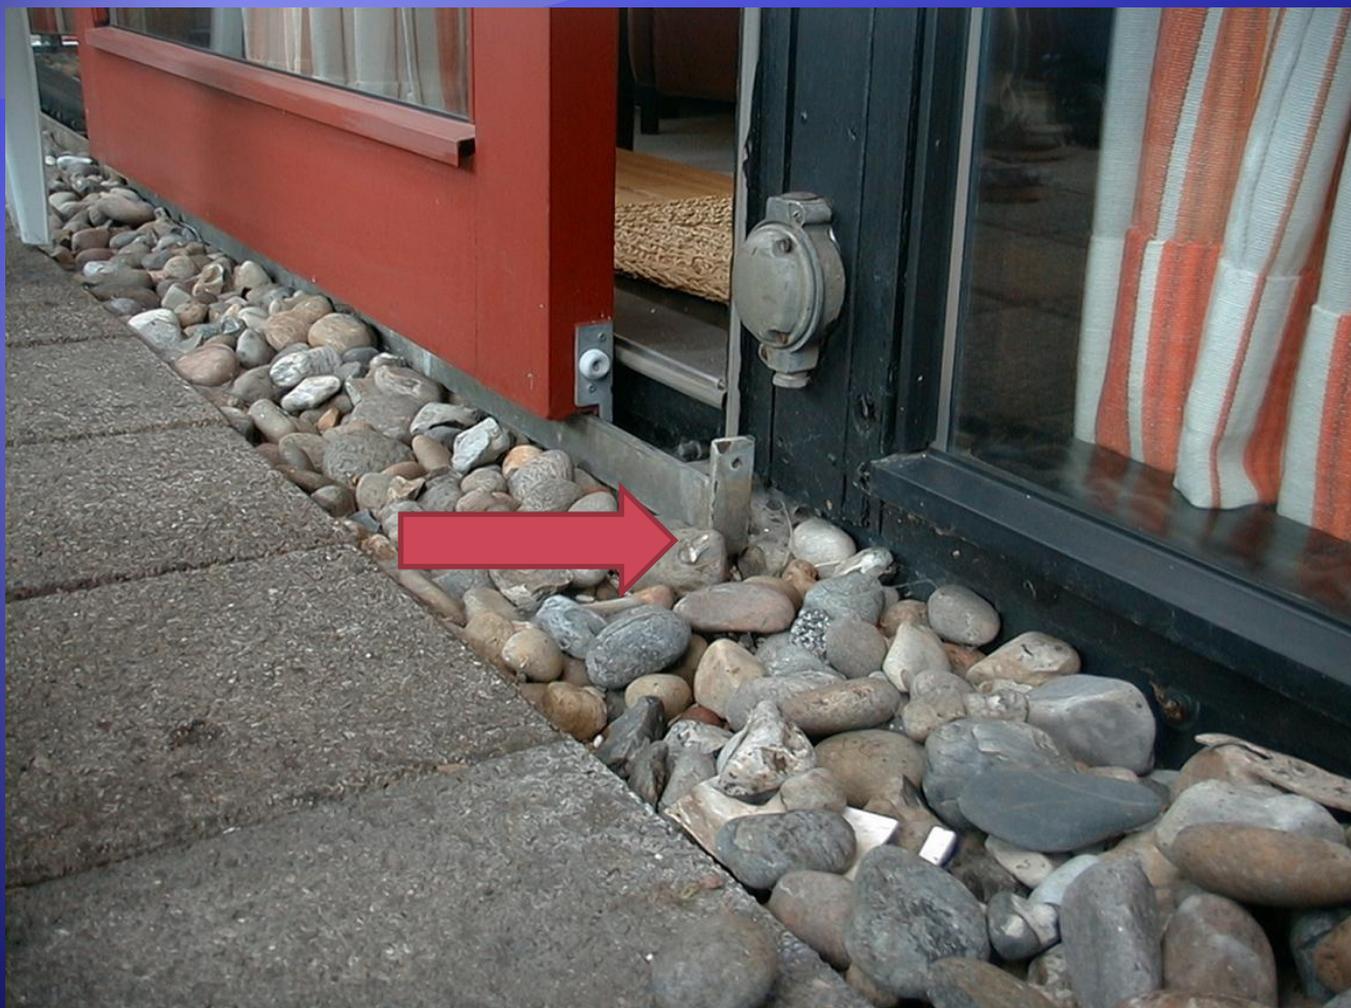
# LOW FLASHING HEIGHT

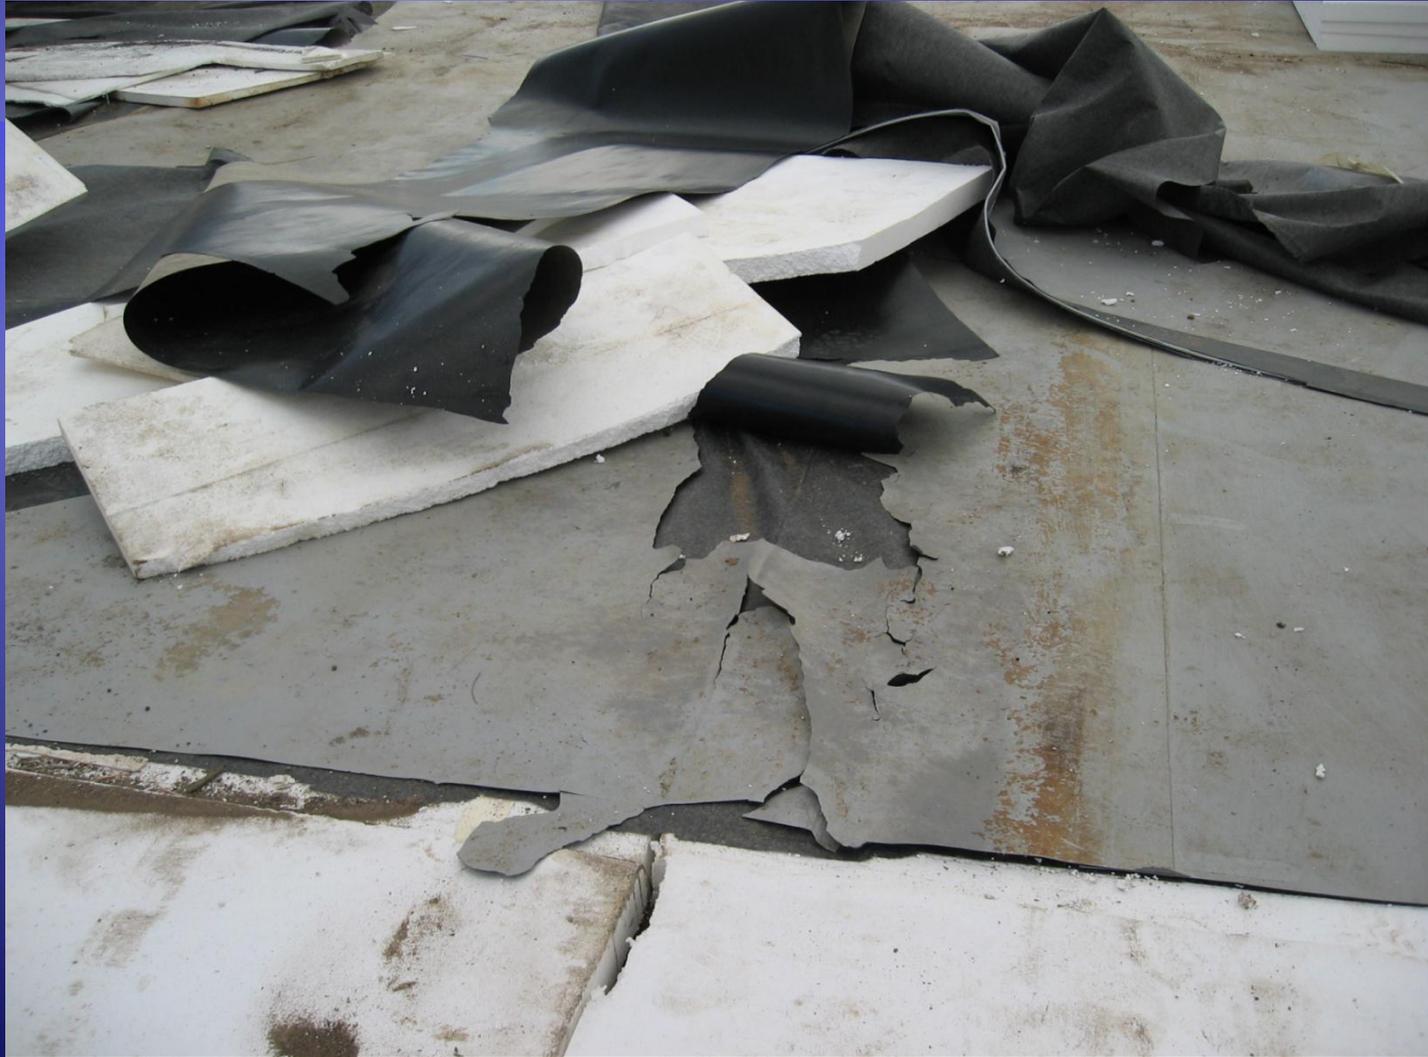
# Loss of plasticizer from 35 % to 5 %

- ◆ Bacteria and mould in soil and ballast
- ◆ Bad quality of plasticizers
- ◆ No significant loss to EPS insulation due to separation layer of glass fiber felt
- ◆ Membrane gets stiff and shrinks
- ◆ Extremely bad PVC quality

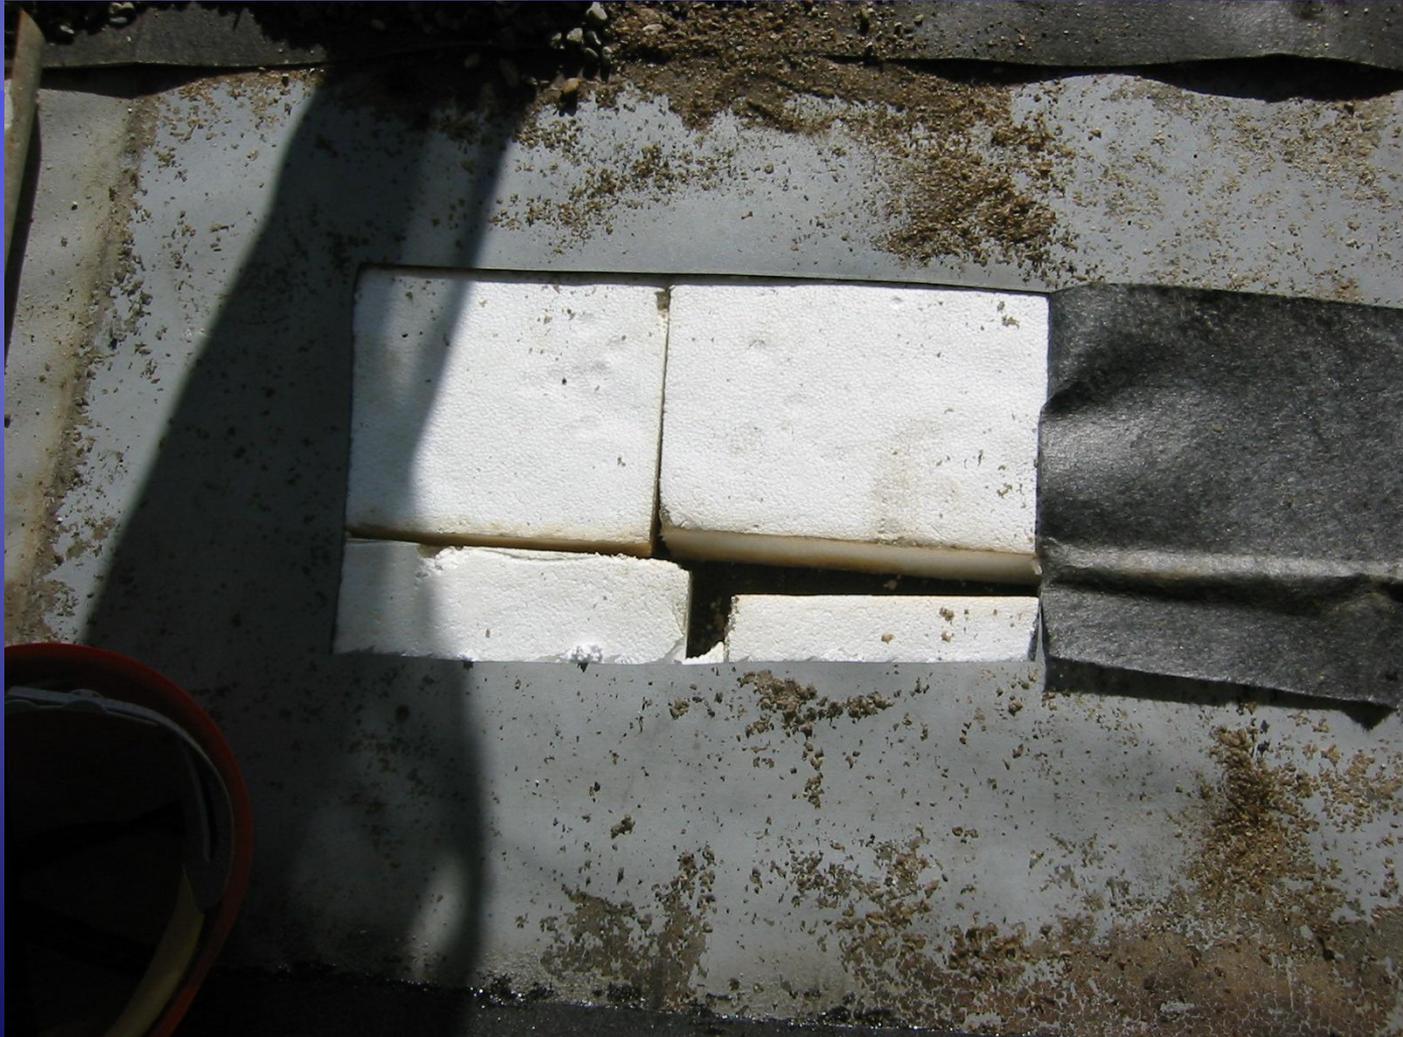
# Shrinkage of the EPS insulation up to 0.5 %

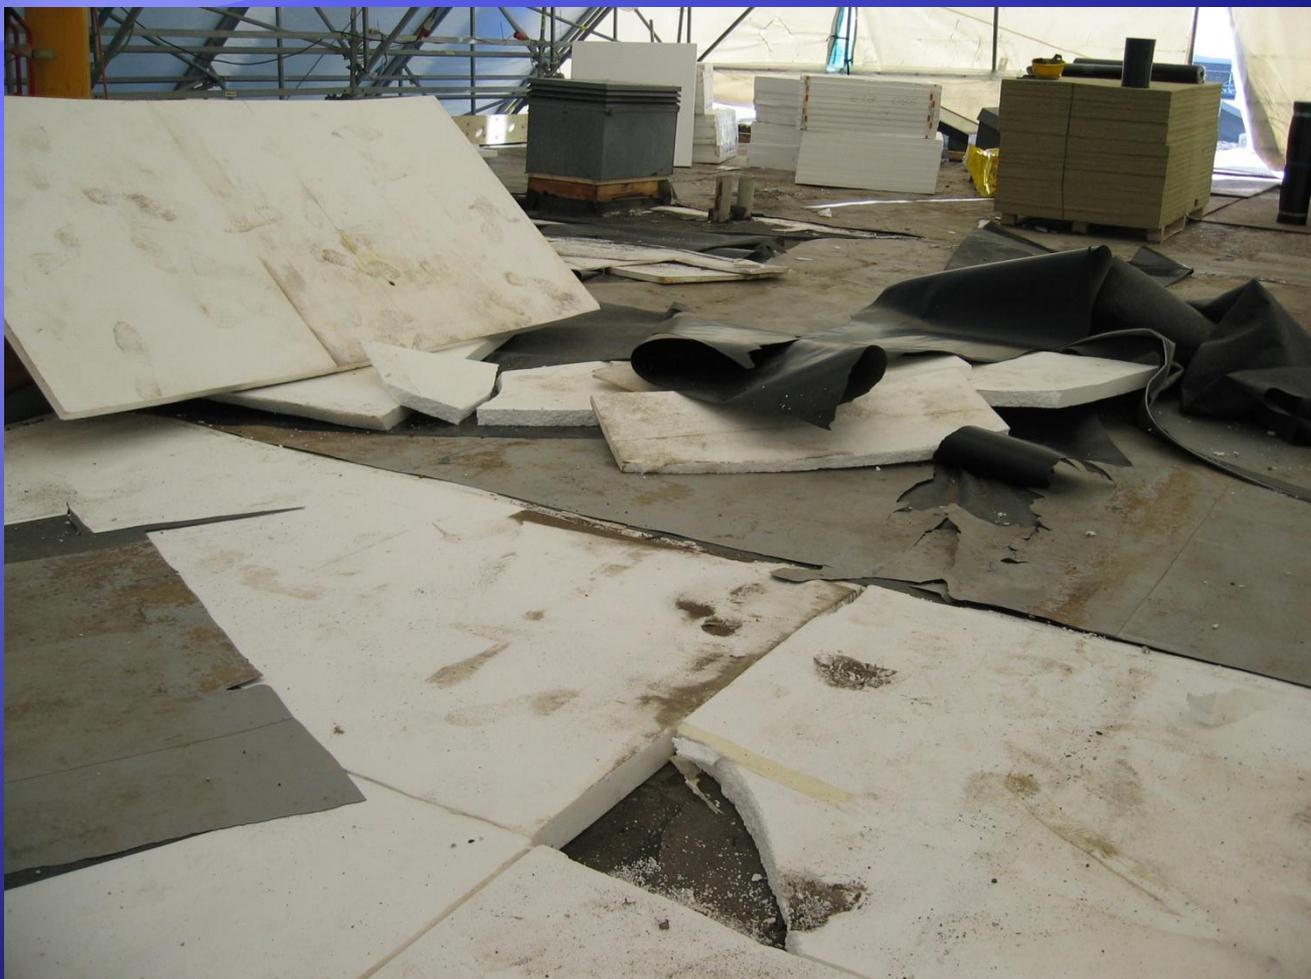
# Wet EPS insulation

- ◆ Criteria : max 1,0 kg/ m<sup>2</sup> of water
- ◆ Corresponding to 1 litre of water per square meter in a 100 mm thick insulation
- ◆ New criteria from 2010 is 0.5 vol. % due to thicker insulation
- ◆ EPS with a density of 20 kg/m<sup>3</sup> can contain up to 98 vol. % water
- ◆ Original insulation was dry on the roofs

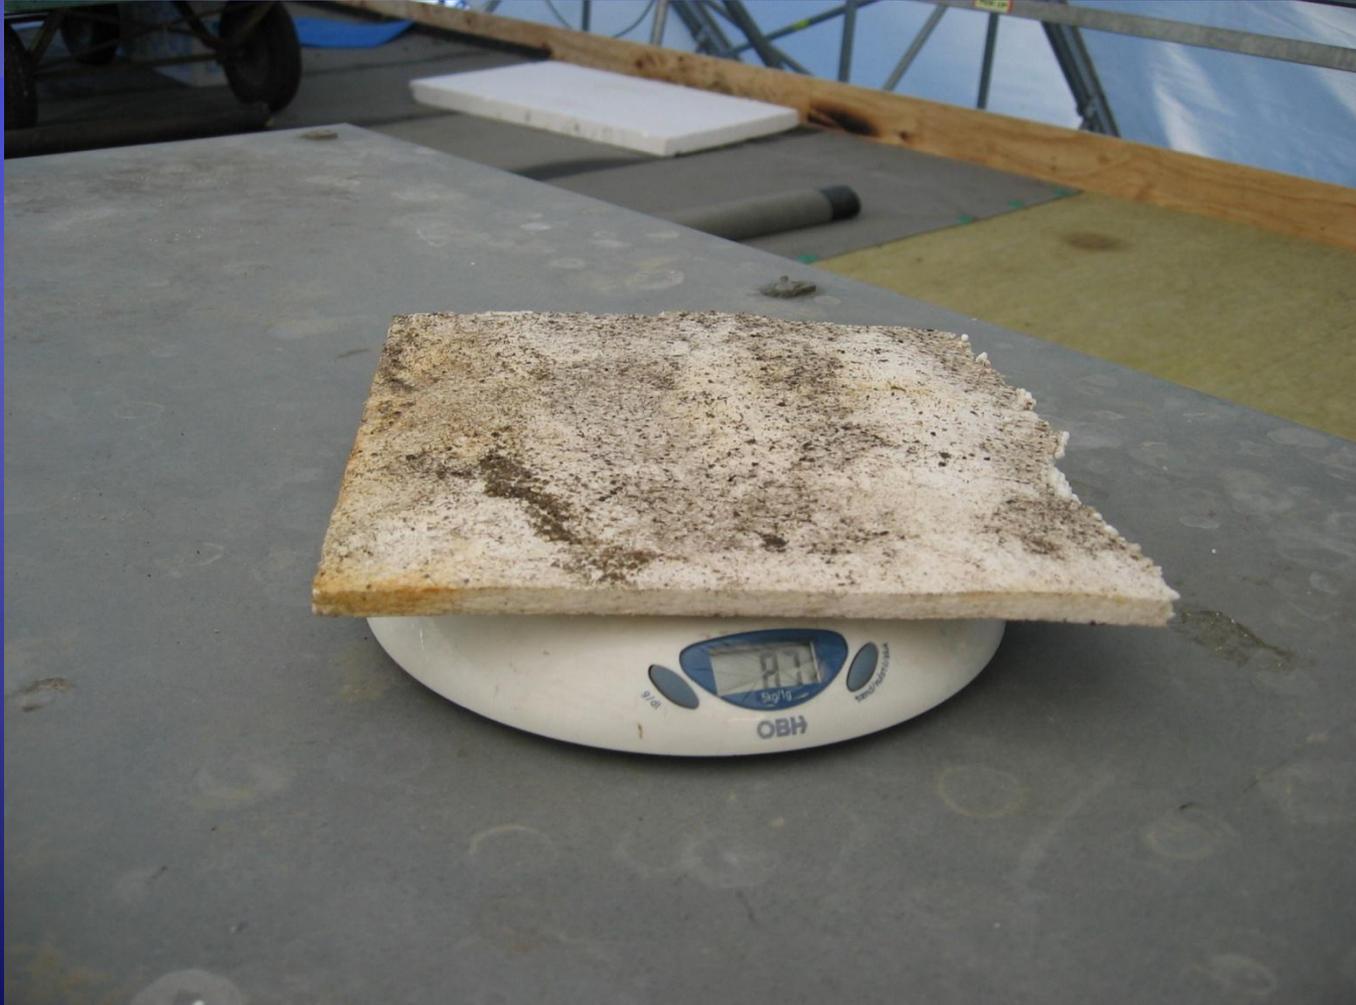
# Acceptance of 1 kg water/m<sup>2</sup>

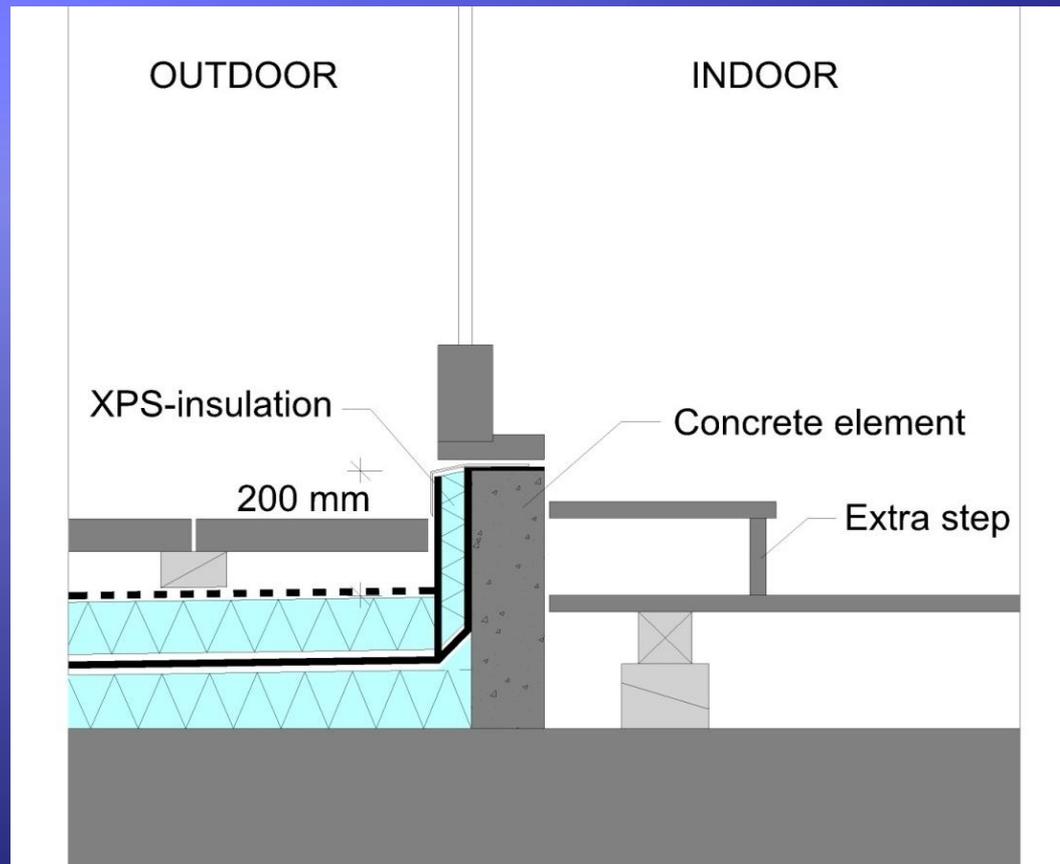
# Higher up stands by changing the façades to be 200 mm smaller

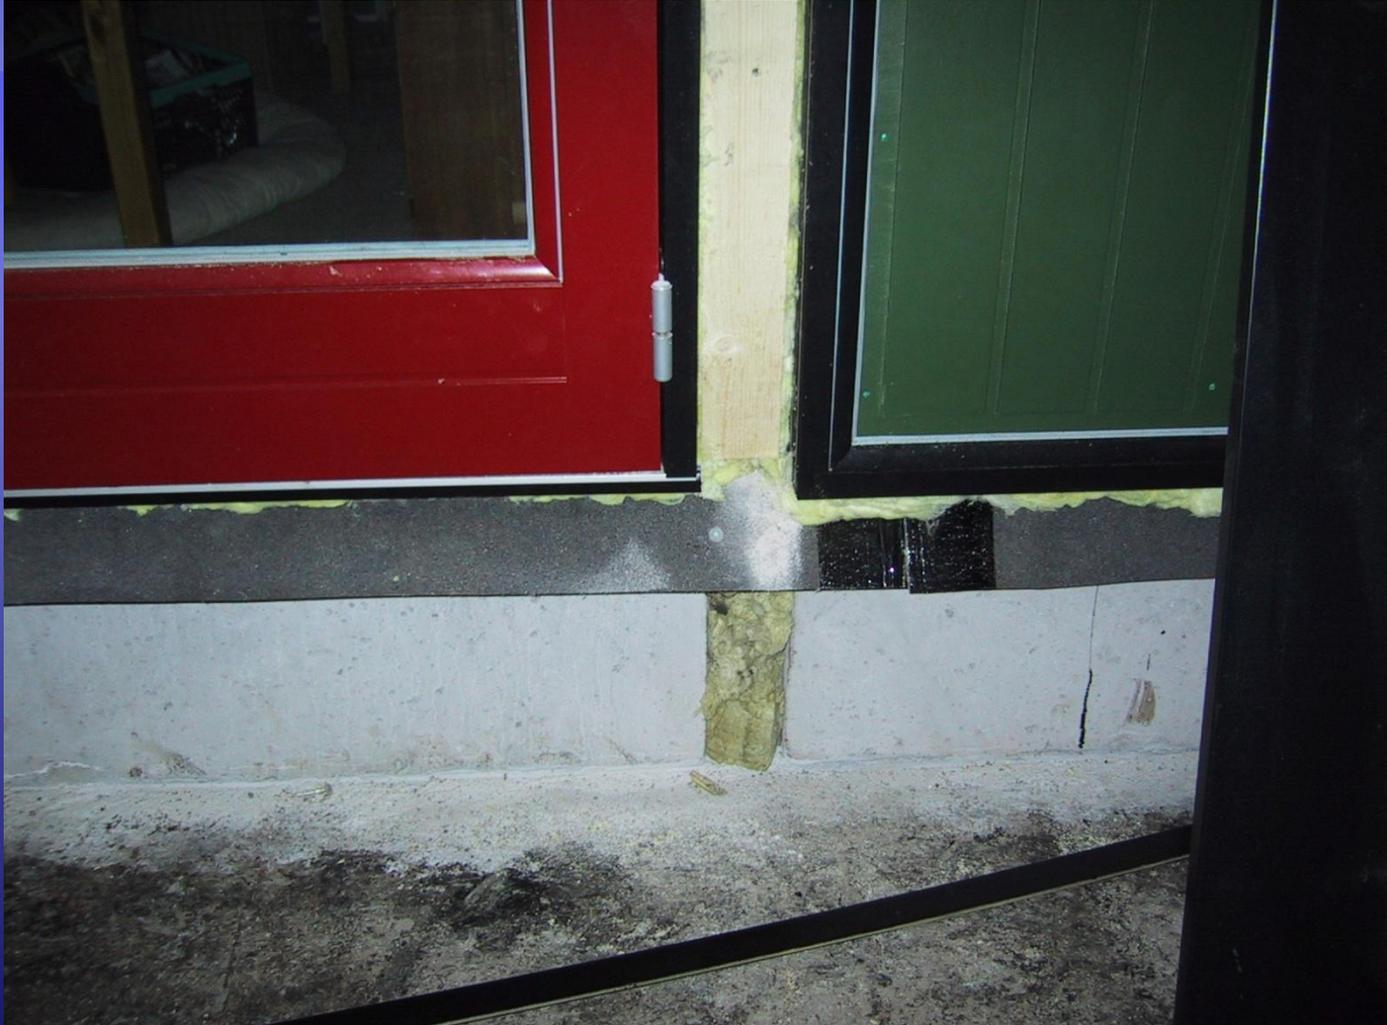
# New concrete up stands and new façades

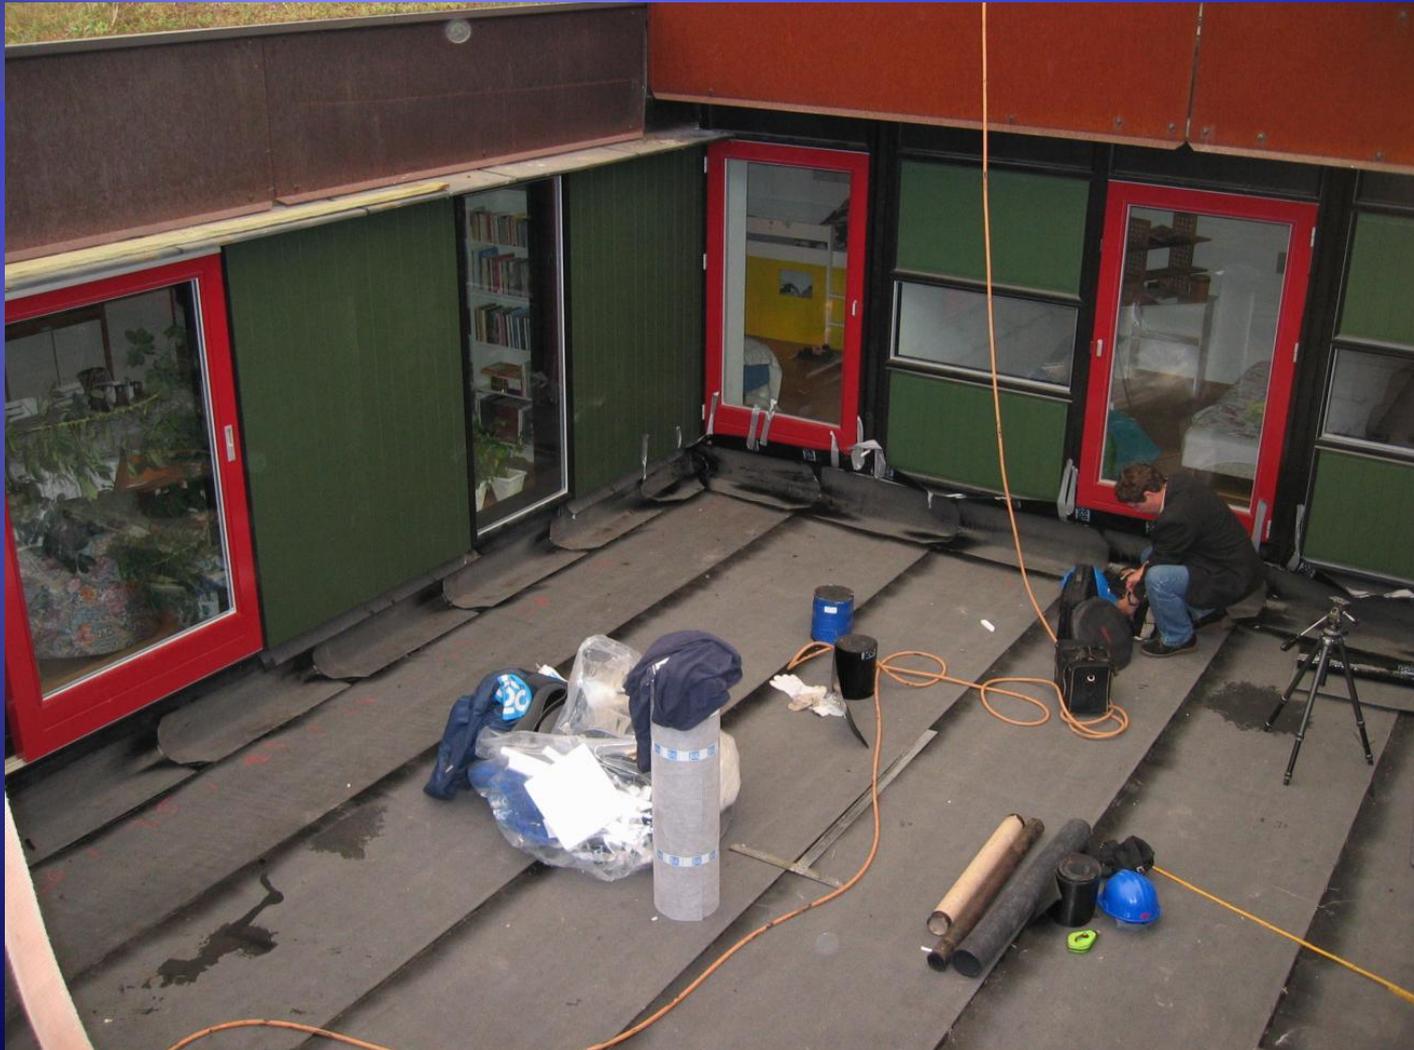
# 2 layer SBS polymer-modified bitumen membrane

- ◆ Two-layer SBS polymer-modified bitumen
- ◆ 4.2 mm polyester reinforced with 180 g/m<sup>2</sup> polyester carrier
- ◆ 1<sup>st</sup> layer loose laid with torched overlapping
- ◆ 2<sup>nd</sup> layer fully torched to 1th layer
- ◆ Insulation EPS ( 150 kN/m<sup>2</sup>)
- ◆ XPS for the insulation on top of membrane

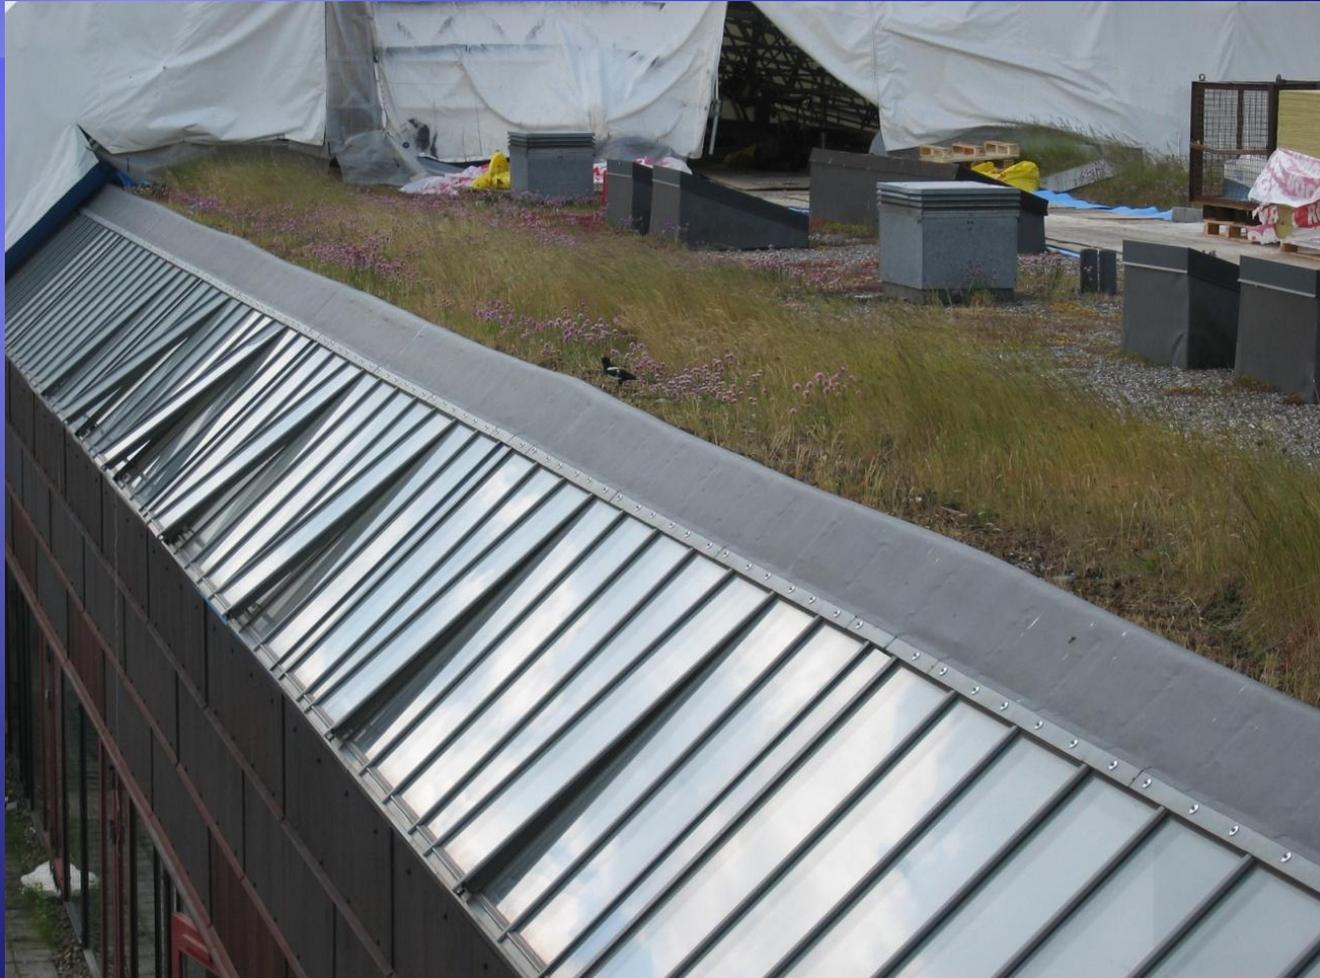
# Vegetation in the edge of the roof was removed

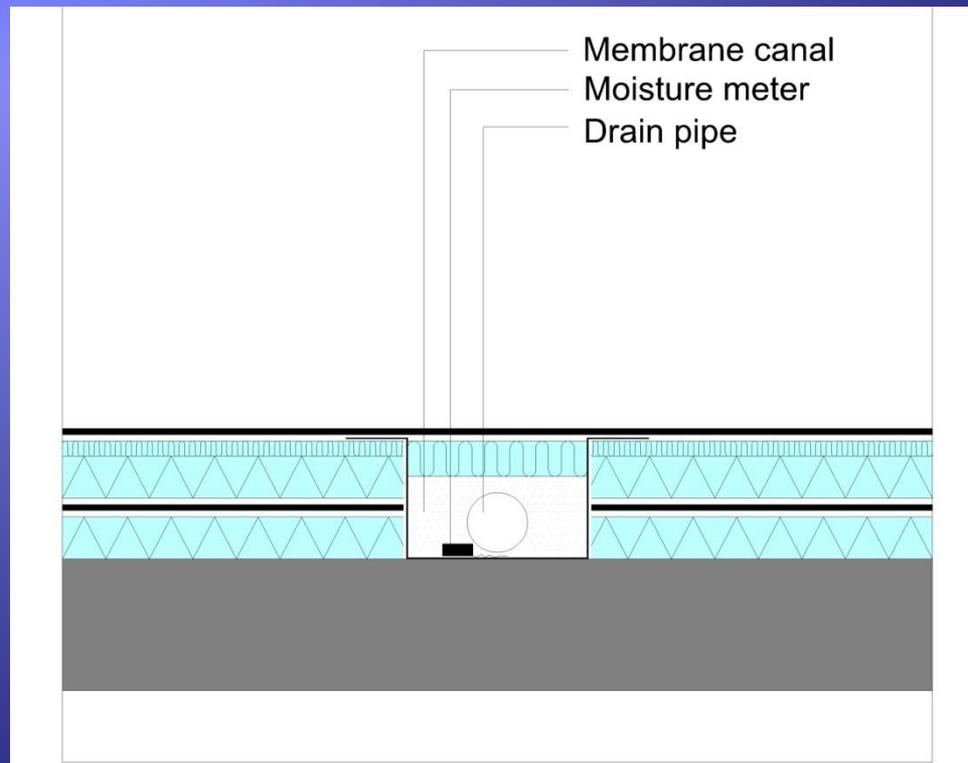
# Symphonic drain with pipes built into the insulation

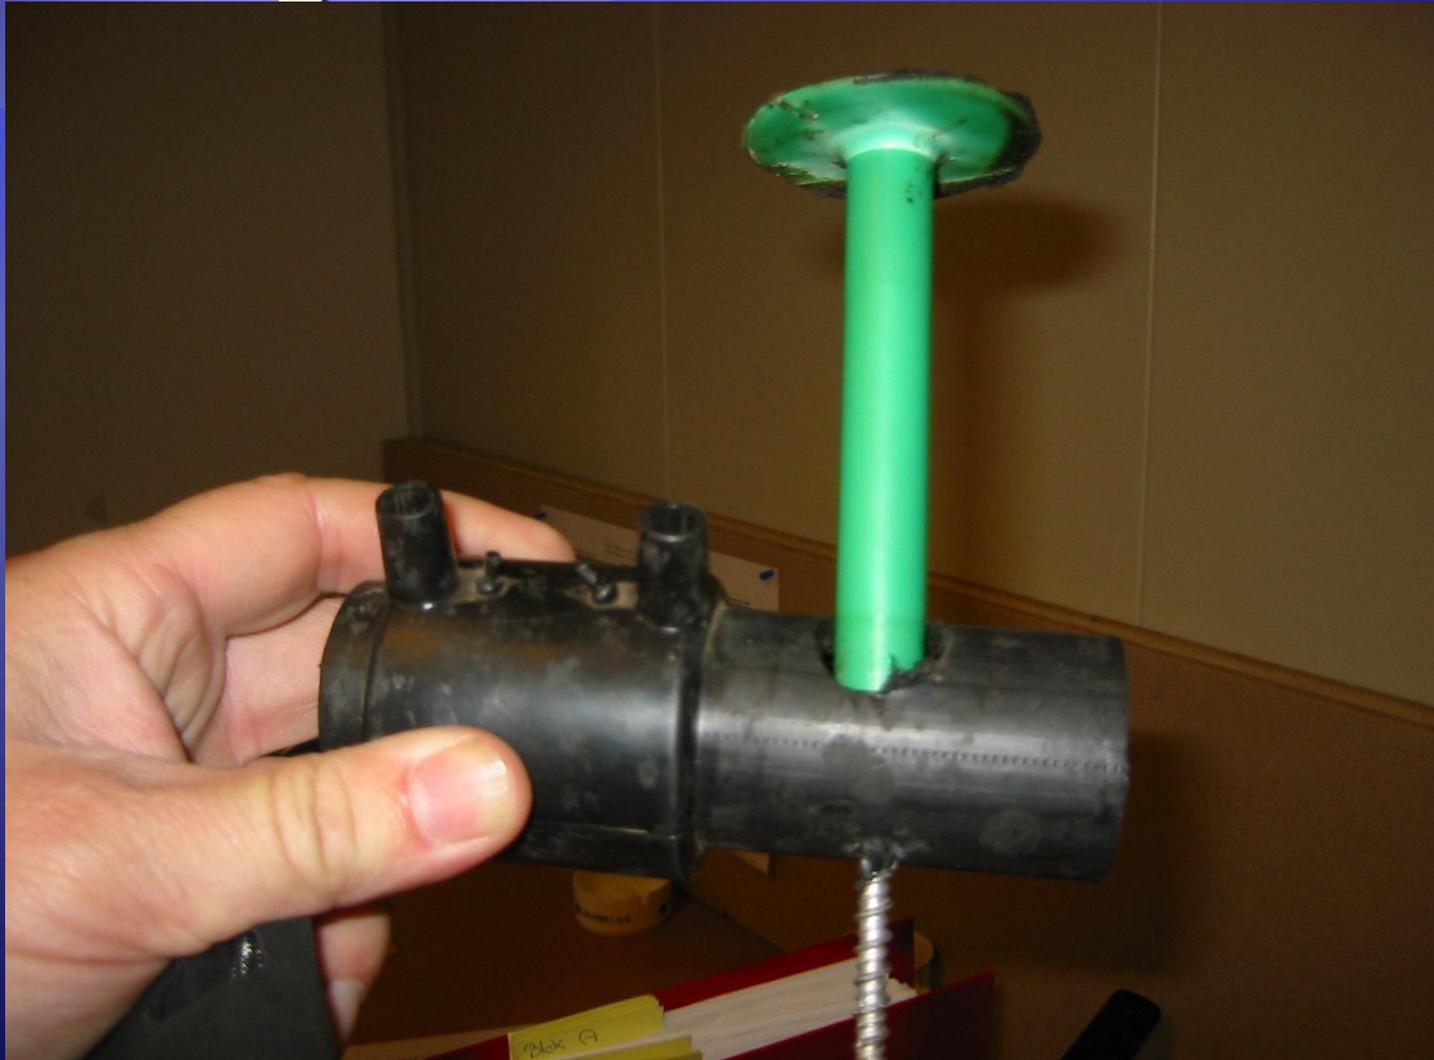
# Mechanical fixing and built in pipes is a dangerous combination

- ◆ Always look at the critical details first - in this case the up stands
- ◆ Choose the right material for the actual environment and get documentation
- ◆ Include an inspection plan in the contract
- ◆ No drainage built into the insulation
- ◆ Drainage system with redundancy - overflow possibility lower than the flashing height

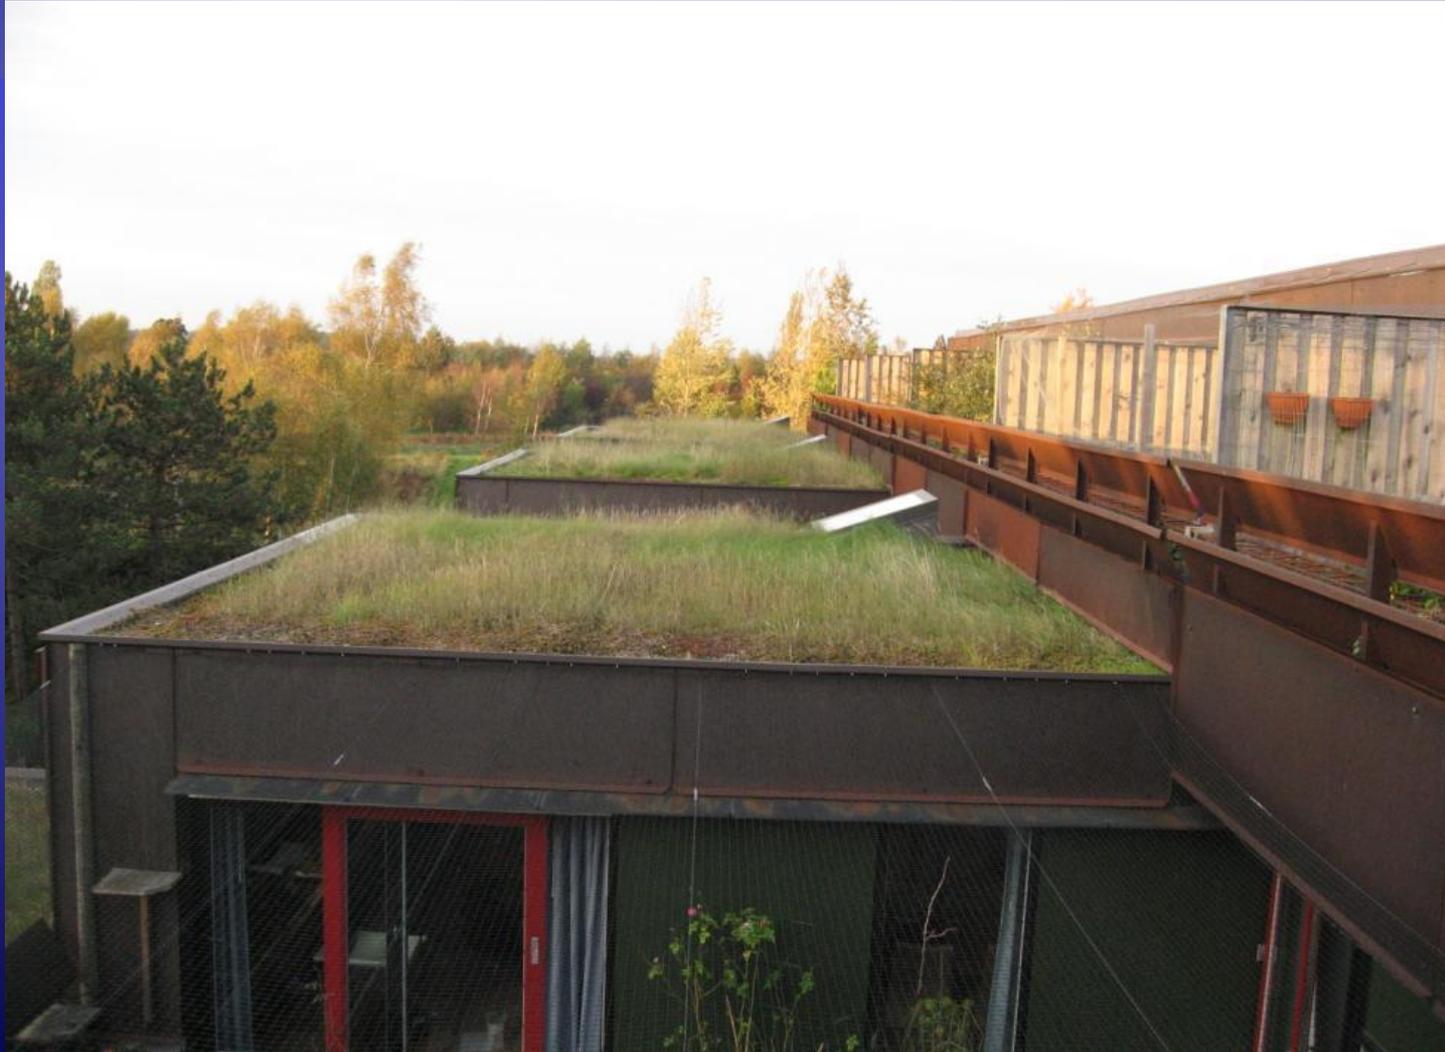
# The small green roofs were not renovated in 2nd renovation

- ◆ 1.2 mm PVC membrane
- ◆ 1.5 mm PVC membrane as sacrificial layer
- ◆ The loss of plasticizer occurred mainly in the sacrificial layer
- ◆ Service life was extended with 10 years
- ◆ Problems at flashing where there was no sacrificial layer
- ◆ The thickness of the vegetation has increased

- ◆ PVC membrane and insulation from first renovation is removed
- ◆ New tapered insulation of EPS
- ◆ 2 layer SBS polymer modified bitumen membrane
- ◆ Vegetation system

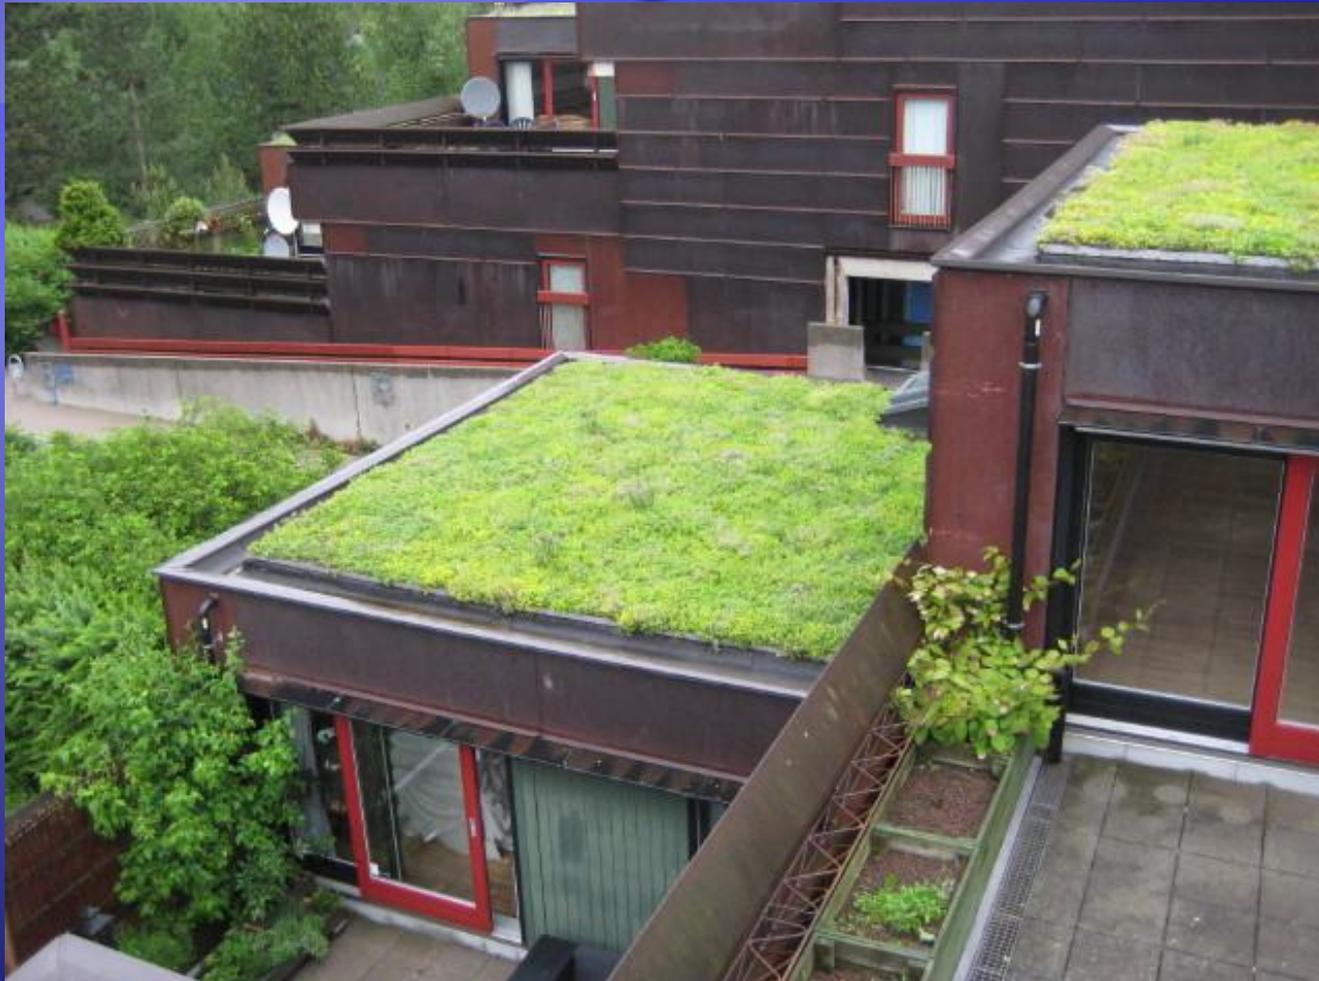
**It looks a bit rusty**  
**but it is water tight**
