Refurbishing Roof Systems and Roof Terraces on a Major Residential Building Complex

**Tommy Bunch-Nielsen, Danish Roofing Advisory Board
Erik Brandt, Danish Building Research Institute
Denmark**

Abstract

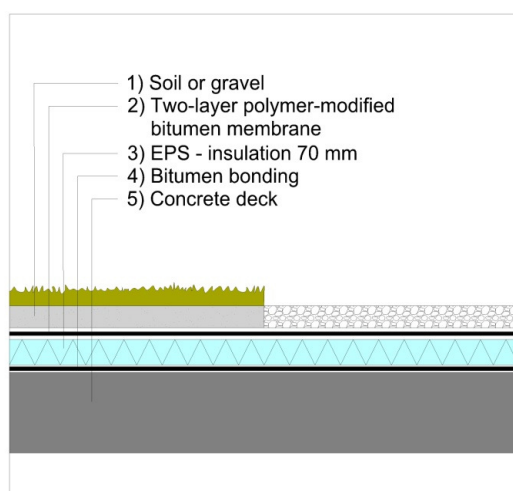
Figure 2: Original vegetative and ballasted roof systems

On the vegetative roof systems, the problem was roots penetrating the roofing materials because they were not root-resistant.

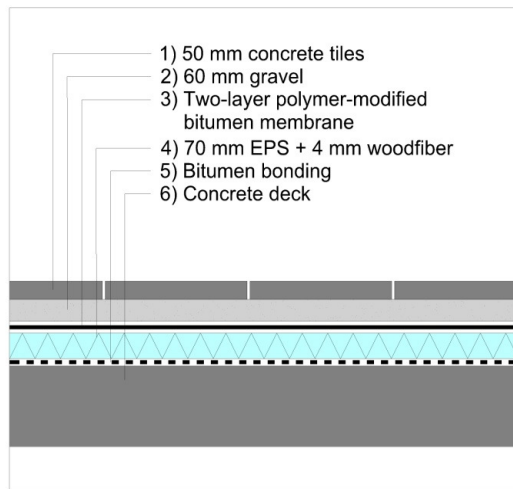
Figure 3: Original roof terraces

The slope of the roof systems and terraces was close to zero, and there was standing water on most roof systems and terraces, though it was hidden under concrete tiles, ballast and vegetation.

One of the surveys' conclusions was that the flashings' height was too low, so water could run over the flashings on the roof terraces.

The flashings themselves also were a problem as frost during the winter made the water in the built-up roof system turn into a solid ice cake that expanded and caused pressure on the roofing materials in the flashings, leading to severe cracks.

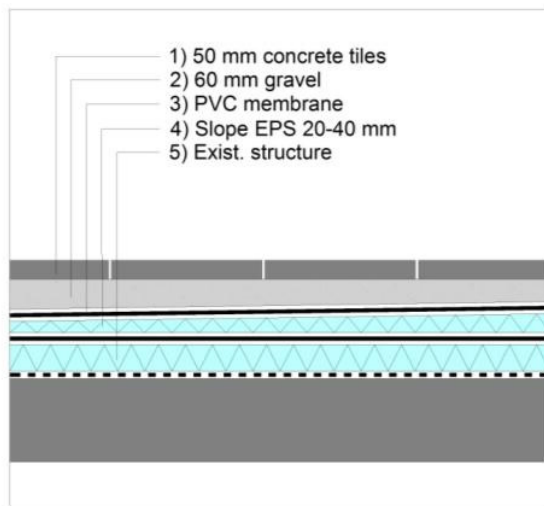
Figure 4: Roof terraces after the first renovation

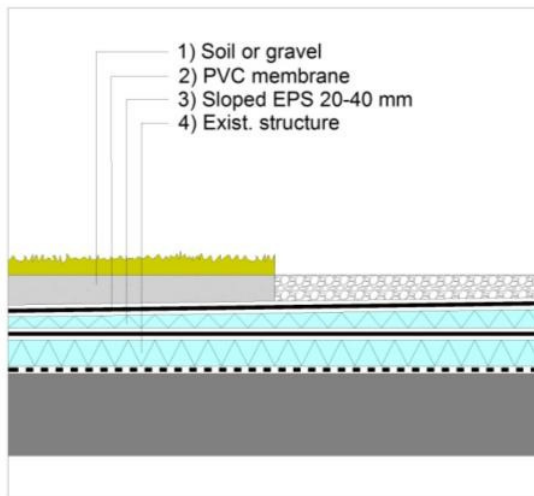
Figure 5: Green roofs after the first renovation

The vegetative roof systems were present in two forms. The top of the buildings had vegetative roof systems and ballasted roof systems with no critical flashings or up stands. For some reason, a normal 1.2-mm PVC roof system with polyester reinforcement was chosen and there was no special treatment to ensure resistance to the environment under soil and gravel.

This proved to be a bad decision because a significant part of the PVC membrane's plasticizers seemed to disappear after a few years.

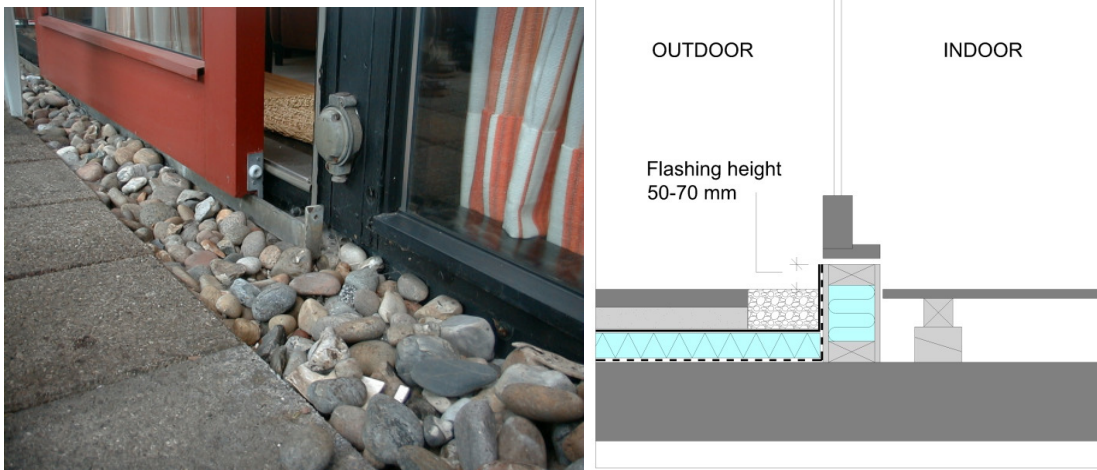
No changes were made to the flashings' height because it would involve changing the windows, doors and wooden facades between the apartments and terraces. Each terrace has two 6 m long façades facing the terrace, and the costs were considered to be too high, even taking into account that it was possible to obtain a 15-year warranty.

Figure 6: Example of flashings between terrace and apartment

The most difficult part was increasing the height of the up stands. After much consideration, it was decided all light facades would be replaced with new facades, new doors and new windows that were 200 mm shorter, making it possible to create new 200-mm higher up stands.

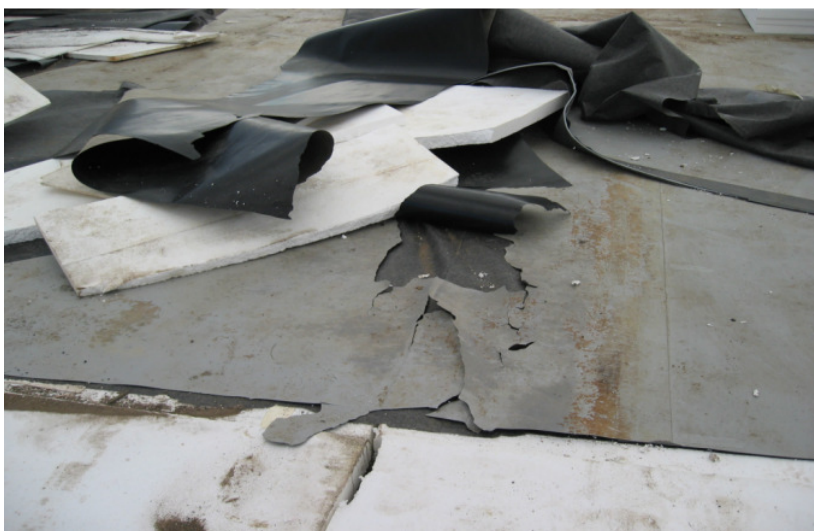
Figure 7: The loss of plasticizers was critical because it caused the membrane to shrink and become brittle.

The biological environment in the soil (bacteria and mold) on top of the membrane probably was the reason for the loss of plasticizers; the plasticizer content fell from 35 percent to 5 percent in 10-12 years. The loss of plasticizer to the EPS insulation was avoided by a separation layer of glass felt.

When the plasticizer content is below 20 percent, the product becomes brittle and cracks readily will occur if people walk on the roofs. The loss of plasticizers also causes the membrane to shrink, which leads to tension in the membrane and creates problems with the flashings, which are pulled off the underlayment.

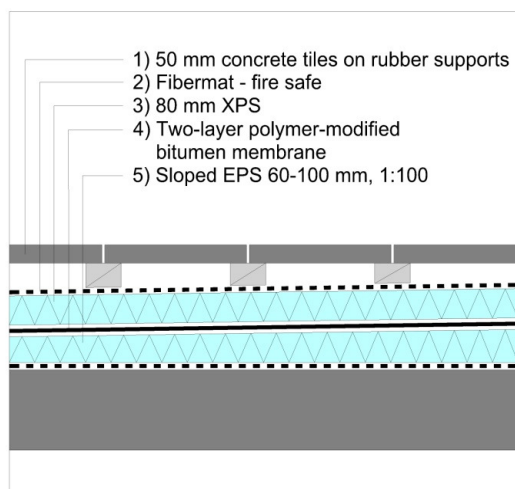
Figure 8: New roof construction of terraces after the second renovation. The roof membrane is protected between two layers of insulation, and water drainage is facilitated by using rubber supports for concrete pavers instead of gravel.

Furthermore, it was deemed important to ensure water readily could get away from the up stands and, therefore, the concrete pavers were placed on footings instead of in gravel as before. The roof's slope also was improved, and the design was changed to a duo roof system (partly inverted roof system) to keep the membrane frost-free during the winter. When using a partly inverted roof system design, the slope can be reduced to 1:100 instead of the normal (in Denmark) 1:40.

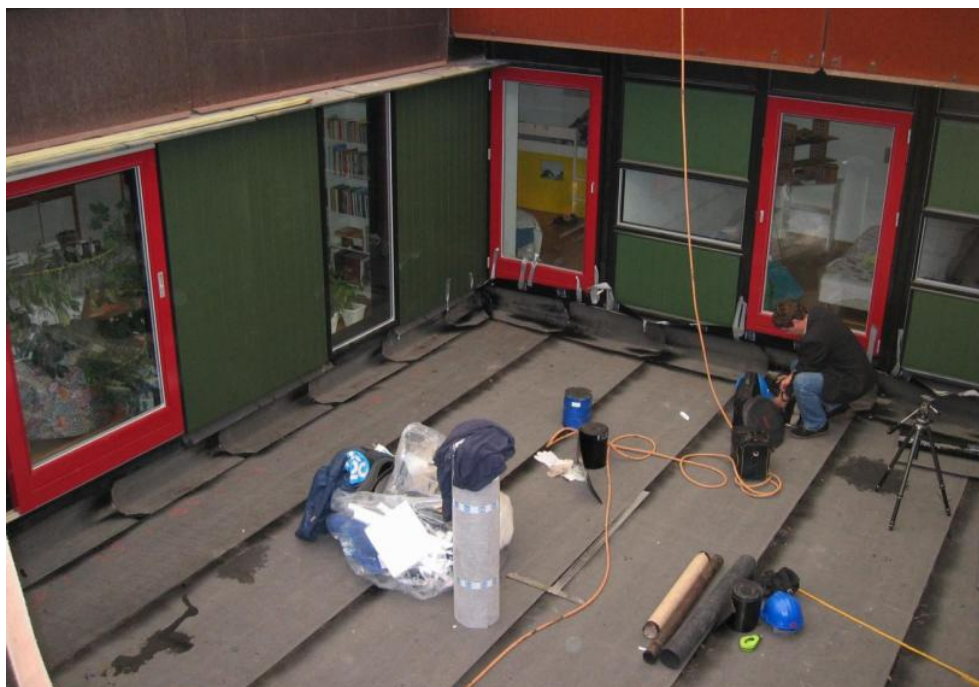
Figure 9: The membrane is installed in a roof terrace after replacing the two facades to create higher up stands.

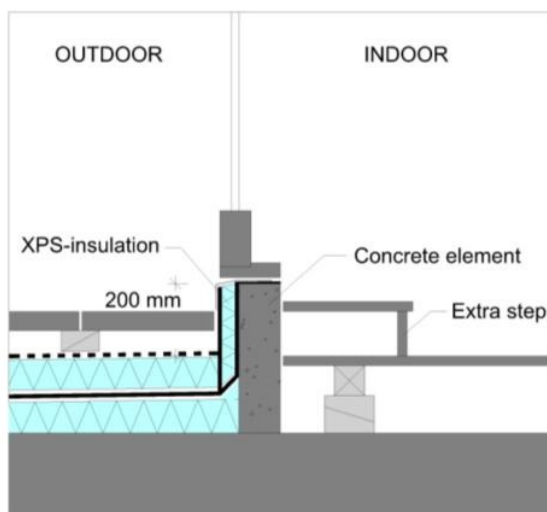
Figure 10: The new 200-mm higher up stands. The up stands are protected from mechanical damage by an external XPS insulation with a render facing.

The up stand design was improved by using concrete elements with external insulation instead of wood parts. The flashings thereby were protected from mechanical damage by extruded polystyrene (XPS) insulation with a mortar surface. As an extra safety precaution, gutters were cut in the front of the terrace so water could run out if the drainage system failed.

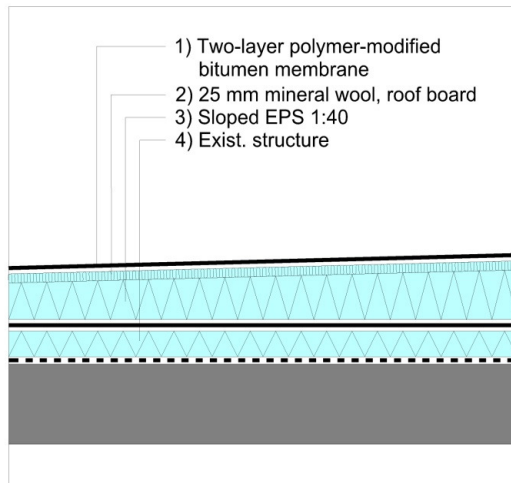
Figure 11: Warm roof system instead of vegetative or ballasted roof systems. The original roof membrane is maintained, the insulation and slope are improved, and the new roof membrane is fully visible.

The building owner wanted a 30-year warranty against leaks, and no contractor in Denmark in 2001 was able to offer that for a vegetative roof system or ballasted roof system. Consequently, it was decided to design and install the roof systems as normal warm (compact) roof systems with visible roofing materials that included two layers of SBS-polymer-modified bitumen mechanically fastened to the concrete substrate. The first renovation with EPS and PVC roof systems was removed, but the original roof covering underneath was kept in place. When the EPS was removed, it was extremely wet and contained up to 5 kilograms of water per square meter, which is more than the limit of 1 kilogram of water per square meter set by the Danish Roofing Advisory Board.

The slope was increased to 1:40 (25 mm/1 meter) using a tapered insulation corresponding to the standard for warm roof systems.

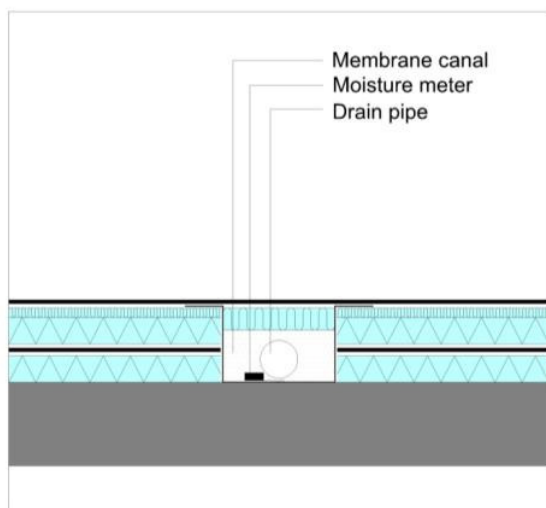
Figure 12: Drainage pipe built into the insulation in a special canal made from the roof membrane

The distance between the outlets of the original roof systems were up to 20 meters apart, and new outlets had to be installed to avoid insulation that was too thick. It was not possible to install a new drainage system in the building, so drainage pipes were installed in the insulation to connect the new outlets to the old drainage system. A siphon system was used to make horizontal pipes possible.

This system often is used but is not considered to have the same safety as normal systems with visible pipes. Therefore, the pipes were installed in a special canal of polymer-modified bitumen roofing materials. The canal is equipped with moisture sensors, allowing it to be checked for water from leaks in the pipes. There are more than 350 moisture sensors installed, and each of them is checked once per year. After the first seven years, it has proved to be working because only five small leaks have been discovered.
