Sustainability is Nothing New

Reroofing Few Hall At Duke University

Larry Meyers Sr.
Carole Ceja

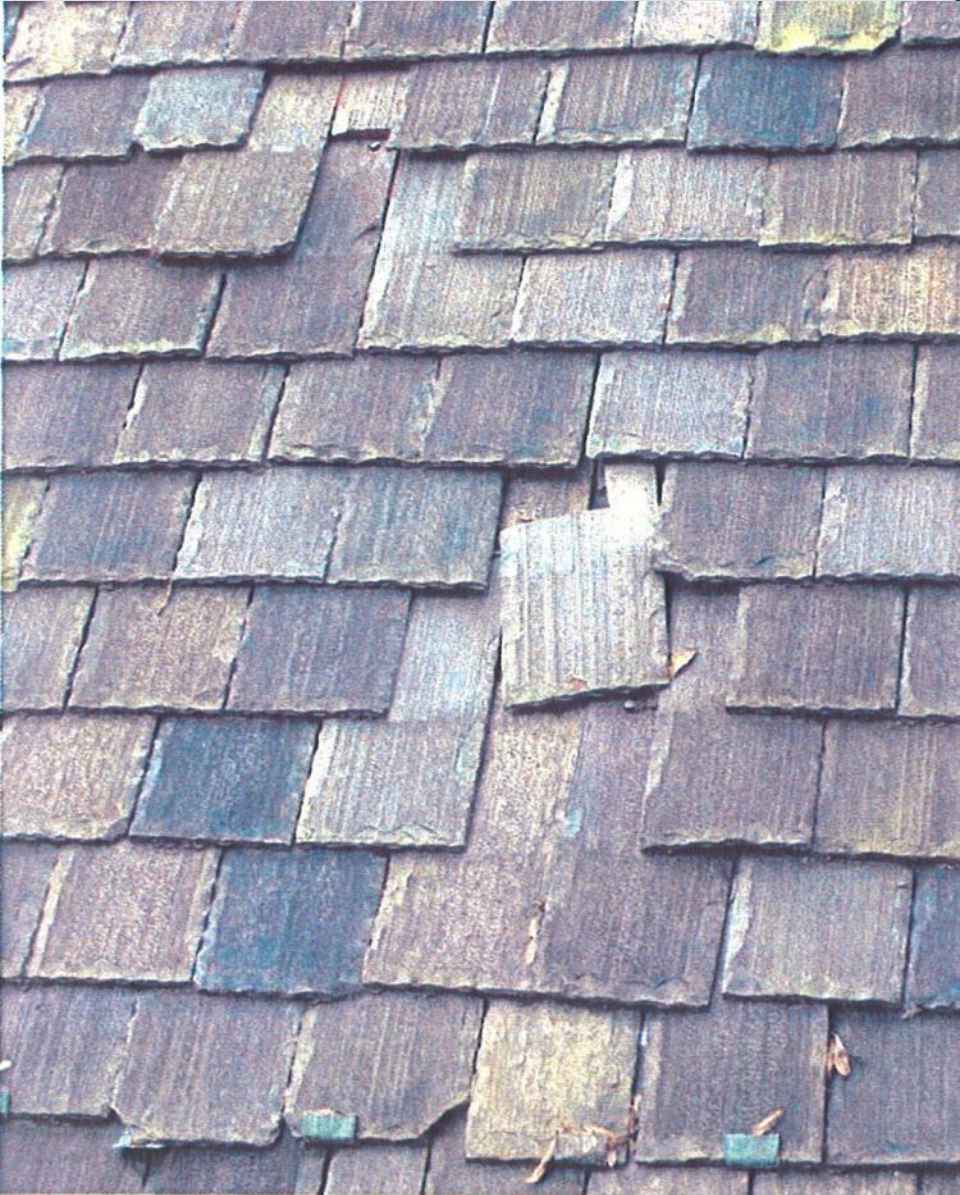
Tile

Broken

Chipped

Loose

Missing tiles

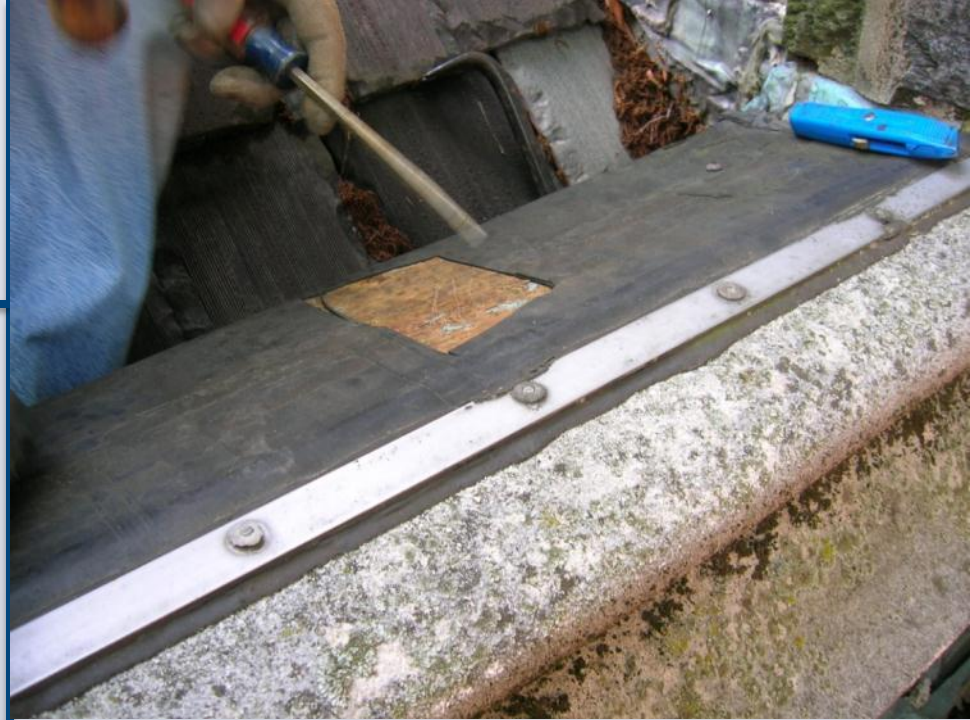
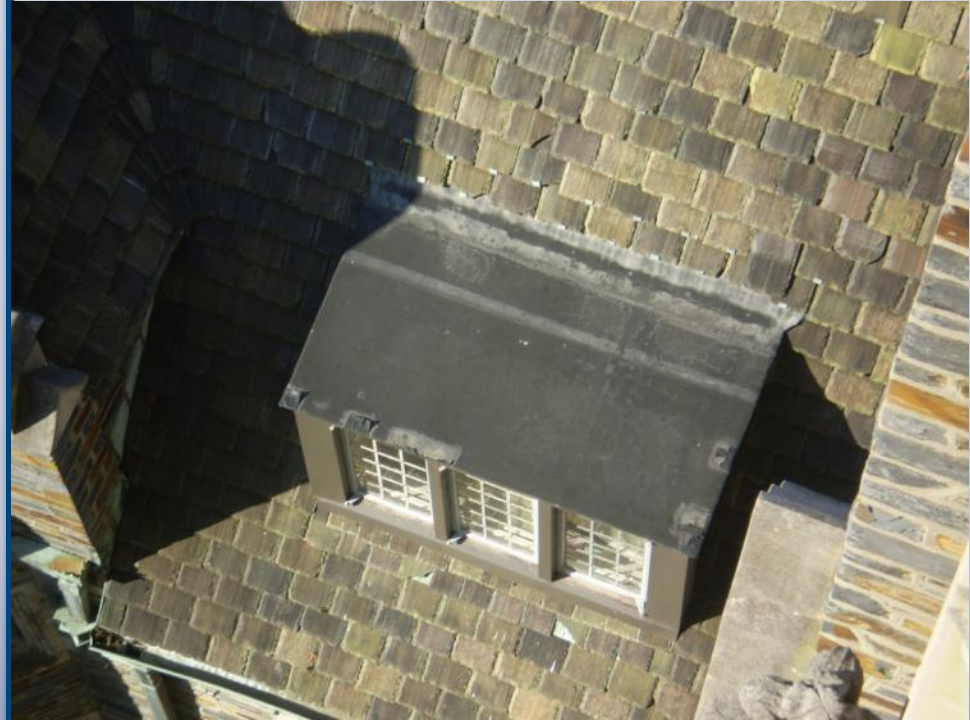
Copper Work

Built-in gutters
Flat dormers
Tower roofs
previously
covered in EPDM

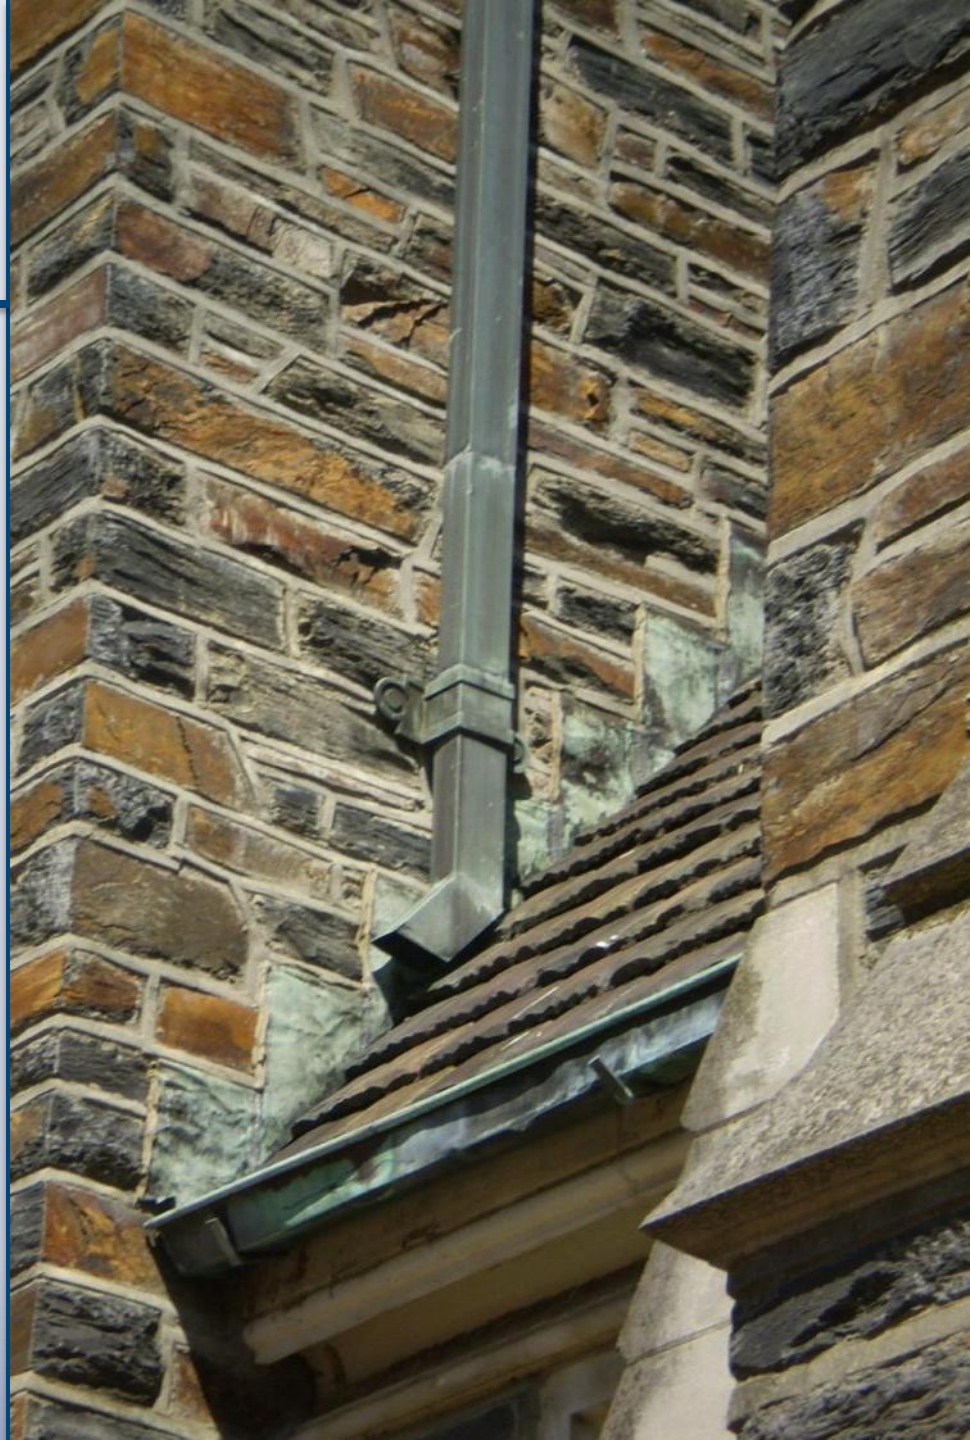
Aged Accessories

Old copper
flashings

Missing ridges

Crushed hanging
gutters

Balconies
