DIMENSIONAL STABILITY AND REFLECTIVITY OF FIELD EXPOSED THERMOPLASTIC POLYOLEFIN (TPO) ROOF MEMBRANES

**Ana H. Delgado¹, Chuck Chapman², KC Barnhardt³, Jim Carlson⁴,
Randy Ober⁵, Dwayne Wacenske⁶, Steve Moskowitz⁷, Michael Ludwig⁴,
Stephen Elliott⁴, Ralph M. Paroli¹**

WSRCA's TPO Task Group

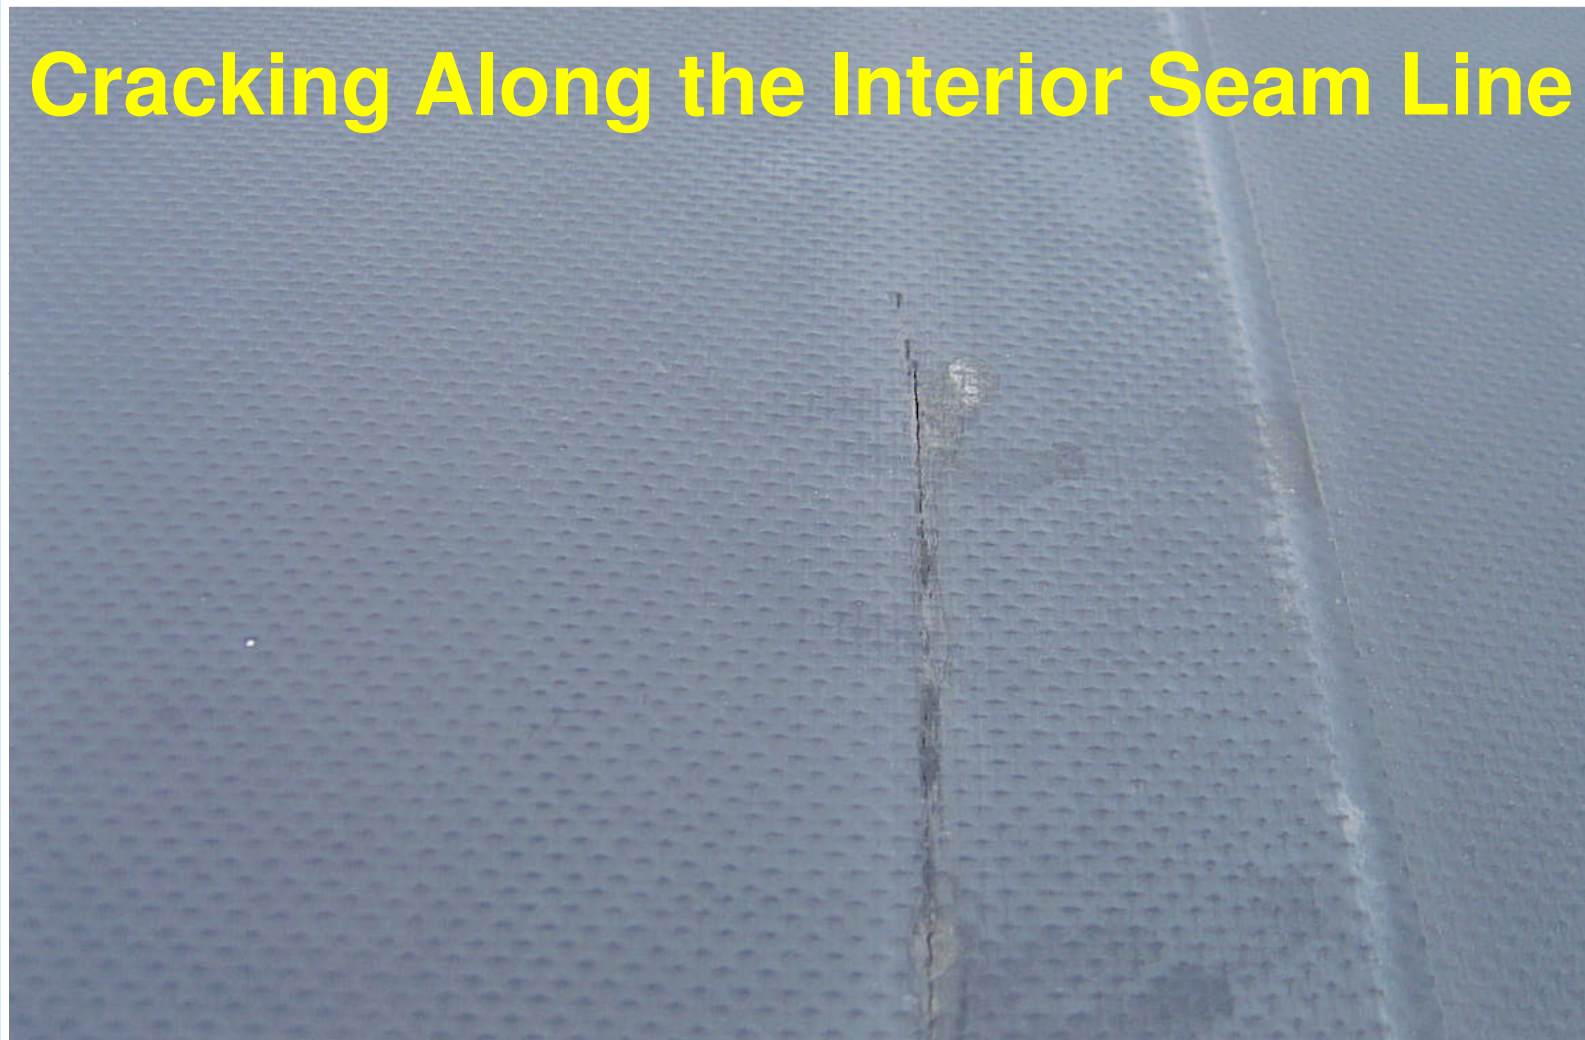
Montana TPO Roof

Cracking Along the Interior Seam Line

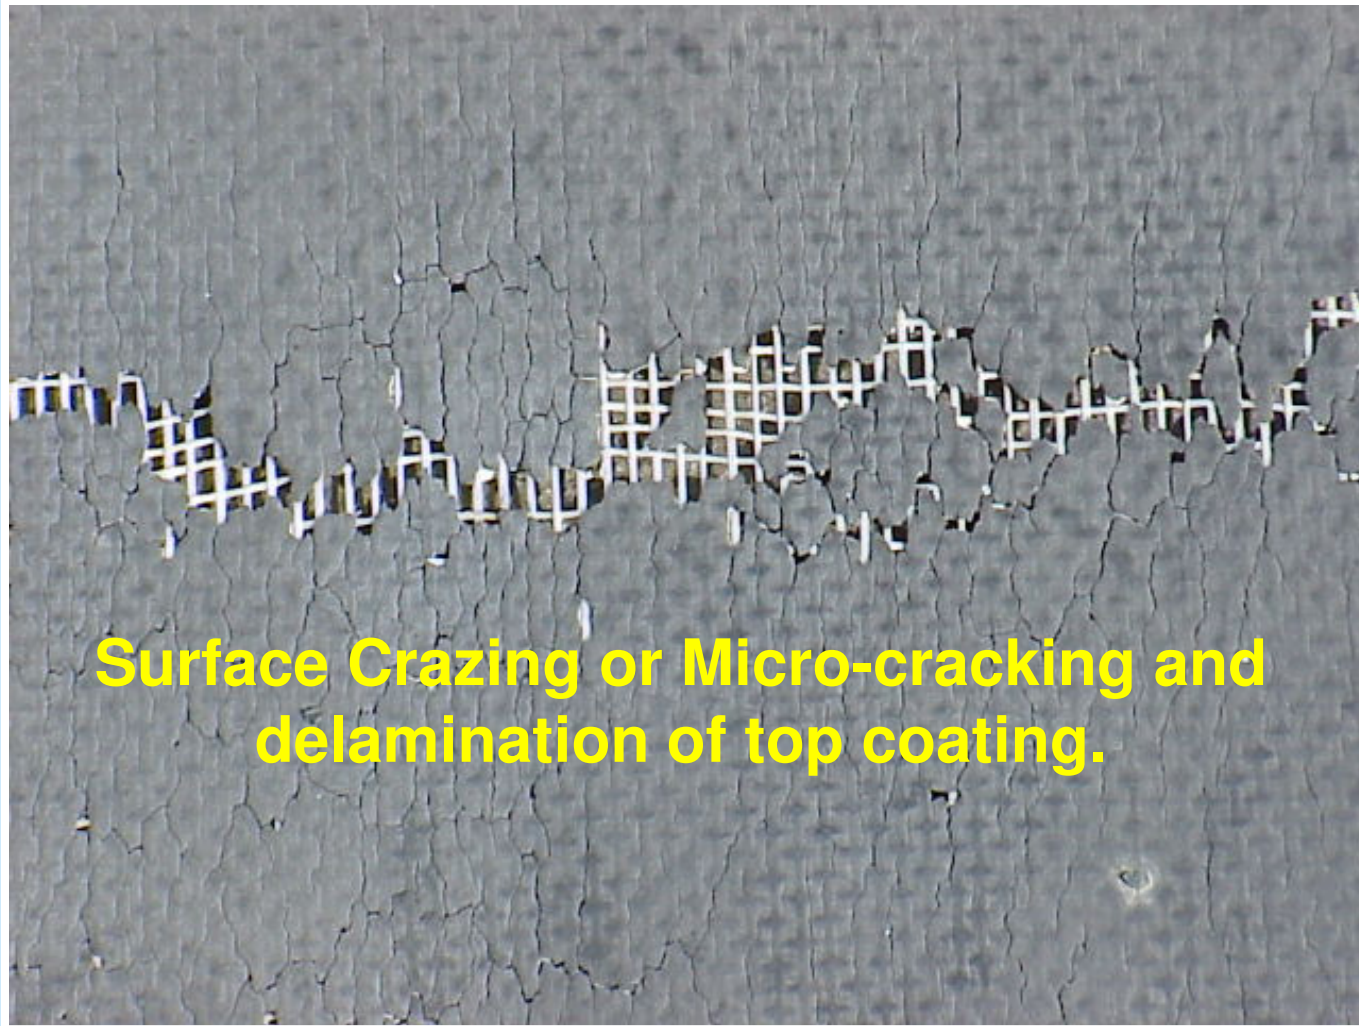
Montana TPO Roof

Surface Crazing or Micro-cracking and delamination of top coating.

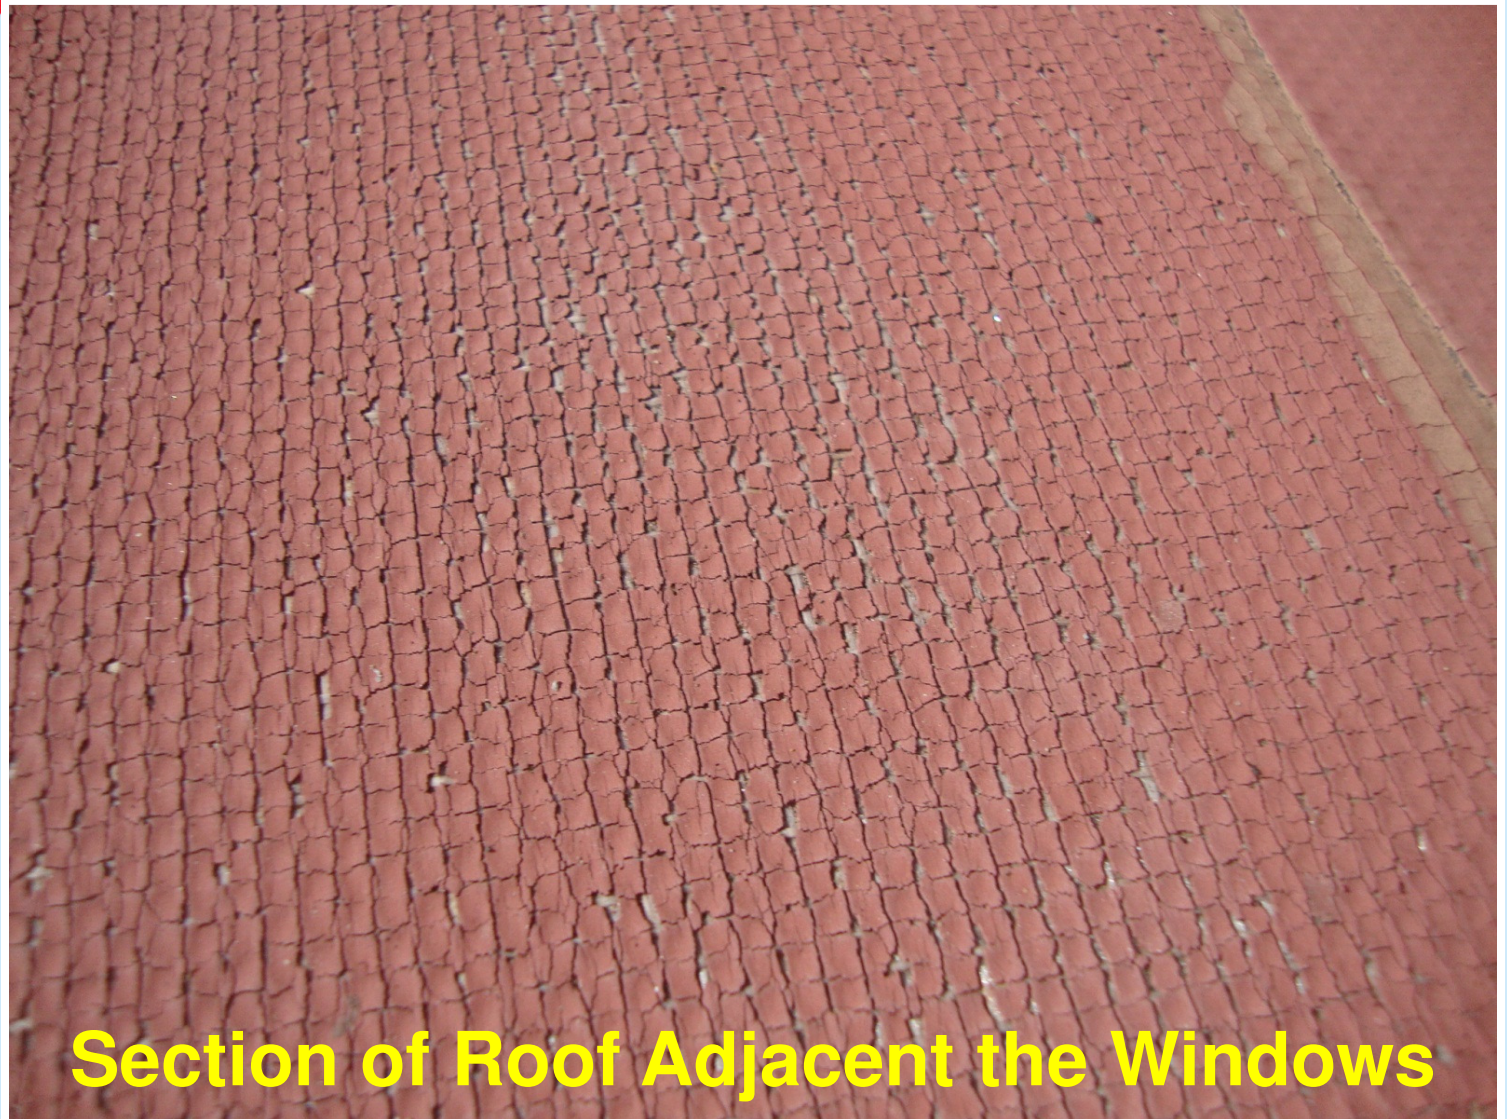
Same Early Generation TPO Roof in Oregon

Section of Roof Adjacent the Windows

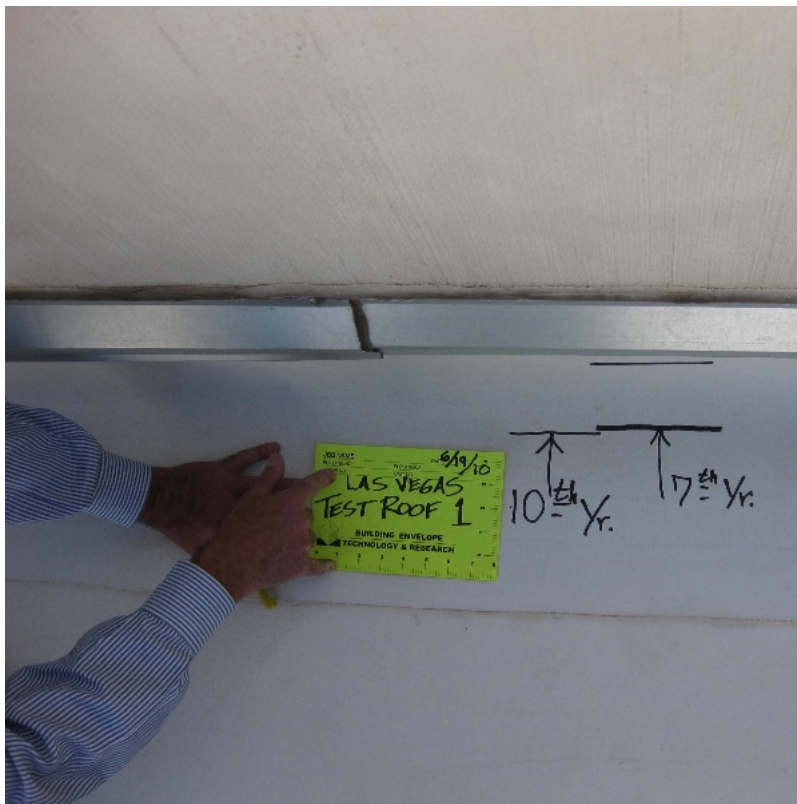
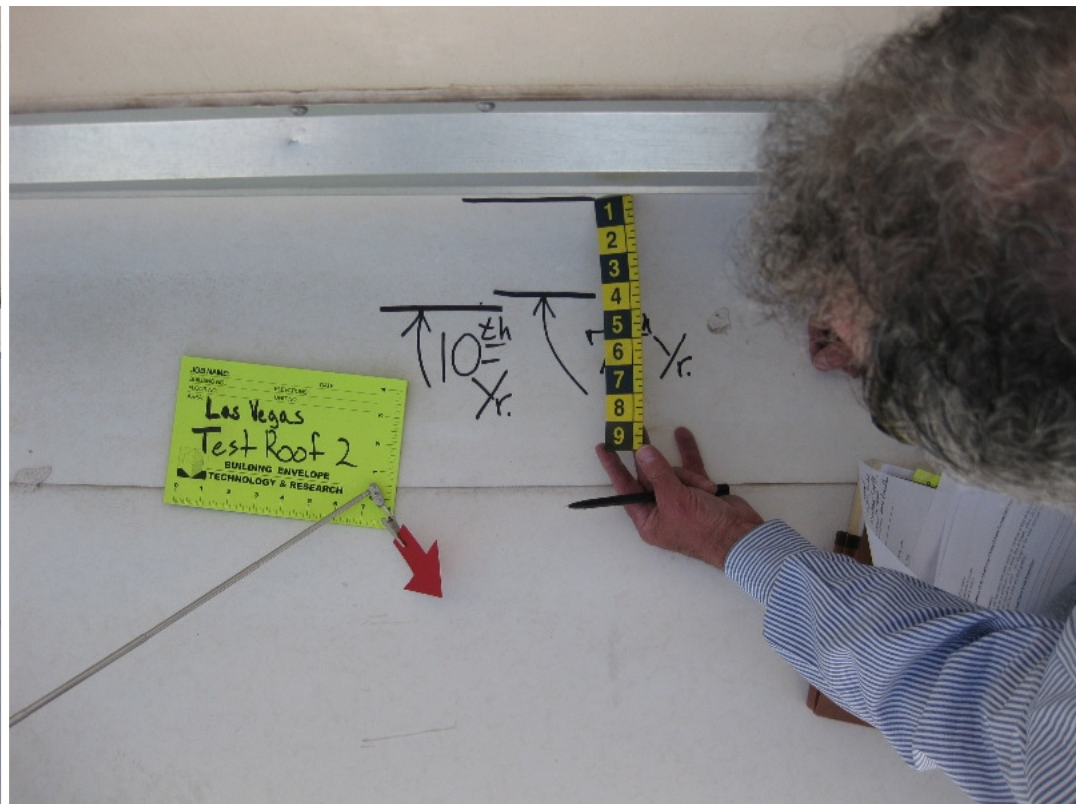
Las Vegas– Roof Area 2

A slight increase in tightening was observed at year ten in multiple locations.

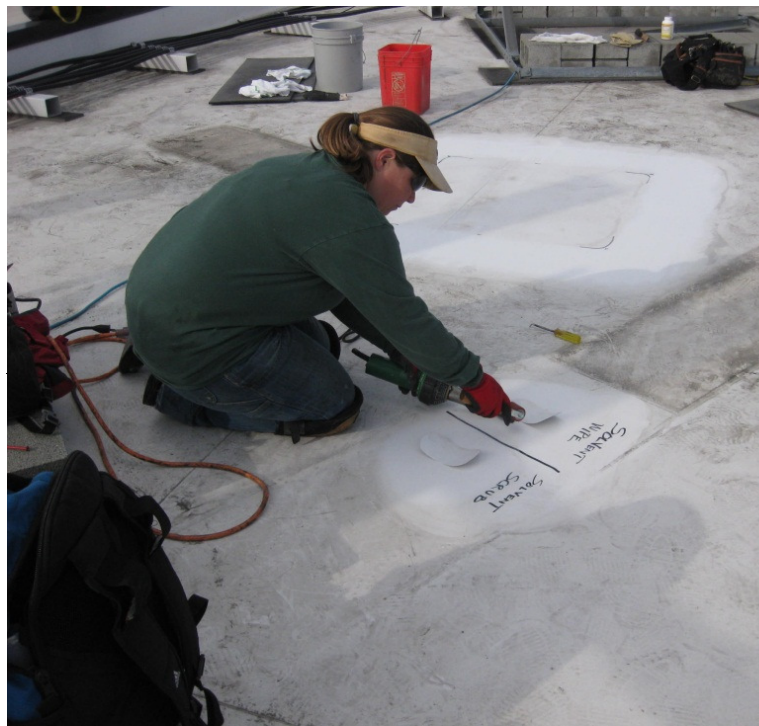
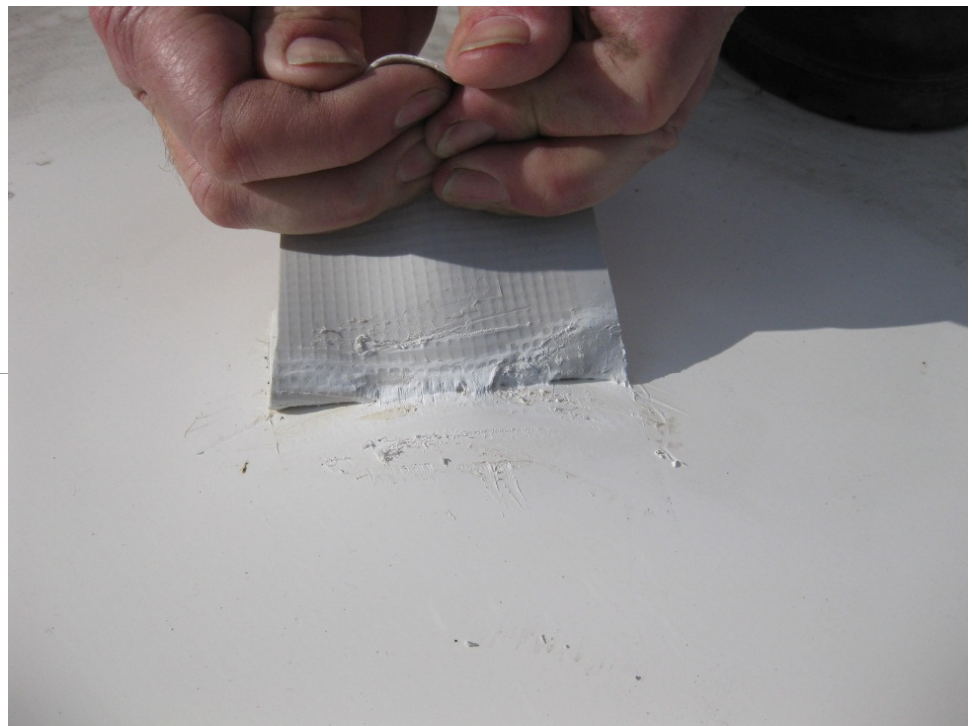
Anchorage – Roof Area 4 Weldability

**Test patches were welded on the existing membrane,
then field peel tests were performed.**

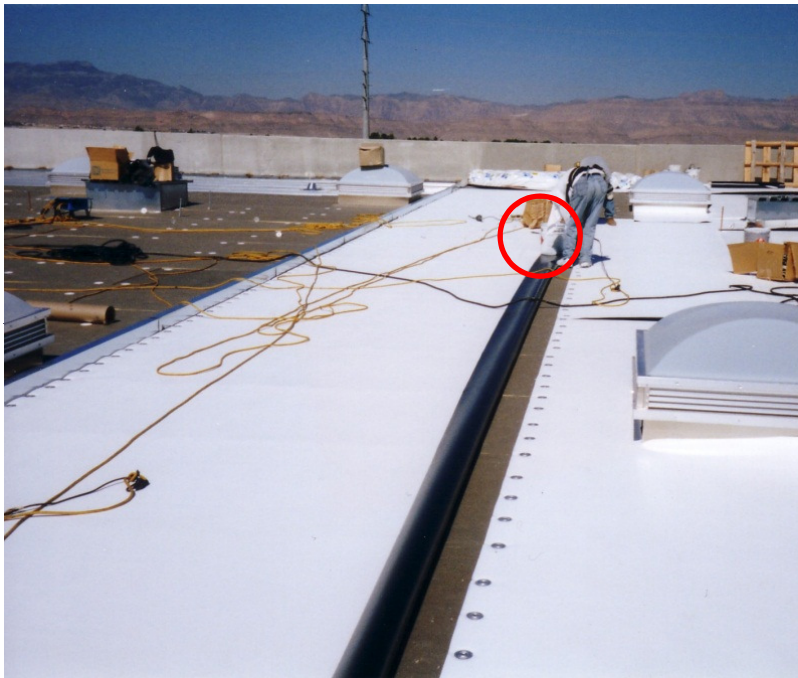
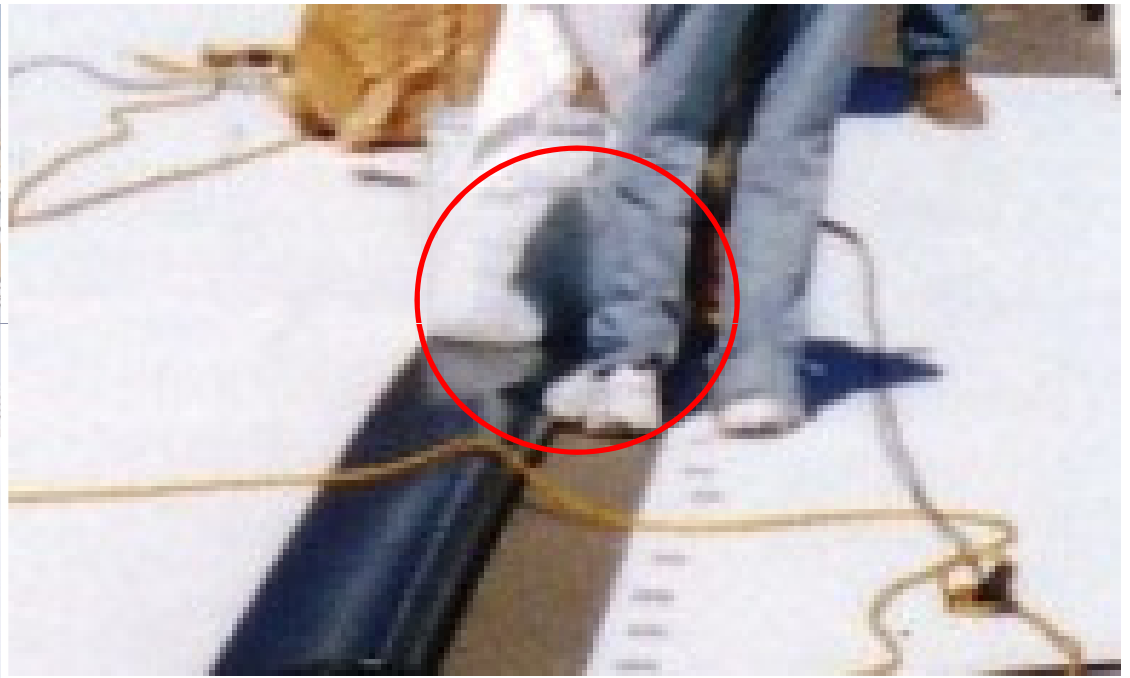
Las Vegas – Roof Area 1

Effect of Hard Creases

A photo from original installation of the TPO membrane in 2000. Note how the bucket and roofer's foot are hard-creasing the membrane.

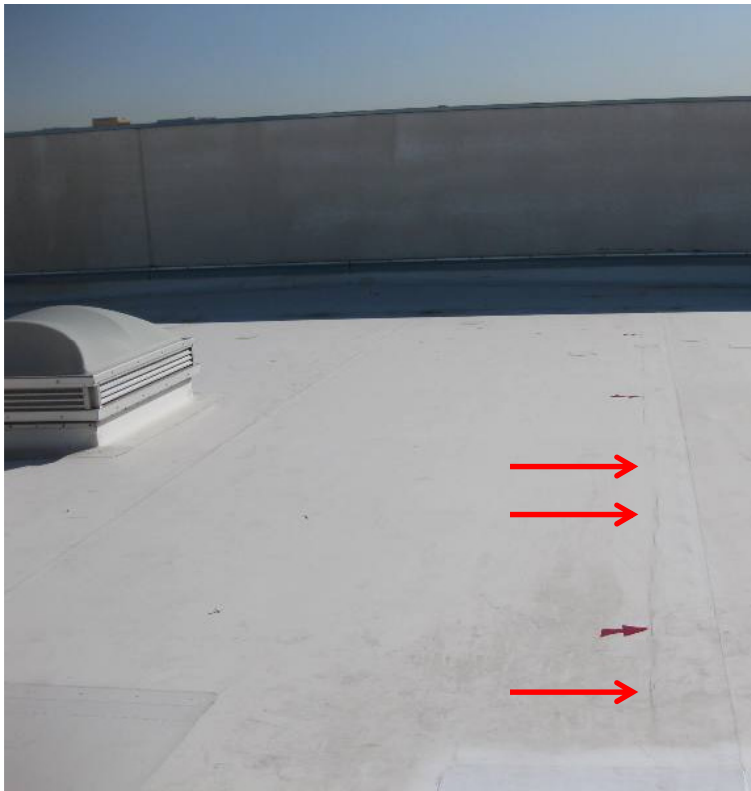
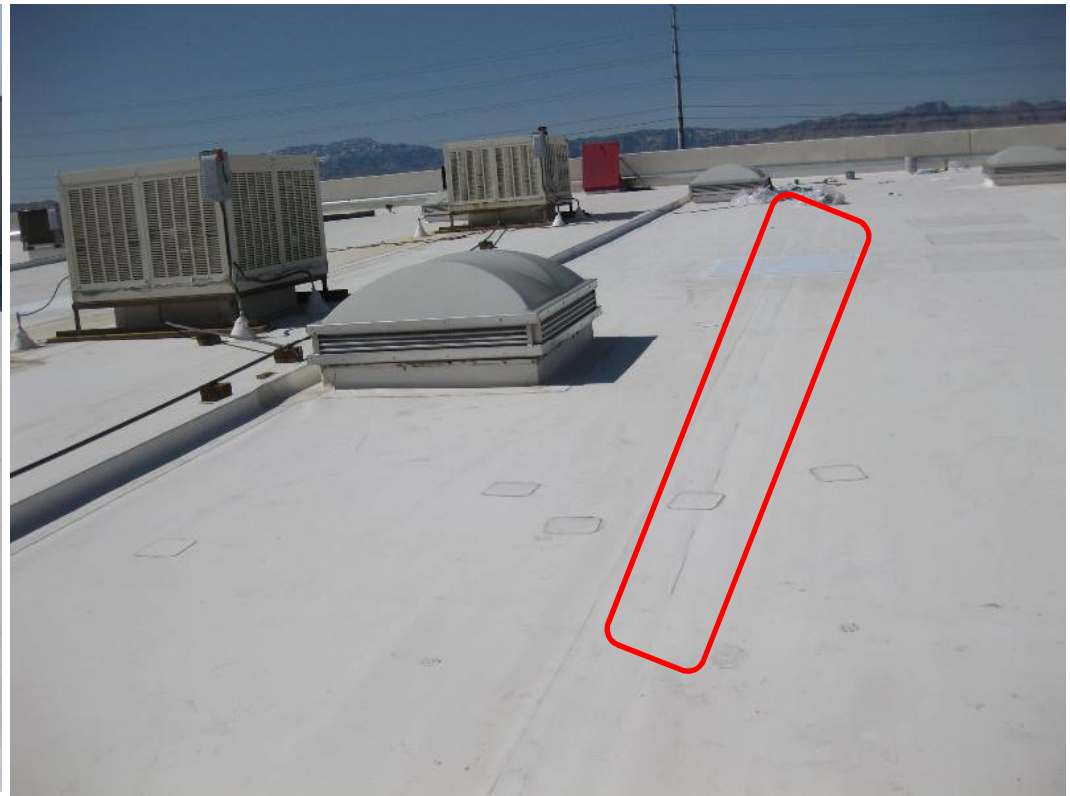
Las Vegas – Roof Area 2

Effect of Hard Creases

A side lap seam where creasing during installation and sun/heat load have led to cracking of the creases (2011)

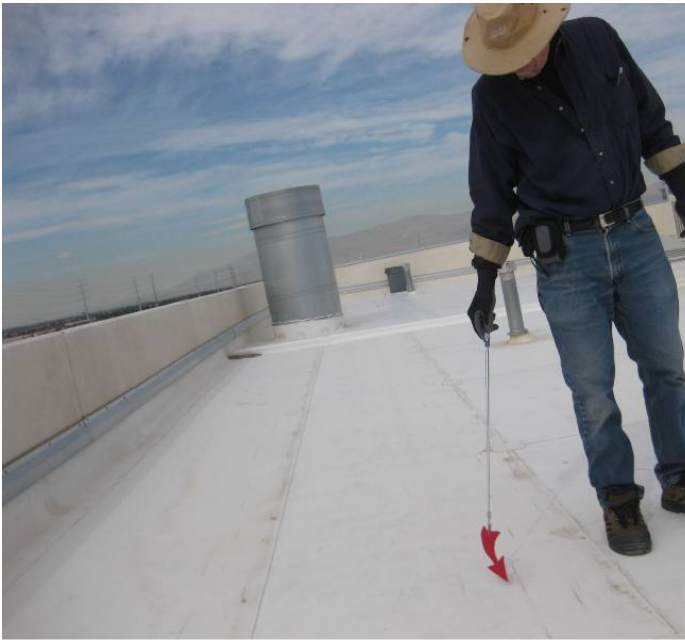
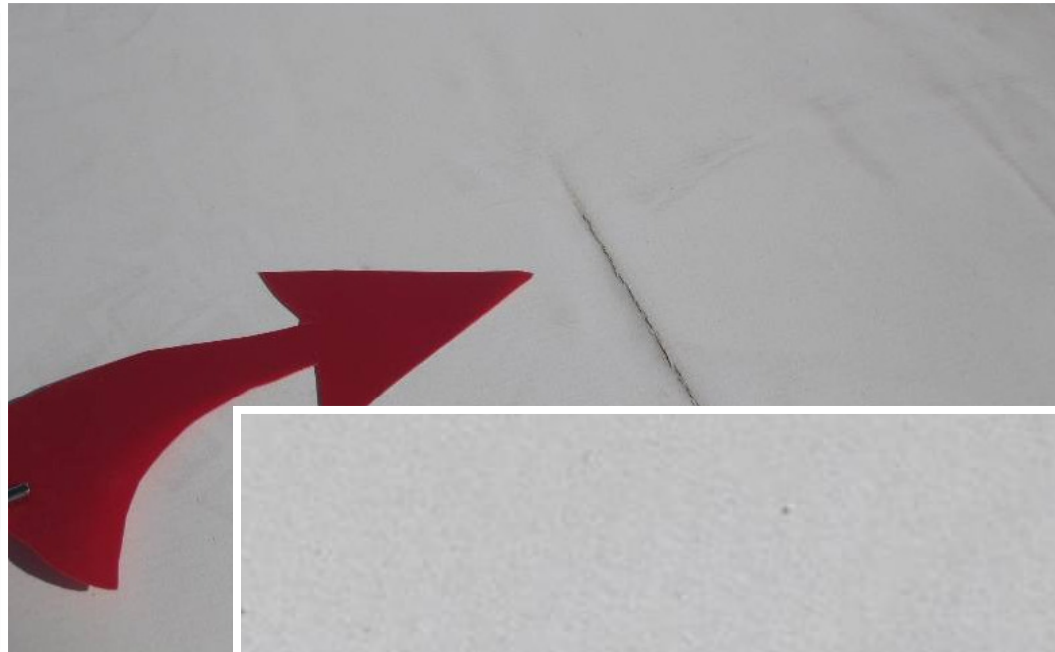
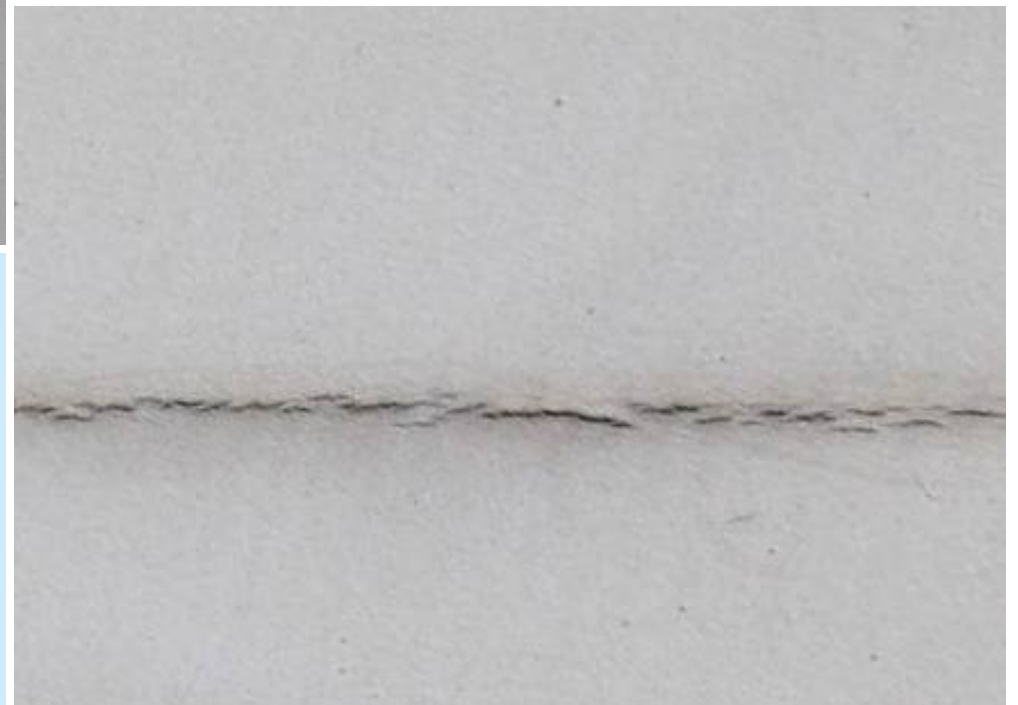
Las Vegas – Roof Area 2

Effect of Hard Creases

**A close-up view of
an isolated “crease
crack”**

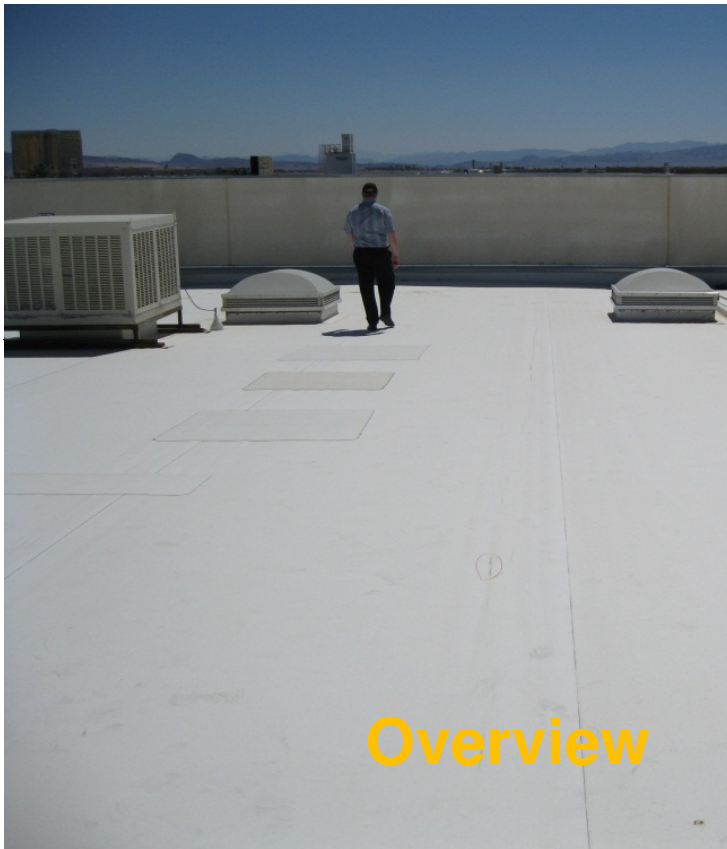
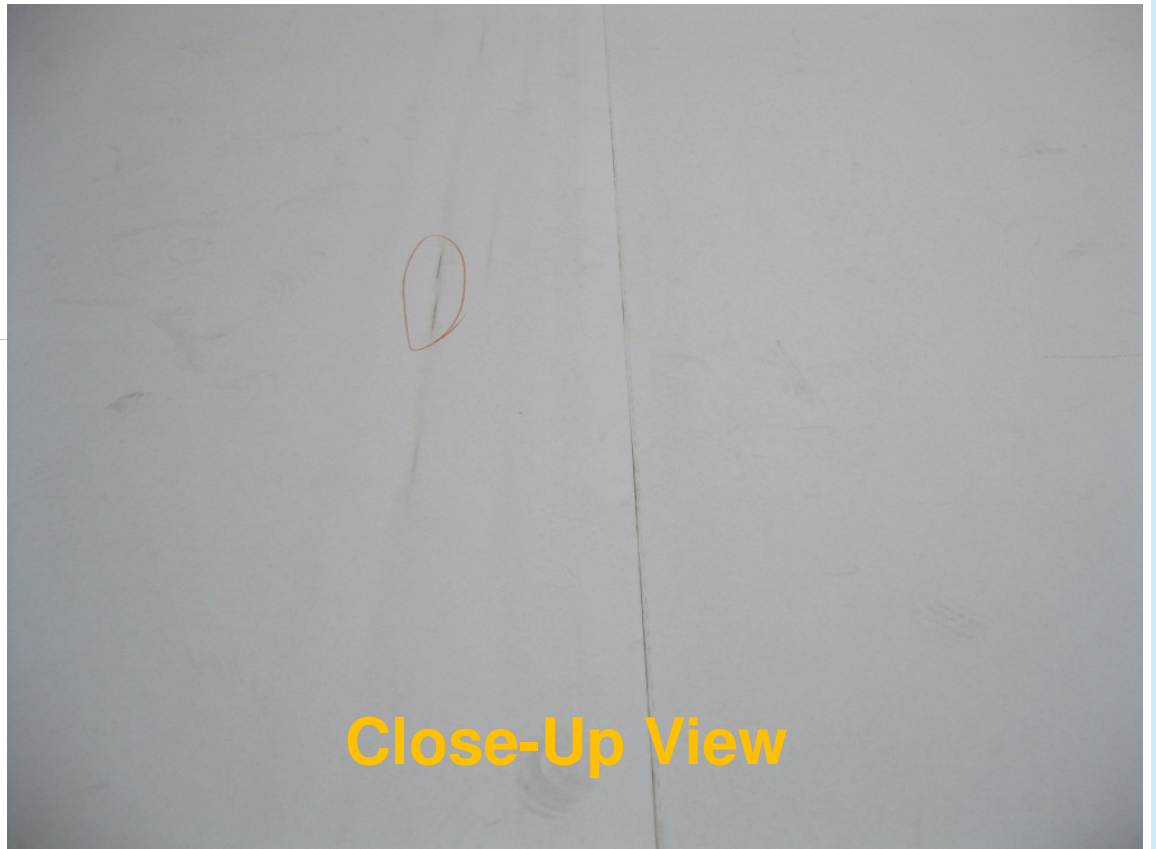
Las Vegas – Roof Area 2

- The widespread rumored TPO craze-cracking, reported by some to be happening on many aging TPO roofs **was not experienced with these 60-mil, white TPO roof research and testing project.**
- Crease-cracking was experienced on one roof area in one isolated location in San Antonio at year 7, and in numerous locations on one roof area in Las Vegas at year 10.
 - Those cracks were initiated by creasing of the roof membrane during installation – a practice that was discouraged by the Task Group 5 years ago

- Micro-cracking adjacent to the outer seam edge was observed at year ten on the Las Vegas roof area that also experienced crease-cracking.
- Some hand-welded T-joint covers, corner boots, and other hand-welded seam edges experienced some disbonding. But, no robotic-welded seams disbonded during this 10+ year study.
- The disbonded hand welds and the crazed or cracked membranes were all repairable, and all membranes are serviceable today.
- No widespread-catastrophic problems were observed. In general, these “3rd generation” white 60-mil TPO membranes are performing successfully.
