Lesson Learned from Hurricane Wind Investigations of Low-slope Roof Assemblies—A Researcher Prospective

A. Baskaran¹ and D. Roodvoets²

National Research Council Canada Ottawa, Ontario, Canada

**Roofing Industry Committee on Weather Issues,
Montague, Mich., U.S.,**

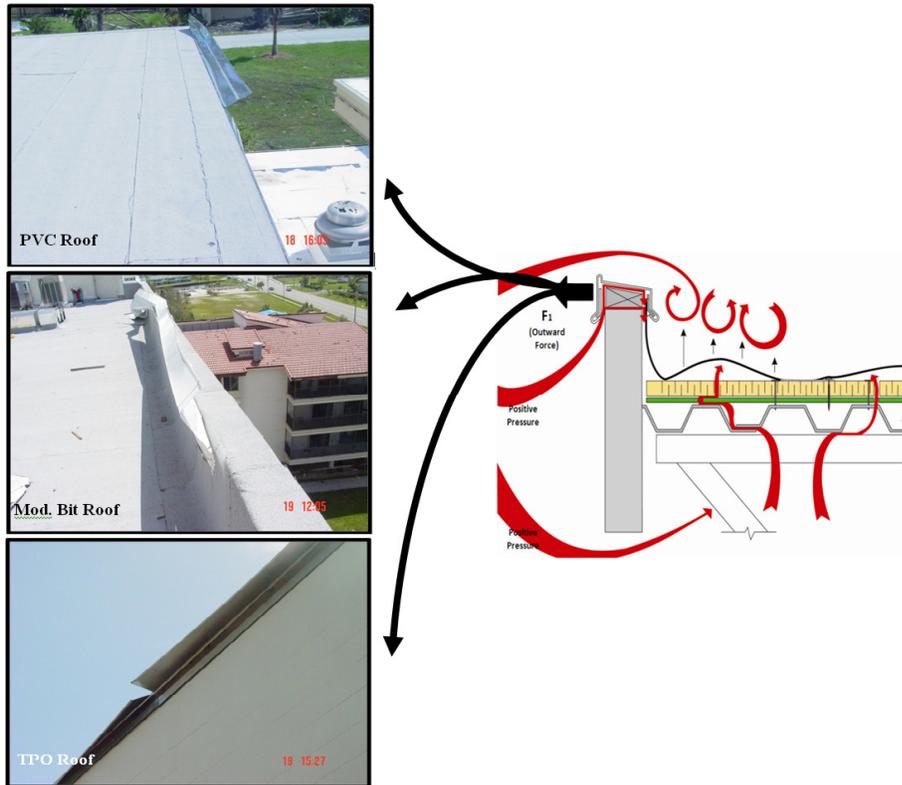
Figure 5. Failure of Roof Edge Because of Wind-uplift Force

Figure 5 shows typical failures observed during the Hurricane Charley investigation. Edge failure is seen in PVC, polymer-modified bitumen and TPO systems. This demonstrates these types of failures are not dependent on the membrane type. In all three cases, the roof membrane is not damaged and the weakest link is the edge system. The PVC and polymer-modified bitumen roof failures mainly result from the wind-induced outward force, F_1 , as discussed previously. There is no cleat installed in these two systems and, therefore, the wind outward forces lifted the coping. The TPO roof had a cleat but because of weak interlock with the coping, it could not resist the wind forces.

“It is recommended that roof edges should be designed and installed as a system rather than as separate components. The design should be based on the well-established engineering procedure that the edge system resistance should be greater than the design load.”

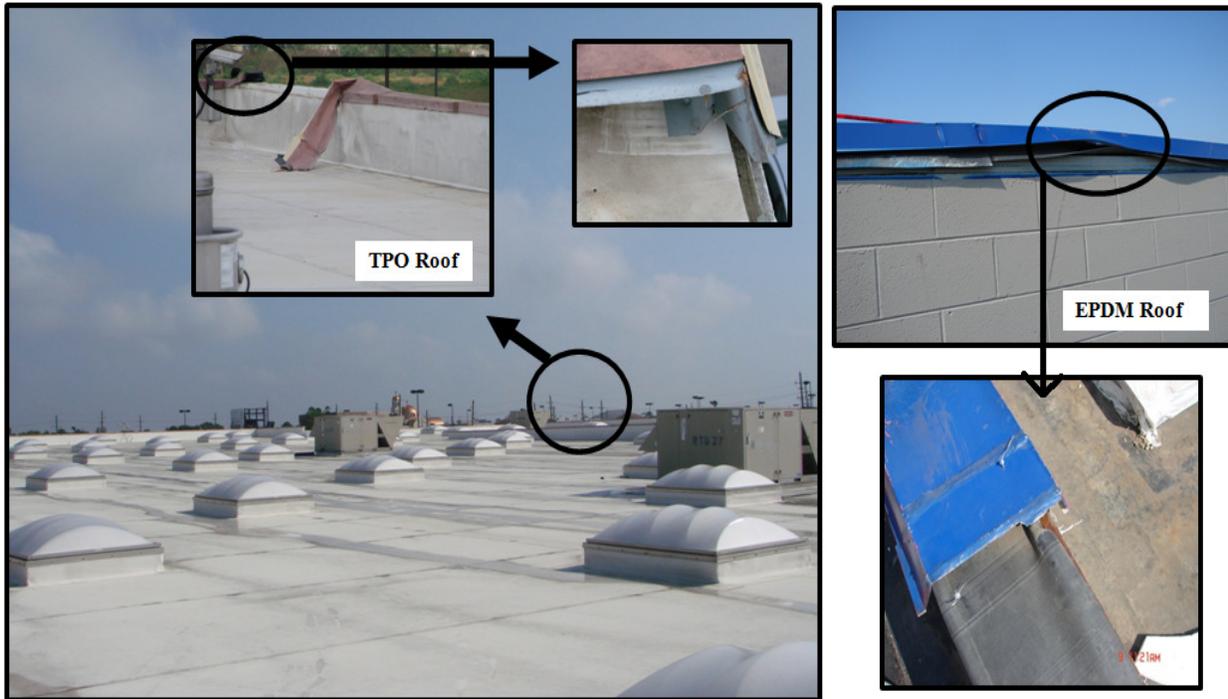
Figure 6. Roof Edge Failures due to Wind Uplift Force

Figure 6 shows the typical failure resulting from wind-uplift forces on the edges as the only failure observed for this TPO roof. The mechanically attached roof system was in good condition, and the rooftop equipment was not damaged. There were only a few membrane punctures because of edge metal debris. As shown in the figure, poor attachment of the metal caused the edge to be the weakest link for the wind uplift forces. In the case of the ballasted EPDM roof, there was major system failure as a result of the failures of the edge. The uplift force completely dislodged the edge system.

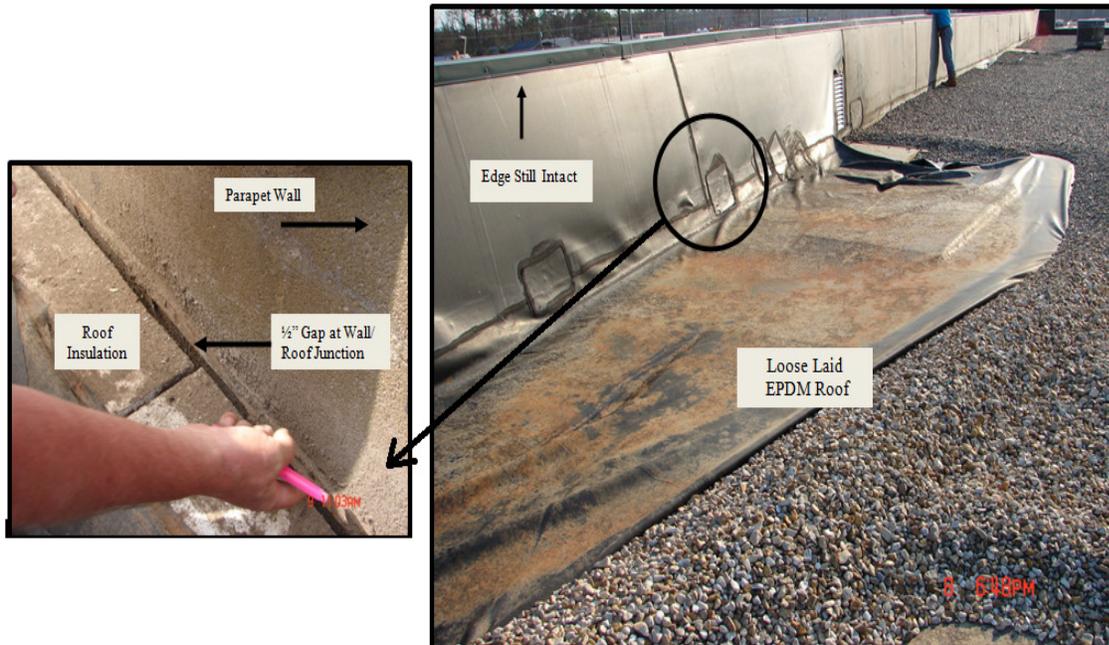
Figure 7. Failure of Roof Edge due to Membrane Pull

Figure 7 demonstrates how the positive internal pressure can lead to roof failure. The loose-laid EPDM roof assembly had a parapet of 4.5 feet (1.4 m) high with a well-designed and installed edge system. However, at the wall/roof junction, there was a gap of more than 0.5 inches (127 mm) along the length of the roof (220ft [67 m]). During the field investigation, it was noticed strong air currents were emerging along that gap. This internal positive pressure lifted the loose-laid membrane along the edge and displaced the stone ballast. The exposed membrane experienced tension when it was subjected to wind uplift. Because the membrane tear resistance was lower than the strength of the edge metal, the membrane ruptured and led to roof failure.

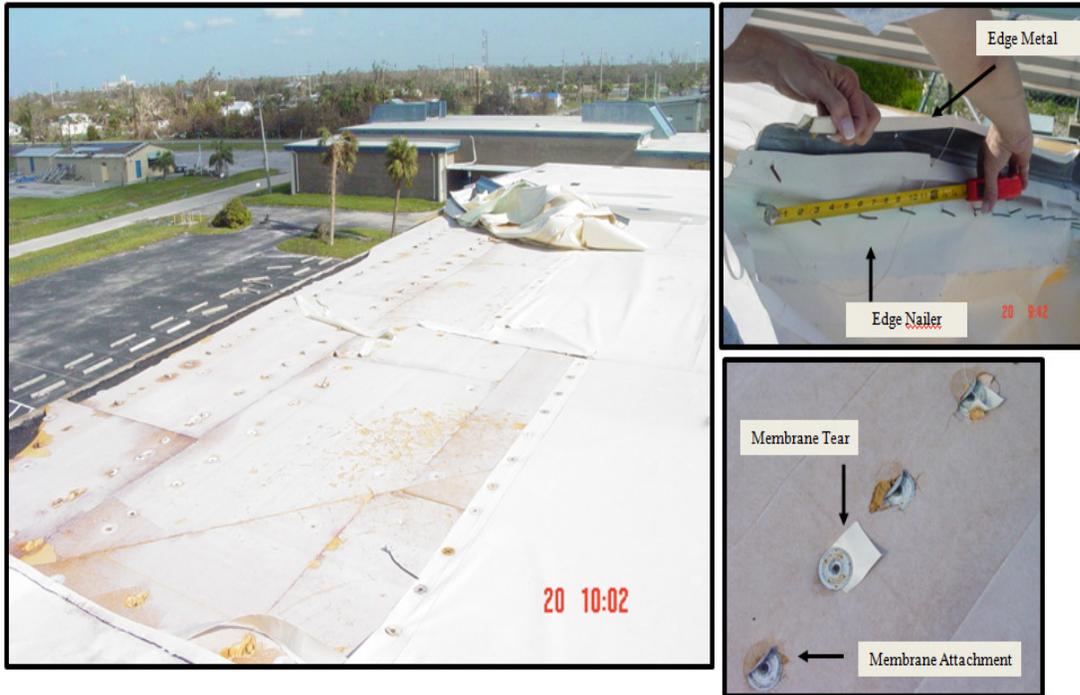
Figure 8. Failure of Roof Edge Because of Combined Forces

Figure 8 shows the failure of a PVC mechanically attached roof. The failed section had one full sheet and two half sheets. During the failure investigation, it was noticed the edge metal was attached using nails at 3 inches (9 mm) on center.

The membrane and coping remained intact. Membrane tear around the membrane metal plate was evident as was the bending of the plates. This indicates the weakest link for this roof system was the membrane having tear resistance lower than the wind-uplift forces. The membrane's failure caused the roof segment's failure. Closer examination revealed that slippage of the roof membrane from the attachment plate led to loss of compression between the roof membrane, insulation substrate and fastening elements and ultimately to the membrane failure by way of tear spread around the fastener shaft. Similar observations of failure modes also were noticed during dynamic

wind-uplift testing (Gerhardt et al, 1989 and Kramer, 1995). However, static tests did not produce this effect on the membrane, and, therefore, did not reveal the weakest link of the system's wind-uplift resistance.

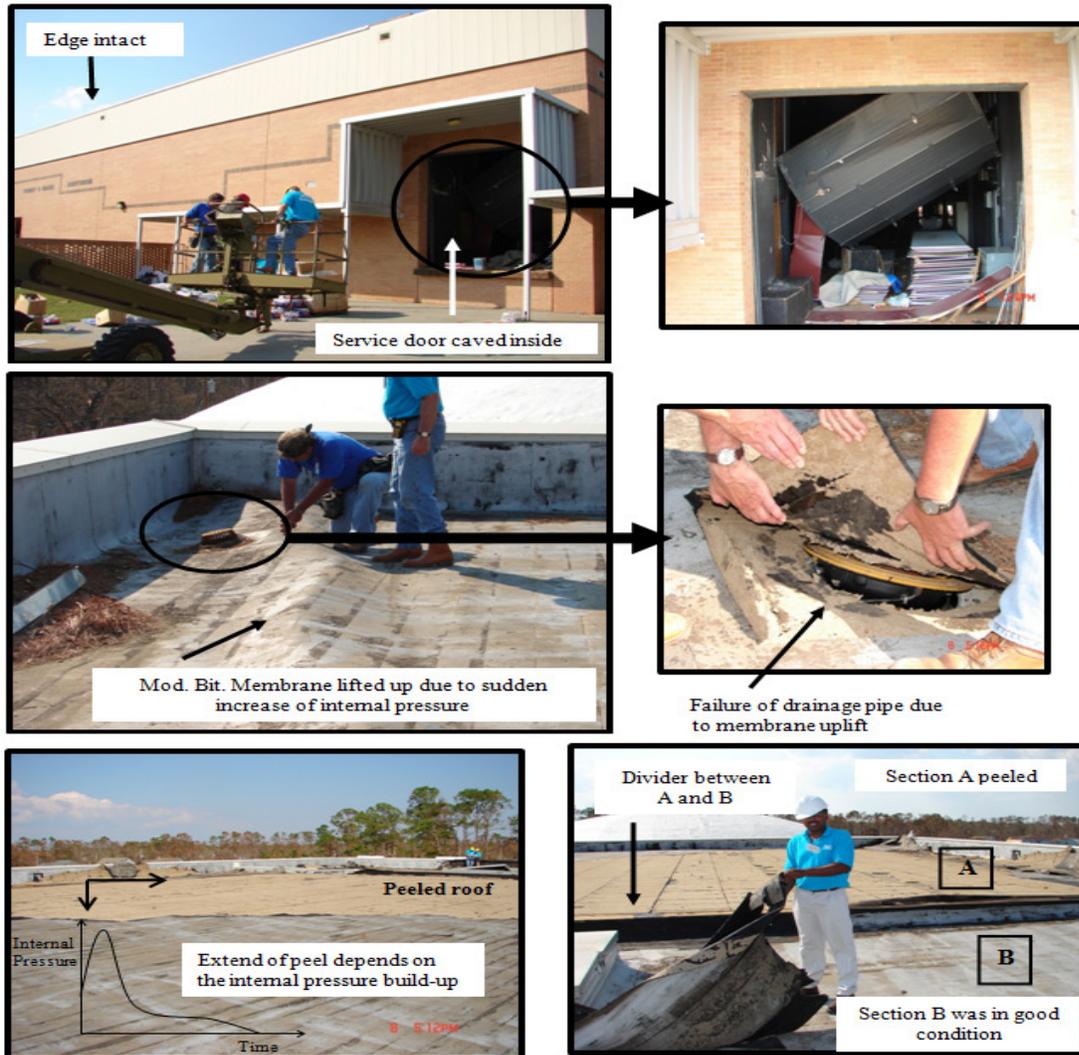
Figure 9. Effect of a Sudden Internal Pressure Build up and its Impact on a Roofing System

Figure 9 presents the effect of sudden internal pressure buildup and its effects on a built-up roof (BUR) system. Several failures were noted during the hurricane investigation. The school building in the photos was 40 feet (12.2 m) high and designated as one of the hurricane shelters. The service door of the school gym, being the weakest link, caved inward during wind flow interaction with the building. A drain directly above this area lifted and broke bonds in the system. The roof systems failed primarily in the top perlite insulation layers as the weakest point. Insulation fasteners mostly were intact; although part of the coping was blown off, coping loss likely is not the cause of the roof damage. The sudden envelope failure increased the internal pressure of the gym as high as the external wind pressure. In turn, the roof assembly was subjected to the internal push and external pull forces. Design wind pressure on a roof is the algebraic sum of the external pressure and internal pressure across the roof assembly. It can be presented as follows:

In examining several of such failures, it has been observed that the intensity of the internal pressure buildup is time-dependent. As shown in Figure 8, the failure of the service door caused the pressure buildup, and this excessive pressure will equalize with the internal volume of the building in time. Pressure equalization time depends on the building volume size, magnitude of the pressure buildup and duration of the external wind gusts. The extension of the roof failure is directly related to the pressure equalization time and intensity. This clearly can be seen in Figure 8; the membrane peel was stopped after a certain distance from the roof edge. The role of the roof divider acting as a peel stopper also is interesting. This is evident from the fact that the extent of the peel is much longer along the length compared with the roof's width. This mainly is because of the divider, which was running across the roof width, preventing the additional peeling. Structural roof design can be simplified as shown in equation 3:

“When there is a probability of building envelope failure such as the service door, it is recommended that peel stop design be incorporated as part of the roofing design. The peel stopper location along the length and width of the roof mainly depends on the size of sudden opening. It is recommended that peel stoppers can be installed at a distance 3 times that of the size of the sudden openings from the roof edge.”

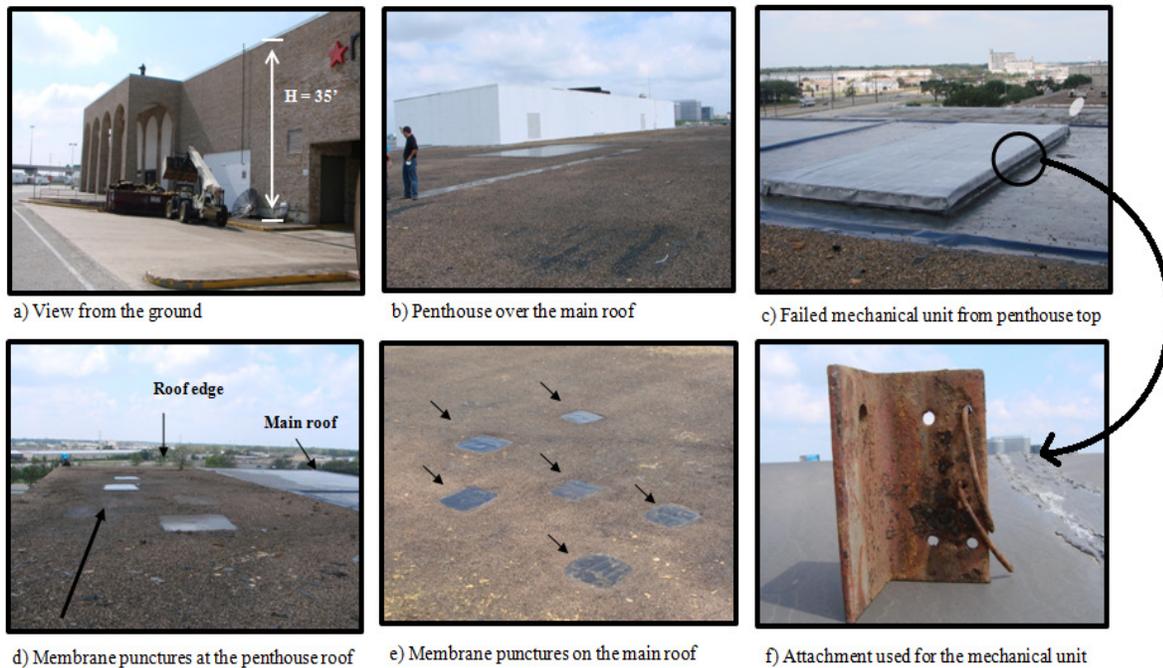
Figure 10. Complete Blow-off of a Mechanical Unit and its Effects on a Roof System

Figure 10 shows the complete failure of a mechanical unit and its effects on the roof assembly. The retail building with gravel-surfaced BUR is 35 feet (10.7 m) high. There was a penthouse on the roof, and it was 15 feet (4.6 m) high above the main roof level. The penthouse had a mechanical unit, which was held in place with metal L angles and attached using nails. Failure of the nail attachment caused the blow-off of the mechanical unit, which caused the major punctures on the penthouse roof.

Subsequent wind flow dynamics caused the mechanical unit to come apart, which affected the main roof by puncturing the membrane at several locations. The debris path is evident from the figure, as well as the propagation of membrane puncture failures, until the debris left the roof surface.

“In comparing and contrasting the failed scenarios with the survivals, two generic recommendations can be summarized: (1) Roof design should include integrating roof top equipment with the structural element of the building and the design should be verified with experimental data, at the minimum for common attachment methods; and (2) Roof top mechanical equipment should be certified for wind uplift resistance.”

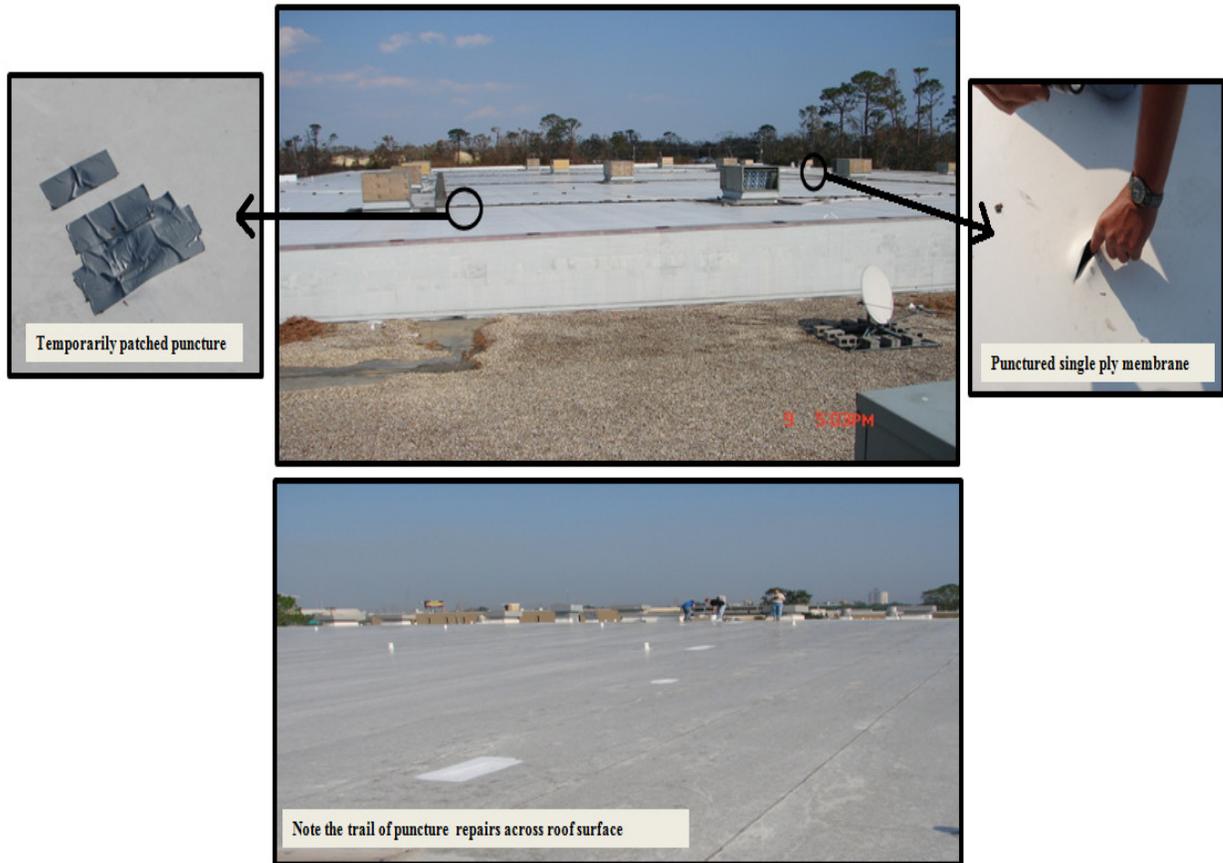
Figure 11. Partial Blow-off of Several HVAC Units and its Effects on a Roof System

Figure 11 shows partial failure of several mechanical units. This two-level roof had loose-laid EPDM on the lower level and mechanically attached PVC roof on the upper level. Both roof systems performed well during the wind event. The bases of the mechanical units and encircled paver still were in place. However, as shown in the figure, for missing metal covers, most of the units temporarily were repaired with plywood. The metal debris from the units caused several punctures to the single-ply membrane where some were temporarily patched and some were unnoticed. Similar to the previous case study, the trail of punctures was observed across the roof surface,

ending at the roof perimeter. These are classic examples of the rooftop unit becoming the weakest link for wind forces and failure of that resistance link in a roof assembly leads to roof system failure.
