# LABORATORY TESTING FOR LOW-SLOPE STANDING SEAM METAL ROOF APPLICATION

LARRY R. MEYERS, RICHARD S. KOZIOL, DENNIS K. JOHNSON, and NORBERT V. KROGSTAD

Wiss, Janney, Elstner Associates, Inc.  
Chicago, Illinois

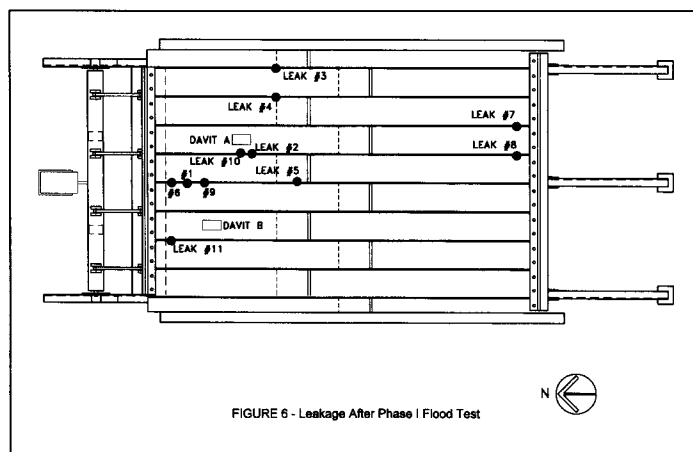
Phase 1 testing began by mechanically cycling the panels. After 1,000 mechanical cycles were completed, the roof mockup was visually examined for evidence of distress caused by the cycling. Two small splits, ranging in size from 3 mm to 6 mm ( $\frac{1}{8}$  in. to  $\frac{1}{4}$  in.), were observed in the transverse seam silicone sealant at one location. The splits occurred on the vertical upturn portion of the sealant along the uppermost edge of the standing seam. However, no water leakage was observed during the ASTM E 331 water spray test when the roof mockup was subjected to water spray in conjunction with static air pressure difference or when the roof was subjected to water spray with and without the application of a static air pressure difference. The testing continued by flooding the roof mockup to the height of the top of the standing seams. Extensive leakage was observed inside beneath the

standing seams when the water was ponded on the surface of the metal roofing panels. These leak locations are shown in Figure 6. The total amount of water that penetrated through the roofing system was not measured due to the volume of leakage. Water entered the roof system through all of the standing seams except one. This seam had been modified by installing silicone sealant along the length of the vertical seam prior to the start of the testing to evaluate its effectiveness in accommodating movement.

FIGURE 6 - Leakage After Phase 1 Flood Test

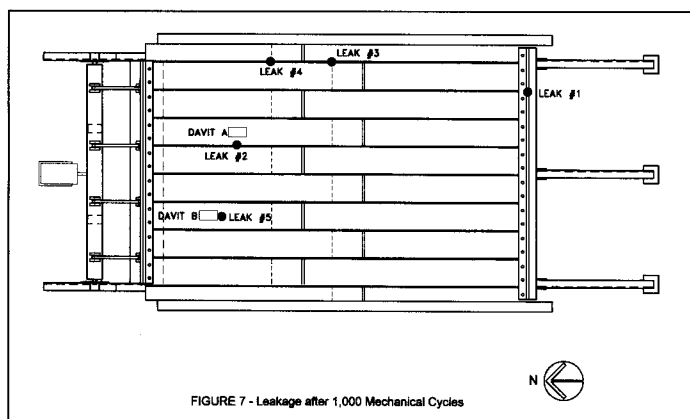
Figure 7.

The source of the initial two leaks and the three new leaks that developed after the first 1,000 cycles of the revised test program was investigated. (Leak locations are shown in Figure 7.) Leak No. 1 was attributed to either a sealant void in the standing seam or leakage at the top portion of the transverse sealant. The leakage occurred along the seam and

Leak No. 2 occurred at Davit A. This area was repeatedly tested by creating small dams of butyl sealant and testing selected areas. The rate of leakage resulting from testing at these smaller isolated areas never equalled the rate observed during the full-scale flood test. Two plexiglass dams were created on either side of the davit between the standing seams. Once the entire area around the davit was flooded, the rate of leakage was approximately the same as that recorded during the flood test. The source of this leak could not be definitively identified without completely dismantling the roof system. However, it appeared to be associated with the standing seam in this area. The solder joints around the cut portion of the roof panel that fit around the davits were damaged when the standing seams were folded.

Leaks No. 3 and 4 were the result of water entering the transverse seam at the point where the transverse seam sealant turned up the standing seam fold. At this location, a shearing action took place in the sealant, resulting in the sealant becoming debonded from the surface of the metal. Water penetrated the sealant at this location and filled the transverse seam lap joint.

Leak No. 5 was located at Davit B. The same procedure was utilized for isolating the leak at Davit A. As the leak was being isolated, cracks were observed in the solder joints around the lead flashing boot. These cracks were soldered tight, the area was flood tested again, and no leakage occurred. The cracks in the solder joints were likely the result of fatigue from the mechanical cycling.

FIGURE 7 - Leakage after 1,000 Mechanical Cycles

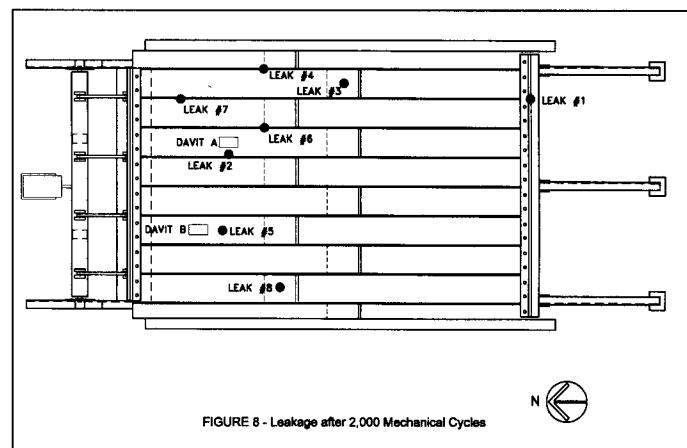
The flood test after the completion of 2,000 mechanical cycles (Phase 3) resulted in eight leaks in the roof system. (Leak locations are indicated in Figure 8.) Leaks No. 1, 2, and 4 occurred at the same locations as noted during the previous test. Leak No. 3 was located at the inspection opening from the previous test made in the first full transverse seam, indicating that leakage occurred through the transverse seam sealant at the vertical upturn.

Intense leakage occurred immediately at Davit B (Leak No. 5) when the mockup was flooded. Water leakage, at a rate of approximately 1.05 mL/s (1 gallon per hour), was collected at the 102-mm- (4-in.-) diameter inspection hole near the davit. The source of the leakage was the hairline fractures in the solder joints.

Leak No. 6 was only a slight drip and occurred either at the fixed edge of the transverse seam lap or a panel cleat that was located in the area. Leak No. 7 was associated with a cleat directly over the slight drip. Leak No. 8 occurred at the far west inspection hole drilled into the solid portion of the deck. The source of this leak was not definitively determined, but was most likely the result of excess water on the roof deck.

FIGURE 8 - Leakage after 2,000 Mechanical Cycles

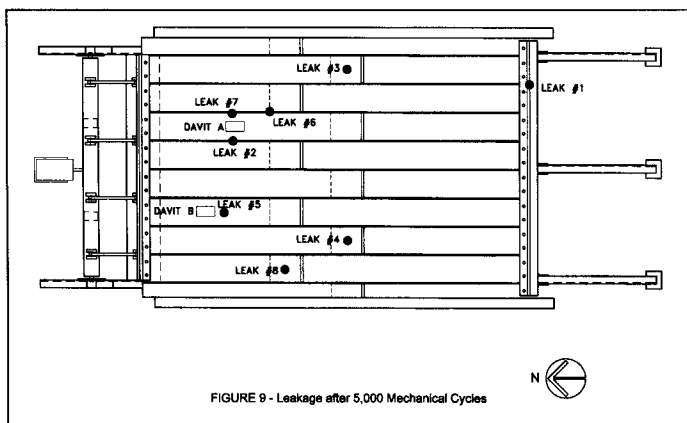
The roof system was flood tested after the completion of the 5,000 mechanical cycles (Phase 3) in three steps. The leak locations from this test are shown in Figure 9. The davits were isolated from the roof with small plexiglass dams to determine the height of water at which leakage occurred. Water was filled to one-half the height of the standing seam with no signs of leakage through the davit areas. The water level was raised to three-quarters the seam height with no leakage observed around the Davit A; however, there was significant leakage at Davit B (Leak No. 5). Fractures occurred in the solder joints around the davit, resulting from the rocking motion. These fractures were covered with butyl sealant and the areas around both davits were filled with water to the top of the standing seam. No further leakage was observed at Davit B; however, a small leak developed at Davit A (Leak No. 2). Although this leak occurred at the same location as noted previously, the rate of leakage was significantly less. Based upon these leaks, it was concluded that standing seams were contributing to leakage.

The remainder of the roof mockup was then flooded to approximately one-half the standing-seam height. No new leakage was observed. Additionally, there was no evidence of new water leakage when the mockup was flooded with approximately 19 mm ( $\frac{3}{4}$  in.) of water. However, once the roof mockup was flooded to the top of the standing seams at approximately 25 mm (1 in.), six new leaks developed. A few of the leaks (Nos. 1, 2, 3, 5, 6 and 8) occurred at the same location as previously noted under Phase 2; some previous leaks (Nos. 4 and 7) had disappeared; and some new leak locations (now identified as Nos. 4 and 7) developed.

Leak No. 8 occurred at a transverse seam. Since the roof deck was previously dry and the Davit B flashing leak did not cause water to flow across the deck, this leak was attributed to water leaking through the vertical upturn of the transverse seam sealant. A new leak (Leak No. 7) developed at the side of Davit A, resulting from a cleat directly over the leak. The source of Leak No. 4 was most likely the vertical upturn in the transverse seam sealant similar to Leak No. 8 described above.

The leak previously identified as Leak No. 4 under the Phase 1 and Phase 3, Part 2 testing disappeared. This leak had been attributed to a vertical upturn of the transverse seam sealant. However, the source of this leak was likely the result of a cleat in the nearby area. The butyl sealant located within the folds of the standing seam probably separated from the adjacent metal, resulting in the earlier leakage.

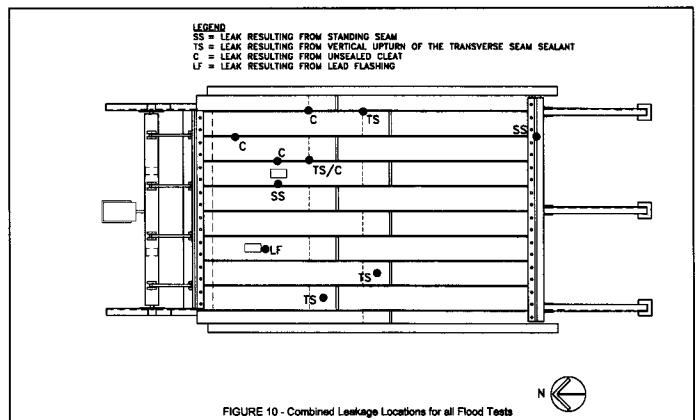
Figure 10.

Three modes of failure were identified in the Phase 3 tests: leakage at davits, leakage through standing seams, and leakage through the vertical upturn of the transverse seam. Leakage occurred at both davit locations, either through the panel splice or from the davit flashing itself. Three leaks could be attributed to the vertical upturn of the transverse seam. Three leaks were also attributed to butyl sealant failing at the panel cleats. Finally, two leaks were attributed to either the vertical upturn of the transverse seam or to a panel cleat (refer to Figure 10).
