PERFORMANCE OF ROOFING SYSTEMS IN WIND STORMS

Joseph E. Minor, P.E.

Director, Institute for Disaster Research, Texas Tech University, Lubbock, Texas U.S.A.

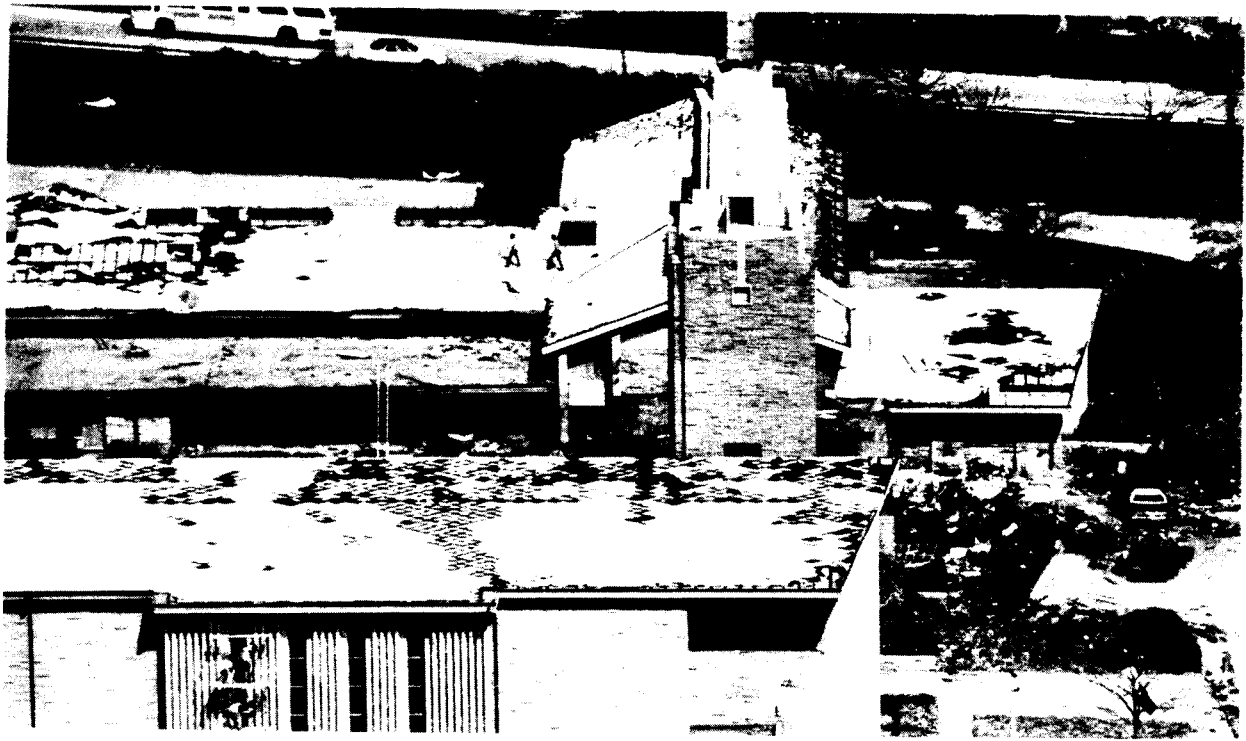
FIGURE 3—PEELING FAILURES

The locally severe, uplift pressures identified with roof corners, ridgelines, and eaves often initiate peeling of roofing materials in windstorms. Figure 3 illustrates this type of failure. Figure 3a shows the effects of peeling from roof corners, eaves, and ridgelines. For a close-up view of the roof corner, see Fig. 3b right-center portion. The failure started with the roofing material at this relatively high pressure point (Ref. Fig 1) and eventually included uplift of roof panels.

a. Relatively large pressures at roof corners, eaves, and ridges often initiate peeling types of failures

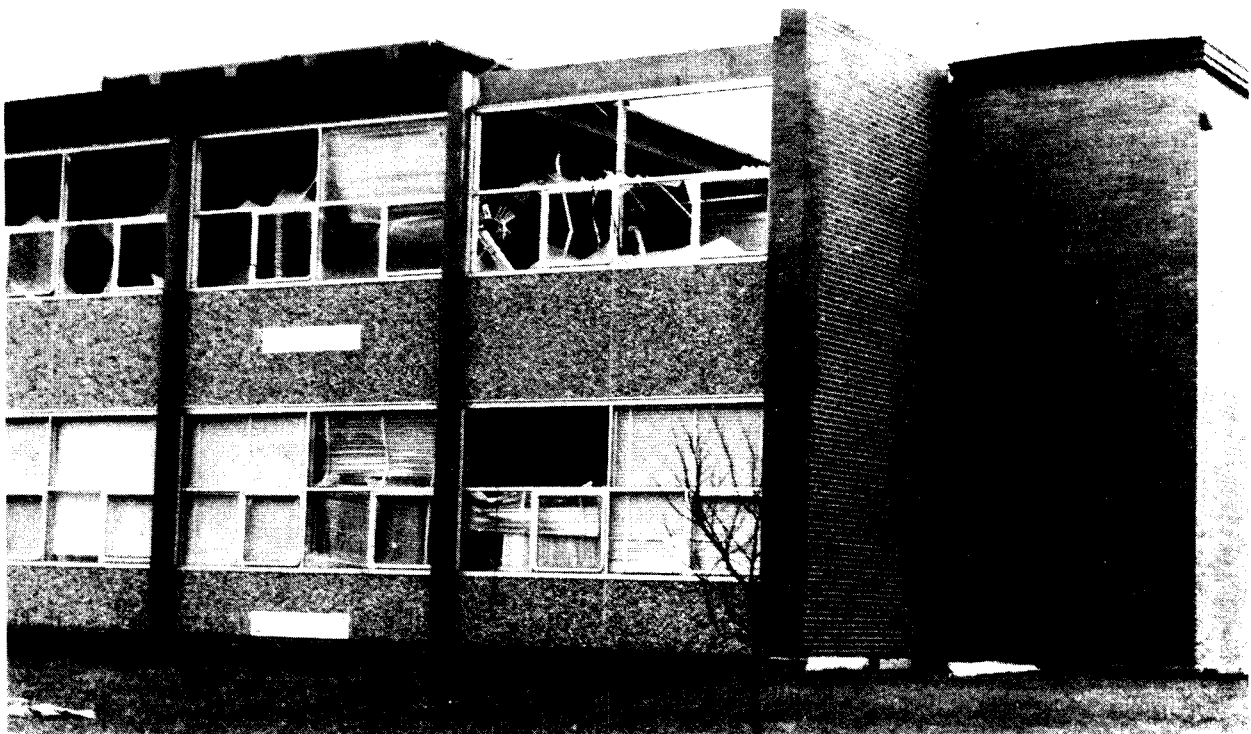
When total uplift pressures acting on overall roofing systems exceed roofing system-to-wall connection strength, system failures may occur. Two examples of this type of failure are offered in Figure 6. In Figure 6a, an open web steel joist roofing system failed at joist-to-wall connection points. In Figure 6b, prestressed, "double T" beams were lifted from their supports by upward-acting pressures. Here, total pressures across the roofing system, which occurred through combined wind actions illustrated in Figure 2, were sufficient to cause roofing system failure.

b. Large uplift pressures can cause system failures of concrete roofs.

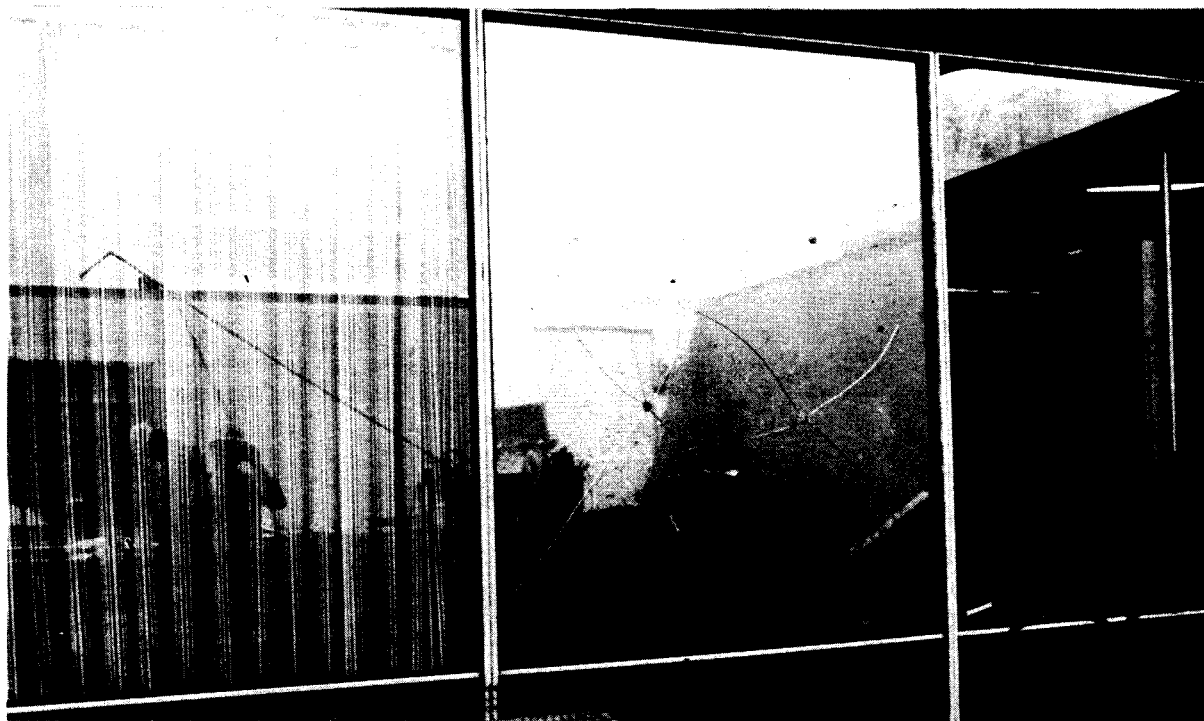
Many roofs containing loose gravel are located in areas where they present a hazard to glass windows and glass spandrel units in adjacent buildings. An example of loose roof gravel menacing a glass-clad building is presented in Figure 7. Evidence of missile impacts on glass panels is presented in Figure 8. The glass panels to the left and right of the center panel in Figure 8 were broken, and have been replaced with new glass; the center panel sustained missile impact damage, but did not fall out of the frame.

FIGURE 8 — EVIDENCE OF MISSILE IMPACTS ON GLASS WINDOWS NEAR GRAVEL SURFACED ROOFS
