# HAND-HELD INFRARED SYSTEMS FOR DETECTING ROOF MOISTURE

Wayne Tobiasson\*, Charles Korhonen\*, and Alan Van den Berg\*\*

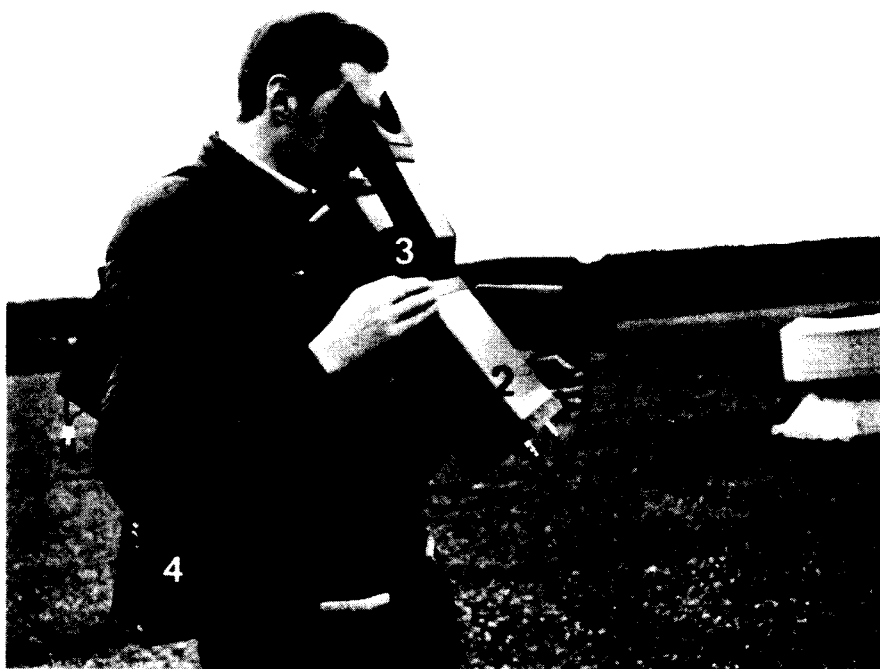
FIGURE 2 - THE AGA THERMOVISION 750 CAMERA SYSTEM.

1. Camera
2. Display unit
3. Polaroid camera and mount
4. Battery pack

Until recently, infrared cameras were quite large and seldom used out of doors. The portable, battery operated AGA Thermovision 750 Infrared System (Figure 2) was used for essentially all the studies discussed in this report. Some roof moisture studies have also been conducted with the Inframetrics Model 510 system, with a hand-held system developed for the Army by the Magnavox Corporation and type classified as the AN/PAS-10, and with the Probeye System developed by Hughes Aircraft.
