# LABORATORY EVALUATION OF EPDM ROOF MEMBRANES: A 17-YEAR HISTORY OF PERFORMANCE

BRIAN D. GISH and KATHLEEN P. LUSARDI

Carlisle SynTec Systems

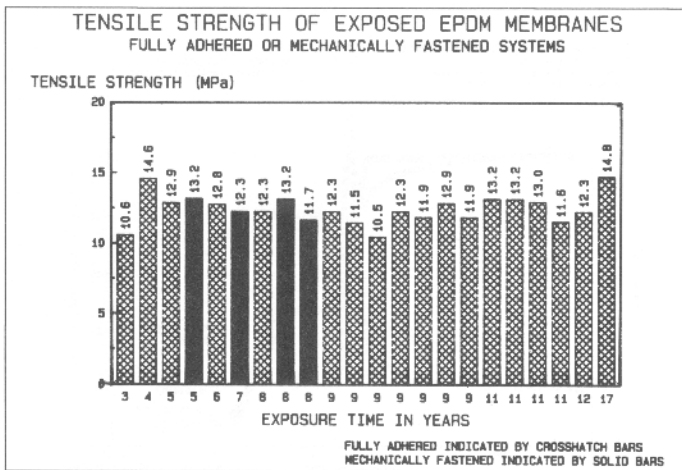
**Figure 1** Tensile strength of exposed EPDM membranes—fully-adhered or mechanically-fastened systems.

The samples were tested for tensile strength and ultimate elongation in the machine direction using ASTM Test Method D 412.<sup>3</sup> The results are shown in Figures 1 through 4. The tear resistance was determined in the machine direction using ASTM Test Method D 624,<sup>3</sup> and the results are

The tensile strengths ranged from 10.5 to 14.8 MPa for exposed membranes and 11.1 to 13.7 MPa for protected membranes (see Figures 1 and 2). The ASTM minimum requirement for new sheet is 9.0 MPa and the MRCA minimum performance requirement is 6.0 MPa. All aged sheet tensile strengths exceed ASTM and MRCA requirements for new EPDM membrane.

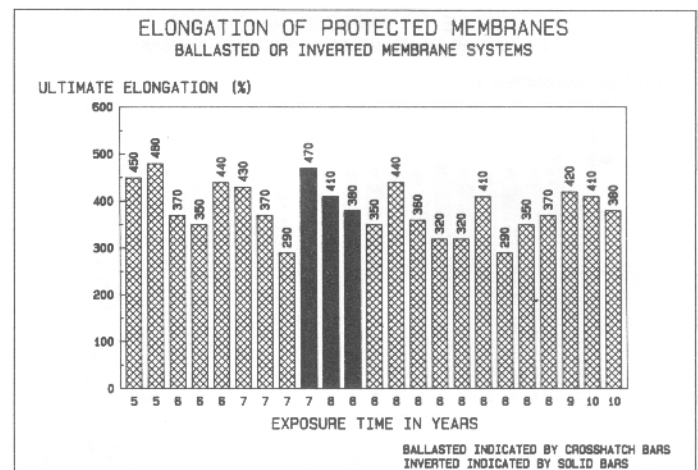
**Figure 4** Elongation of protected membranes—ballasted or insulated membrane systems.

The ultimate elongations ranged from 230 to 530 percent for exposed membranes and 290 to 480 percent for protected membranes (see Figures 3 and 4). The ASTM minimum requirement for new sheet is 300 percent and the MRCA minimum performance requirement is 250 percent. All sheet ultimate elongations, except the 17-year old exposed membrane (230 percent), exceed the MRCA performance requirement for elongation.

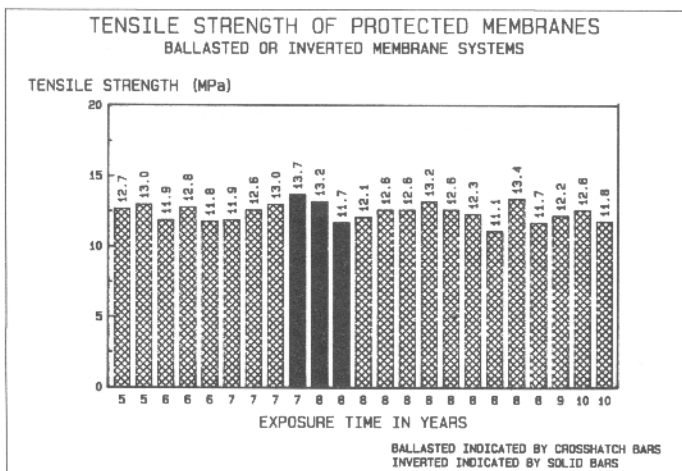
**Figure 2** Tensile strength of protected membranes—ballasted or insulated membrane systems.

lasted or insulated (also known as protected membrane roofs). Figures 2, 4, 6 and 8 show protected membrane properties. The ballasted systems have some protection from solar radiation depending upon the ballast coverage density, and the insulated membranes are protected by insulation/ballast.

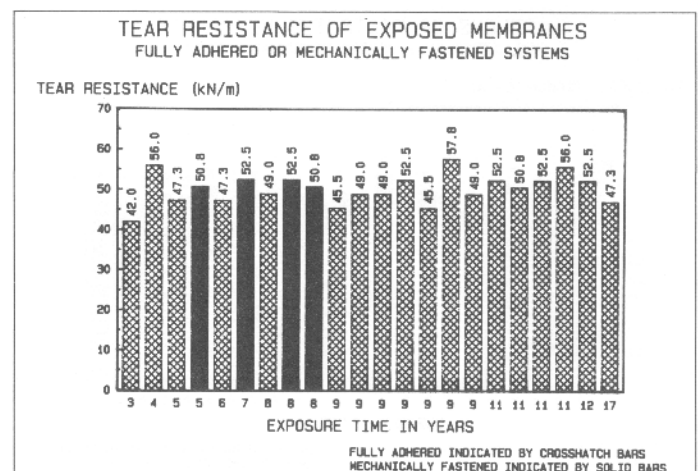
**Figure 5** Tear resistance of exposed membranes—fully-adhered or mechanically-fastened systems.

Tear resistance ranged from 42.0 to 57.8 kN/m for exposed membranes and 45.5 to 59.5 kN/m for protected membranes (see Figures 5 and 6). The ASTM minimum requirement for new sheet is 26.0 kN/m and the MRCA performance requirement is 21.0 kN/m. All aged sheet tear resistances exceed ASTM and MRCA requirements.

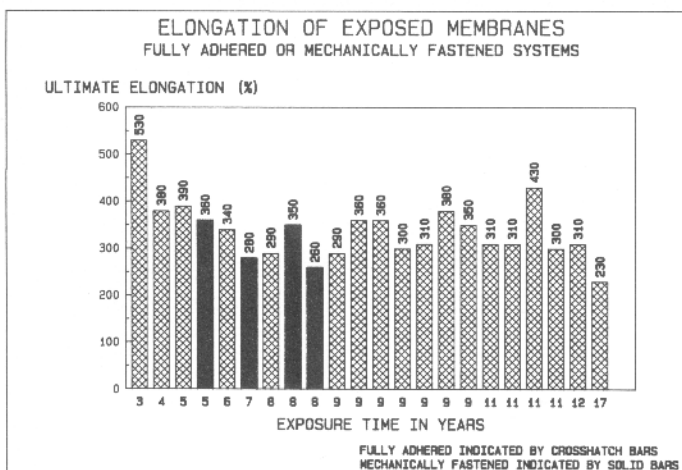
**Figure 3** Elongation of exposed membranes—fully-adhered or mechanically-fastened systems.

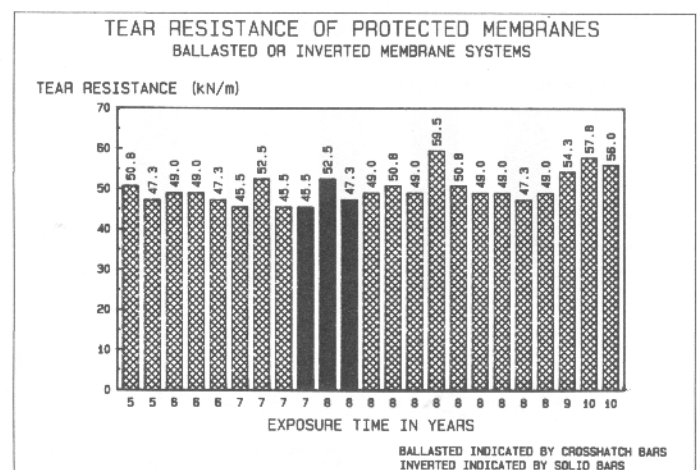
**Figure 6** Tear resistance of protected membranes—ballasted or insulated membrane systems.

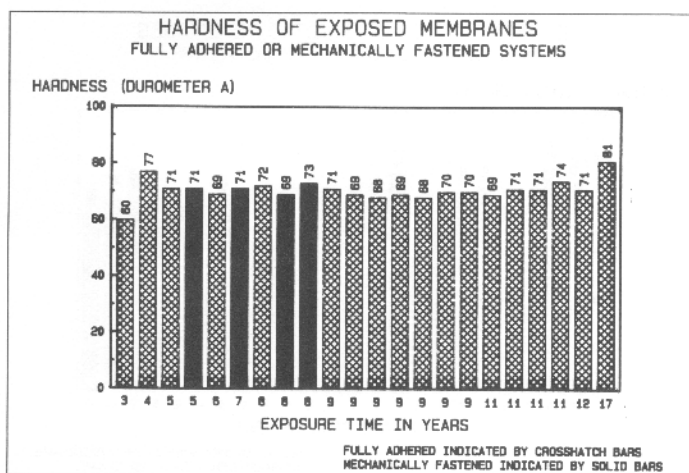
Figure 7 Hardness of exposed membranes—fully-adhered or mechanically-fastened systems.

Hardness ranged from 60 to 81 for exposed membranes and 62 to 76 for protected membranes (see Figures 7 and 8). There are no ASTM or MRCA requirements for hardness. Although there are no standard requirements for hardness, it is an important gauge to measure the cure state of rubber articles. As EPDM sheets weather, the hardness generally increases. The aged hardness can be compared to the original unaged hardness.

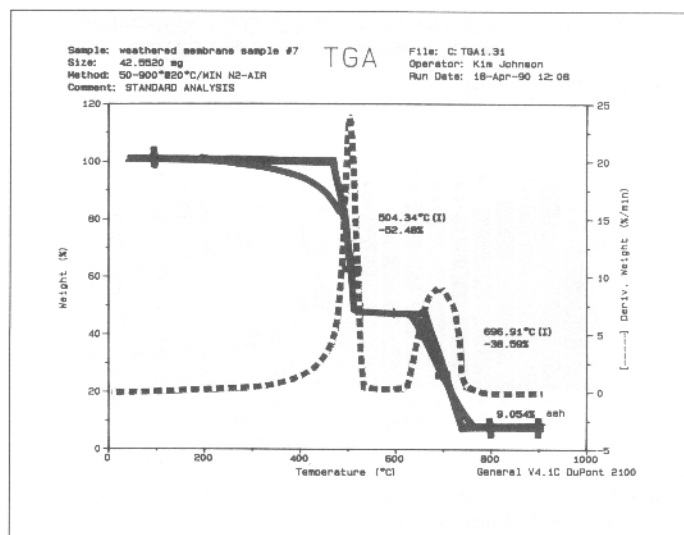
Figure 10 TGA—weathered membrane sample #7.

TGA measures the change in mass as a function of temperature. The sample is heated at a fixed rate in a controlled furnace atmosphere. As the sample is heated, components begin to volatilize. The resulting mass change versus temperature curve (also called a thermogram) provides valuable information on the thermal stability and composition of the material. It is important to remember that most of the information obtained from the TGA is empirical in nature—that implies it is dependent on instrument parameters such as heating rate and atmospheric conditions around the sample. A standard thermogram is shown in Figure 10. It can be seen that as the sample is heated in a nitrogen atmosphere, polymer and oil components volatilize simultaneously. After this step is completed, the atmosphere is switched to air and combustion of any other organic material occurs. In the case of black EPDM rubber compounds, this component is usually carbon black. At the end of the test, an ash remains which can be used for elemental analysis to determine if the membrane contained ingredients like zinc oxide, titanium dioxide, talc, clay, mica, etc. Comparison of scans of unaged and aged membrane gives us the ability to monitor how the materials composition is affected by long-term weathering. For instance, oil or plasticizer loss can be monitored and subsequently correlated to changes in physical properties.

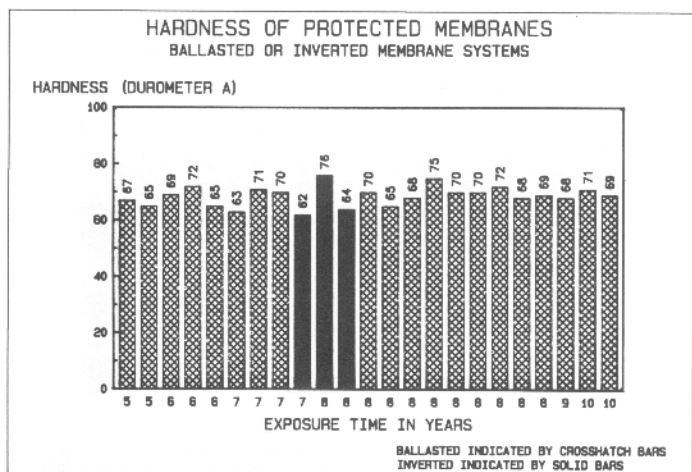
Figure 8 Hardness of protected membranes—ballasted or insulated membrane systems.

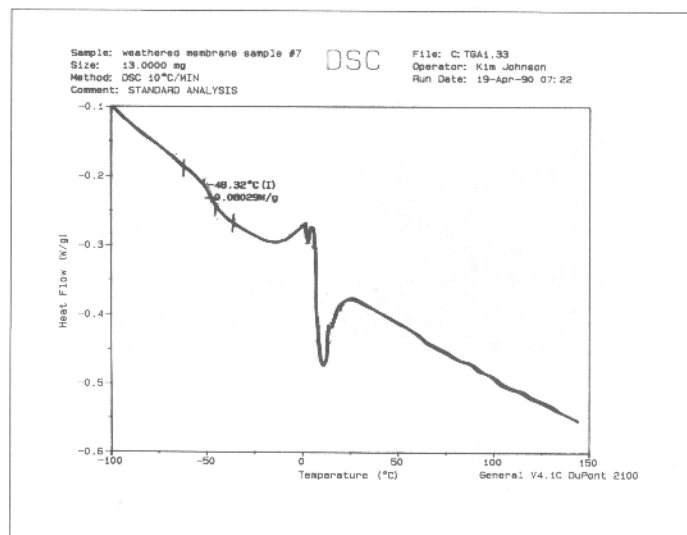
Figure 11 DSC—weathered membrane sample #7.

Differential scanning calorimetry (DSC) measures the heat energy emitted or absorbed by the sample as the temperature is increased at a controlled rate. For rubber, it is most useful for determining phase changes and the glass transition temperature. The glass transition temperature is the midpoint of the temperature range where the sample changes from a rubbery to a hard and relatively brittle material. Five samples were subjected to DSC analysis and the glass transition temperature was compared to the brittleness temperature as determined by ASTM Test Method D 746.<sup>4</sup> An example of a DSC analysis is shown in Figure 11.

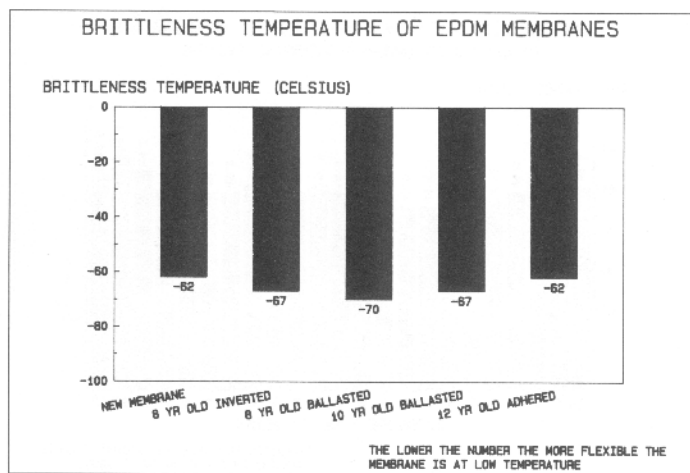
Figure 9 Brittleness temperature of EPDM membranes.

The brittleness temperatures ranged from  $-62^{\circ}\text{C}$  for unaged sheet to  $-70^{\circ}\text{C}$  for aged membrane (see Figure 9). The ASTM minimum requirement for new sheet is  $-45^{\circ}\text{C}$  and the MRCA performance requirement is  $-40^{\circ}\text{C}$ . All samples tested passed the low temperature requirements. The lower the brittleness point, the better the membrane is for low temperature flexibility.

The physical properties of the samples taken from the roofs show a general increase in tensile strength, tear resistance, and hardness, and a reduction in ultimate elongation as compared to typical original, unaged properties. This can be seen by comparing Figures 1 through 8 with the original sheet properties shown above. The brittleness temperature actually improves upon roof exposure even though the membrane hardness increases. This is shown in Figure 9.

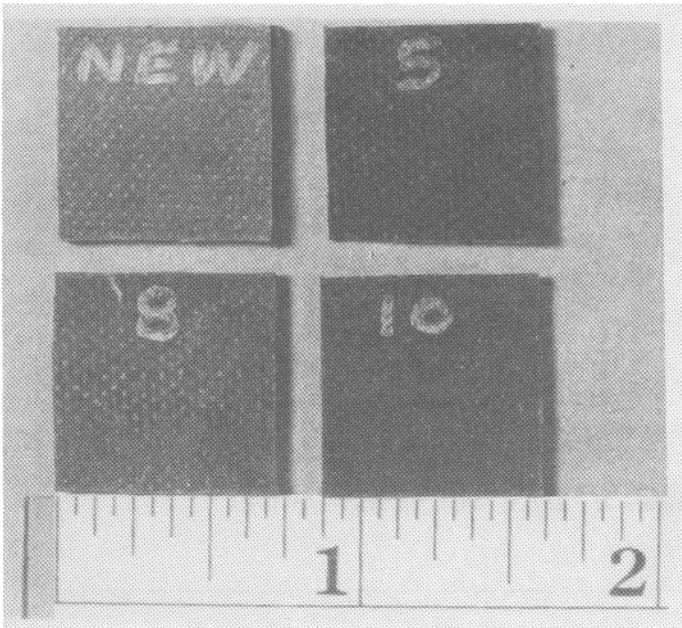
Figure 12 Surface appearance of protected EPDM membranes from five, eight and 10-year old roofs compared to new membrane.

Photographs were taken of new and aged membranes and enlarged to 2X. Figure 12 shows the surface appearance of protected EPDM membranes from five, eight and 10-year old roofs compared to new membrane. Figure 13 is a pho-

tograph of exposed membranes from five, nine and 17-year old roofs with a new sample for comparison. None of the membrane samples had any visual indication of weather degradation (no cracking or crazing) other than the usual very thin black layer of powder observed on most aged EPDM roofs.

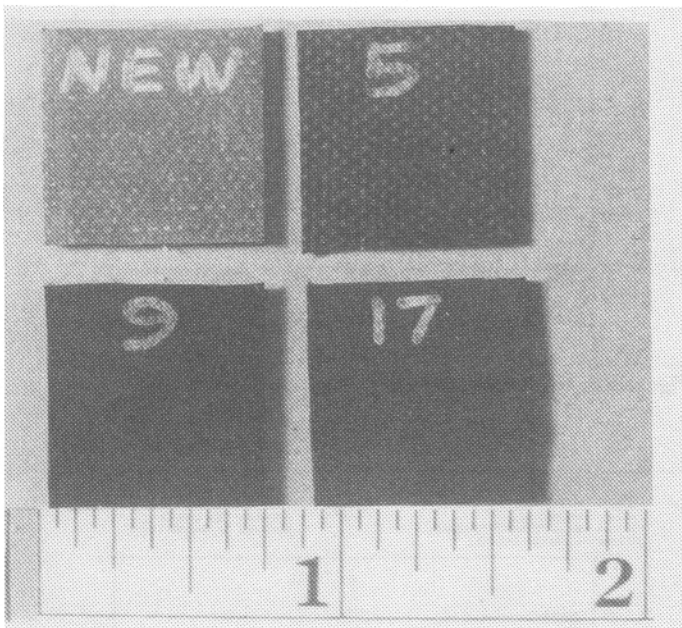
Figure 13 Surface appearance of exposed membranes from five, nine and 17-year old roofs compared to new membrane.

Surface appearance is of little value for determining the age of the membrane. Most of the protected membrane surfaces look like new sheet after the dust was removed. The exposed membranes all had a black film also called "black chalk" that is seen on practically all weathered EPDM surfaces. The amount of the black film did not increase as the membrane age increased. Perhaps the film is washed away so that it does not accumulate as the membrane gets older. Reduction in thickness may be a technique for determining exposed membrane age, but no data was available for this study because exact original, unaged thicknesses were not accessible.

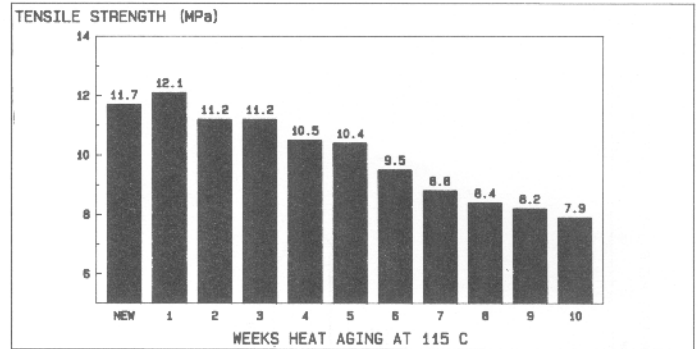
Figure 14 EPDM tensile strength after heat aging—10-week study.

The physical properties of EPDM membranes follow predictable trends during heat aging. The tensile strength increases after short-term aging (i.e., one week at 115°C), and then gradually decreases to about 8 MPa at 10 weeks of aging.

Figure 14 shows a typical response of tensile strength to aging at 115°C out to 10 weeks accumulated time. Ten weeks of heat aging at 115°C is approximately equivalent to 20 years of 65°C membrane temperatures for eight hours every day.

A question that is often asked and usually avoided is, "Just how long will the single-ply membrane last?" The heat aging data shown in Figures 14 and 15 can be used to predict the point at which tensile strength and elongation will drop below MRCA ME-20 requirements for aged membrane.

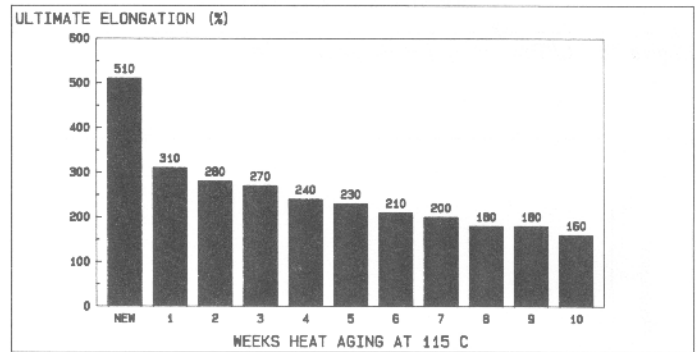
Figure 15 EPDM ultimate elongation after heat aging—10-week study.

Figure 15 shows the response of ultimate elongation to heat aging. The elongation has the highest rate of reduction during the first week of heat aging at 115°C and has a very gradual downward trend from one week through the 10th week of aging.

The ME-20 aged minimum values are 5.5 MPa for tensile strength and 200 percent for ultimate elongation. The data shows the elongation will drop below the 200 percent requirement after seven weeks aging at  $115^{\circ}\text{C}$ .

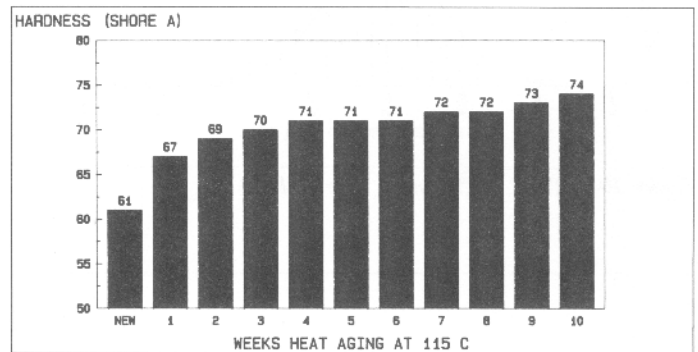
Figure 16 EPDM hardness after heat aging—10-week study.

Hardness, like elongation, has the most change due to heat aging during the first week. After the first week, the hardening process proceeds at a much slower rate. The hardness increase from heat aging is shown in Figure 16.

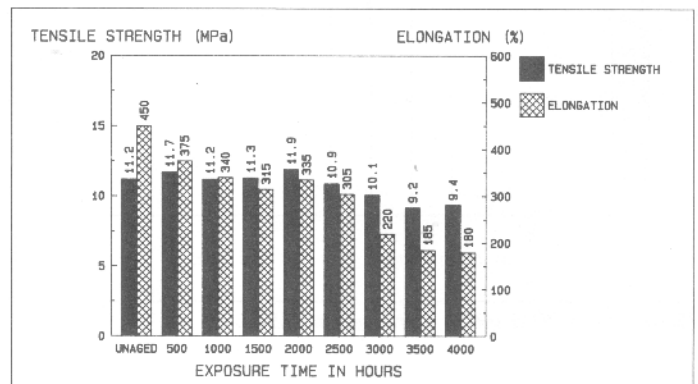
Figure 17 Properties of EPDM after xenon-arc exposure.

If the property values from Figures 1 through 8 are compared to what will occur at some point in time with heat aging (Figures 14, 15 and 16) and xenon-arc weathering (Figure 17), all membranes except the 17-year sample are still in the early years of their service life. The 17-year old sample has approached middle age, although the tensile strength is still at a high value. Figures 1 through 9 do not show any particular trend in the properties as the roof age increases, which is contrary to the expected reduction in tensile and elongation during laboratory accelerated weathering. Apparently, more roof aging will be required to begin to show the slow reduction in physical properties expected from the lab aging.

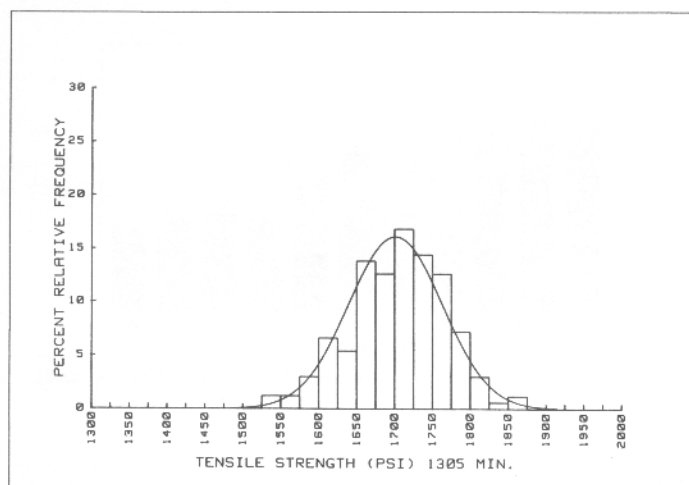
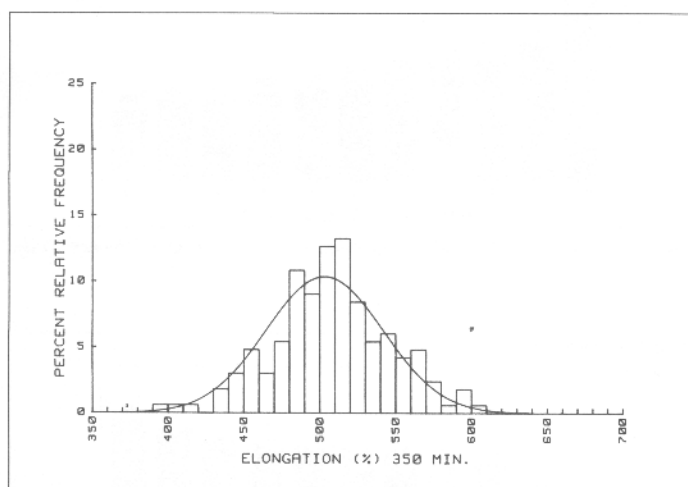
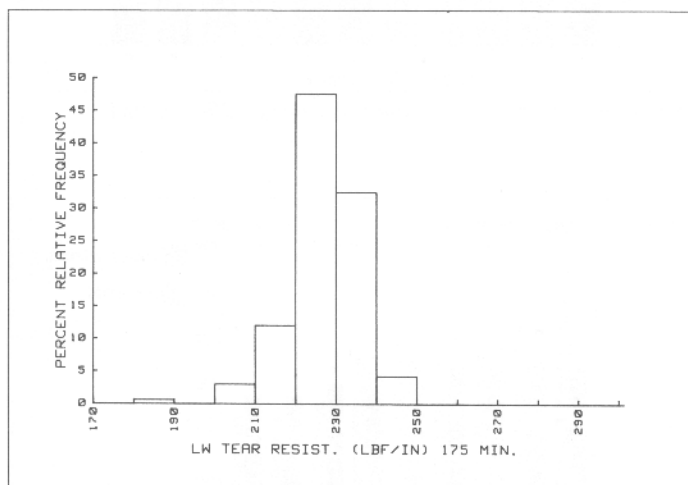
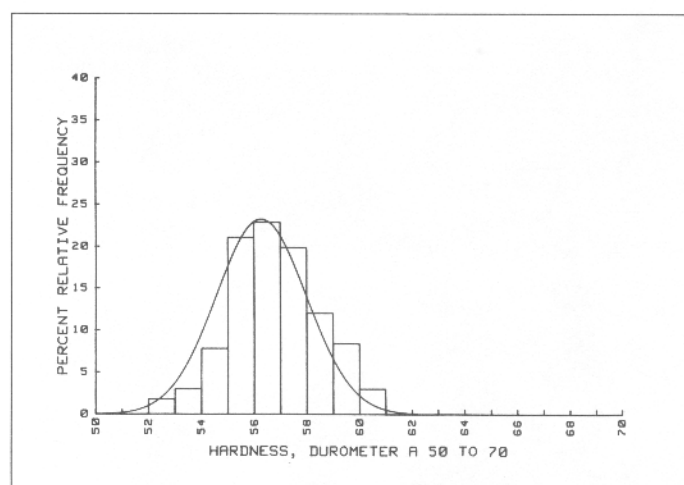
Figure 18 EPDM (465), fourth quarter 1983.

Figure 21 EPDM (465), fourth quarter 1983.

Figure 19 EPDM (465), fourth quarter 1983.

Figure 20 EPDM (465), fourth quarter 1983.

It is possible to note some general conclusions or trends that are evident from the exposure data by comparing the field aged samples with laboratory aged samples and original typical physical properties. Figures 18 through 21 show actual physical properties of new EPDM membrane produced during the fourth quarter of 1983. The 1983 data is used as typical data for the purpose of this discussion. The graphs (Figures 18 to 21) were produced in 1983 and are in non-SI units. The data, converted to SI units, is summarized below:

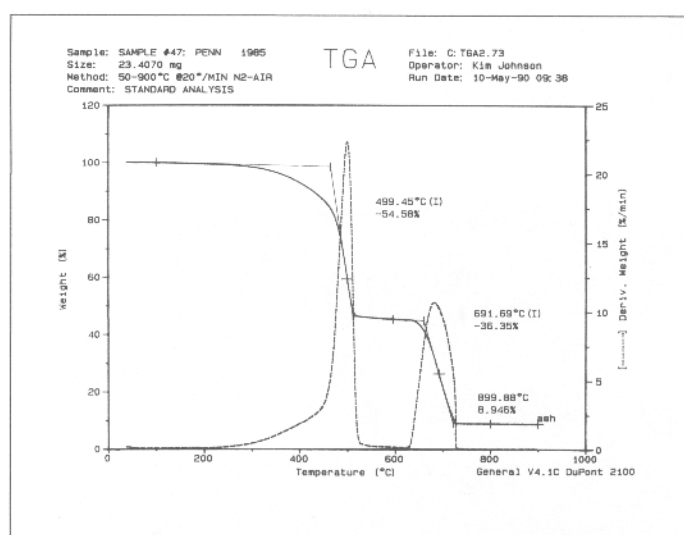
Figure 22 TGA—sample #47, Pennsylvania 1985.

Figure 22 is a TGA scan of a 5-year old roof in Pennsylvania and Figure 23 is a scan of a 10-year old roof in Illinois. The solid line curves practically match showing that there is no correlation between age and TGA scan. The use of TGA as a means to determine the age or to evaluate the performance of EPDM is even more limited if original formulations are unknown. Formulations are usually kept confidential by manufacturers, so TGA analysis performed on aged roof samples by non-manufacturers would be of limited value.

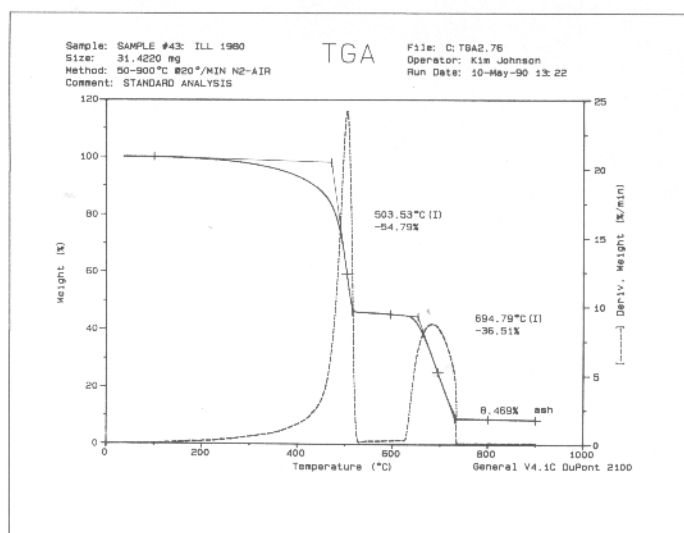
Figure 23 TGA—sample #43, Illinois 1980.
