# PROTECTED MEMBRANE FLASHINGS DESIGNED TO WORK

**DOUGLAS C. FISHBURN**

Fishburn Roofing Sciences Group Ltd.  
Toronto, Canada

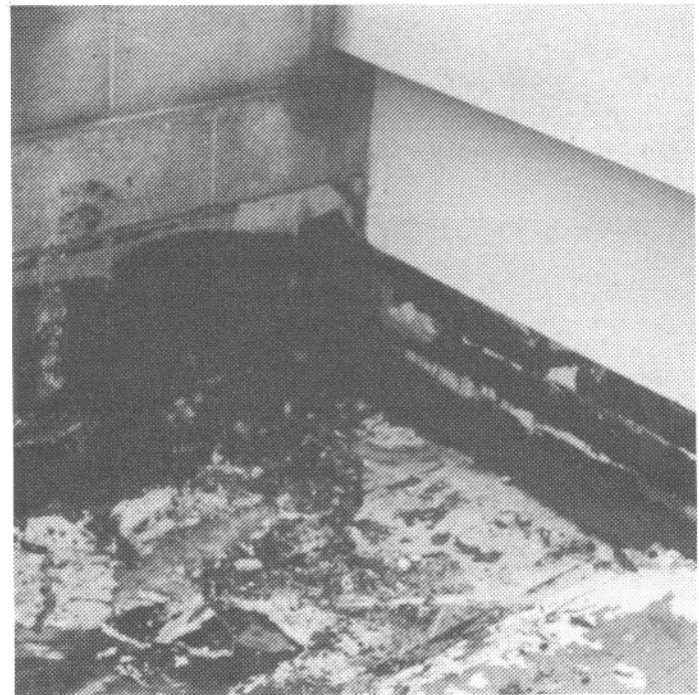
Figure 9 Moisture deterioration of an unprotected fiber cant.

Figure 9 shows moisture deterioration of an unprotected fiber cant on a protected membrane roof due to moisture ingress from below. Figure 10 shows deterioration of a wood blocking on an exterior wall on a protected membrane roof.

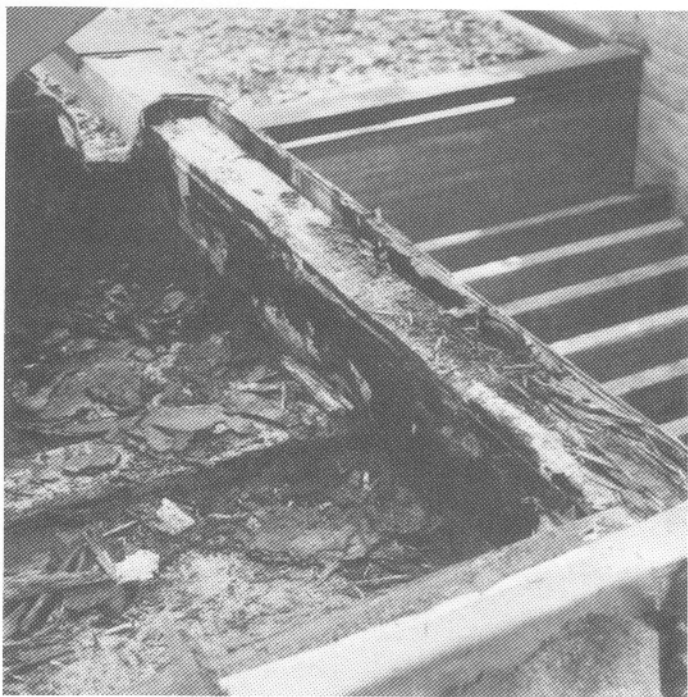
Figure 10 Deterioration of a wood blocking on an exterior wall.

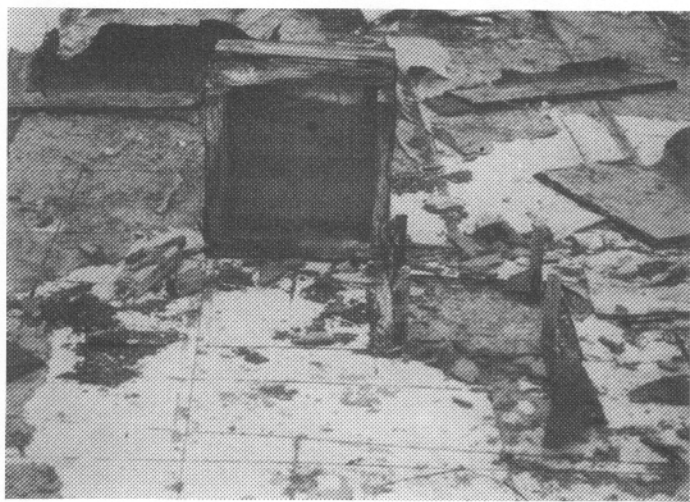
Figure 11 Wood curb built over a steel column.

Figure 11 shows the effect of air leakage and vapor diffusion. The image was taken during the removal of an existing protected membrane roof. Figure 11 shows a wood curb that was built over a steel column penetrating through a concrete deck that was to be used for a building addition. The curb was built directly on top of the concrete deck and the roof membrane carried up and over the curb.

The curb showed no signs of extensive leakage. There was no evidence of membrane failure or water migration from adjacent roof areas. It is concluded that the lack of an air or vapor retarder at the deck level allowed water vapor to become trapped inside the curb allowing dry rot to occur.
