# ELECTRIC HEATING SYSTEMS FOR COMBATING ICING PROBLEMS ON METAL ROOFS

**JAMES BUSKA, WAYNE TOBIASSON, and ALAN GREATOREX**

Cold Regions Research and Engineering Laboratory (CRREL)  
Hanover, New Hampshire

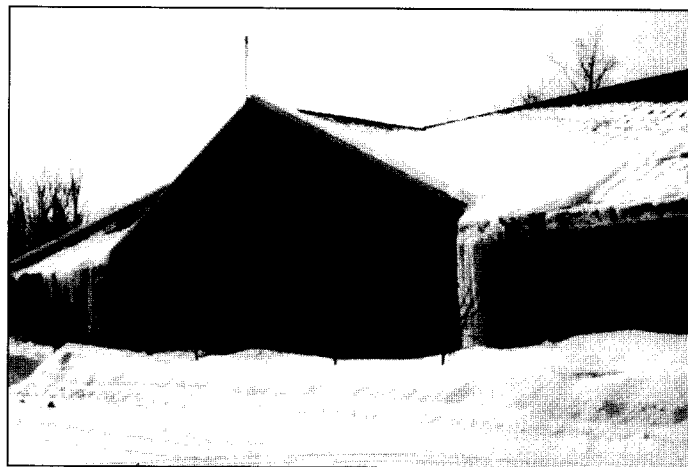
Figure 2. Large ice dams and icicles form where the gable parapet ends at the bottom of valleys.

stricted a valley at each end (Figure 2). An electric heater was installed in the left valley on each building and the adjacent unheated right valley was used as a control. The structural standing seam metal roof on these buildings had flat-topped standing seams. The 20-mm- (0.8-in-) wide, 51-mm- (2-in.-) high seams were spaced 0.5 m (20 in.) apart. Power consumption and air and roof surface temperatures were recorded using dataloggers. Periodic photos were obtained by the authors and Public Works personnel.

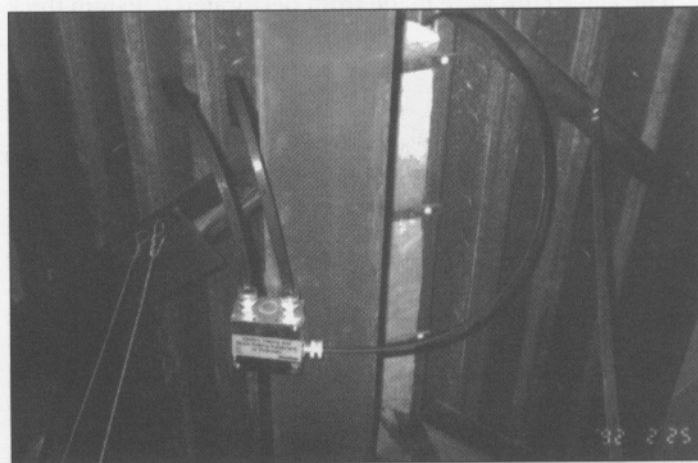
**Figure 5.** System with high output heater installed below the metal roof in a valley.

runs of high output heater were placed in the flutes of the metal decking supporting that valley (left side of Figure 5). On the other side of that valley, a loop of high output heater was run down and back up under the insulation shown strapped to the bottom of the metal decking. These heaters ran about 7.6 m (25 ft) up the valley. The area behind the parapet and the fascia and eaves were heated with medium output heater adhesively attached to the outer surface of the metal roofing. All six systems had a run of heater along the drip edge similar to the one shown in Figure 6 and vertical runs of heater on the fascia with drip loops provided at their lower end.

Electric heaters placed under the metal roofing of one valley (Figure 5) kept a wide, clear melt path down the valley.

However, the 1649 watts provided in that valley (Table 1) was too much and it melted more snow than was necessary. That extra meltwater refroze on cold portions of the fascia and created a large dangerous icicle (Figure 9a) even when no icings were forming on the control valley. The authors concluded that there was too much heat provided in all valleys. Meltwater was produced by the heaters even when it was too cold outside for the warm roofs of these buildings to be producing meltwater. The low output heater used on one roof provided enough heat to create a melt path through the ice dam and to avoid ponding there.

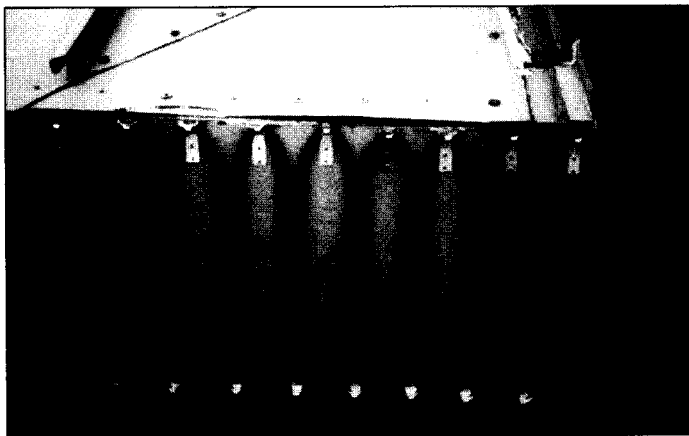
Figure 12. Heater looped over butterfly clips mechanically attached to fascia.

Heater runs on the fascias of three buildings were looped over butterfly clips mechanically attached to the metal fascia (Figure 12) and then covered with a false fascia either closed at the top as shown in Figure 13 (Buildings 10150 NW and 10210) or open at the top like a chimney (Building 10230). Installation of heaters and false fascias was much easier than placing heaters behind existing fascias. False fascias also allow for easier access if repairs were necessary. Heated water diverters were used on all roofs to direct meltwater flow over the heated fascia and drip edge. A diverter is shown at each end of the false fascia in Figure 13. Diverters were able to prevent icings just beyond heated portions of fascias.
