RE-COVERS: REROOFING BY SUPERIMPOSING NEW ROOF SYSTEMS OVER EXISTING—A DISSENTING OPINION

LADISLAV JERGA

WeatherTech Consultants, Inc.
Troy, Michigan

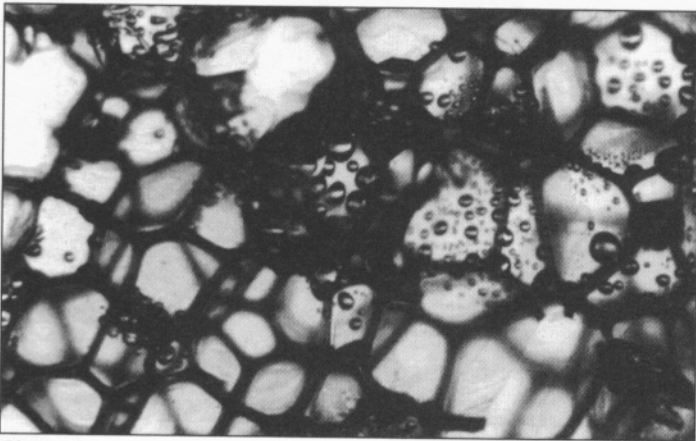
Photo 13.

Most insulations are either destabilized by moisture or they are chemically activated. Moisture infusion across the cell walls of cellular foams (Photo 13) causes deformation of the boards and, regardless of the level of mechanical attachment, renders the insulation layer in overlays unsuitable as a substrate (Photos 14, 15, 16 and 17). Vertical deformations of insulation boards render the overlay roof completely unserviceable. The more commonly encountered horizontal deformation (picture framing) exposes the overlay membrane to a grid of incremental cyclical fatigue, eventually fatigue-cracking the overlay membrane (Photo 18).

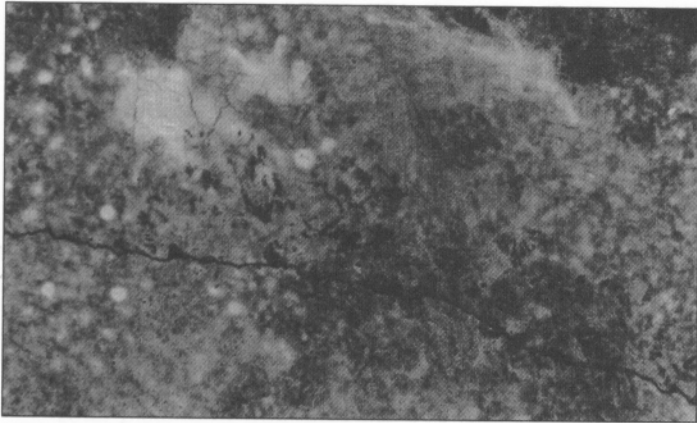
Photo 22.

creates an extremely chemically aggressive medium. Fungus and mold growth on the underside of insulation panels of the overlays in the presence of slag is common (Photo 22). (The fact that the surfaces of slag-surfaced roofs are acidic is confirmed by occasional biogrowth in absence of extensive ponding; plants prefer acidic environments [Photo 23]).

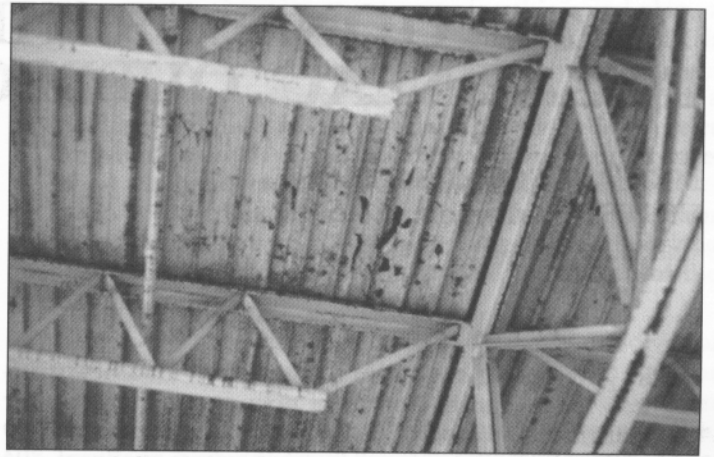
Photo 24.

Chronic ghost leaks common with overlays when the top membrane allows moisture intrusion tend to accelerate the deterioration of the metal decks by allowing the intruding water to become hydrogen-rich¹⁰ as it migrates across the surface of the original roof membrane to the old leak locations. This frequently occurs in corners and along the perimeter walls, where the anchoring of mechanical fasteners is critical and where it becomes most likely to be compromised by corrosion-weakened decks with reduced fastener-holding capacity (Photos 24 and 25).
