ASBESTOS IS OUT, BUT WHAT ABOUT SUBSTITUTES?

A review of problems with some roof shingle replacements

AUTHORS Stephen J. Condren, P.E., and
Werner H. Gumpertz, P.E.

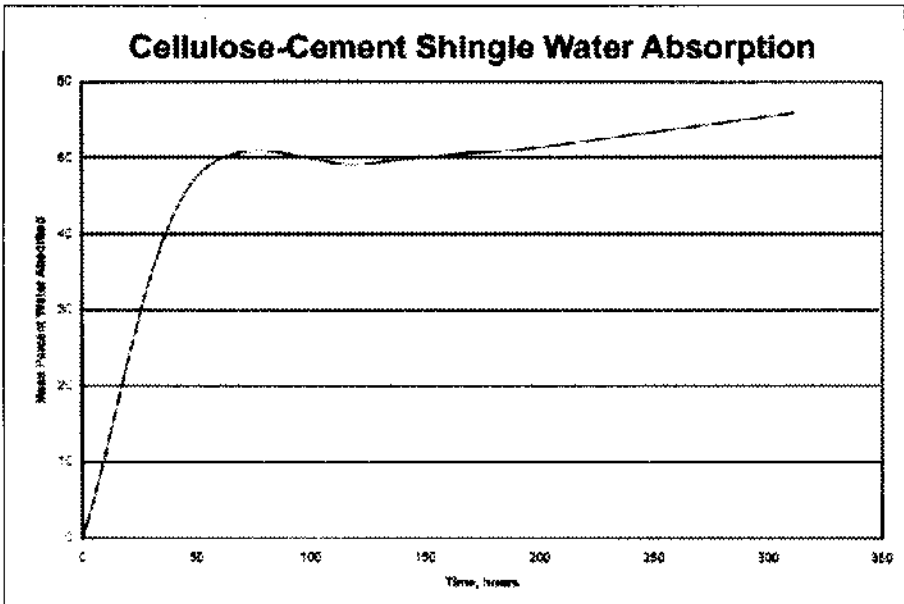
Figure 1

The common denominator for the failures of all of these products is the very high water absorption they exhibit (Figure 1). One product absorbs almost half its dry mass in water after a three-day water soak. Wood fibers can absorb 25% water depending on the species selected. The wood fibers swell as the moisture content increases and contract as they dry out.
