Waterproofing Details – Design Under Constrained Conditions

Samuel Vesely, B.Sc.

Key Words: Waterproofing details, constrained conditions, expansion joints

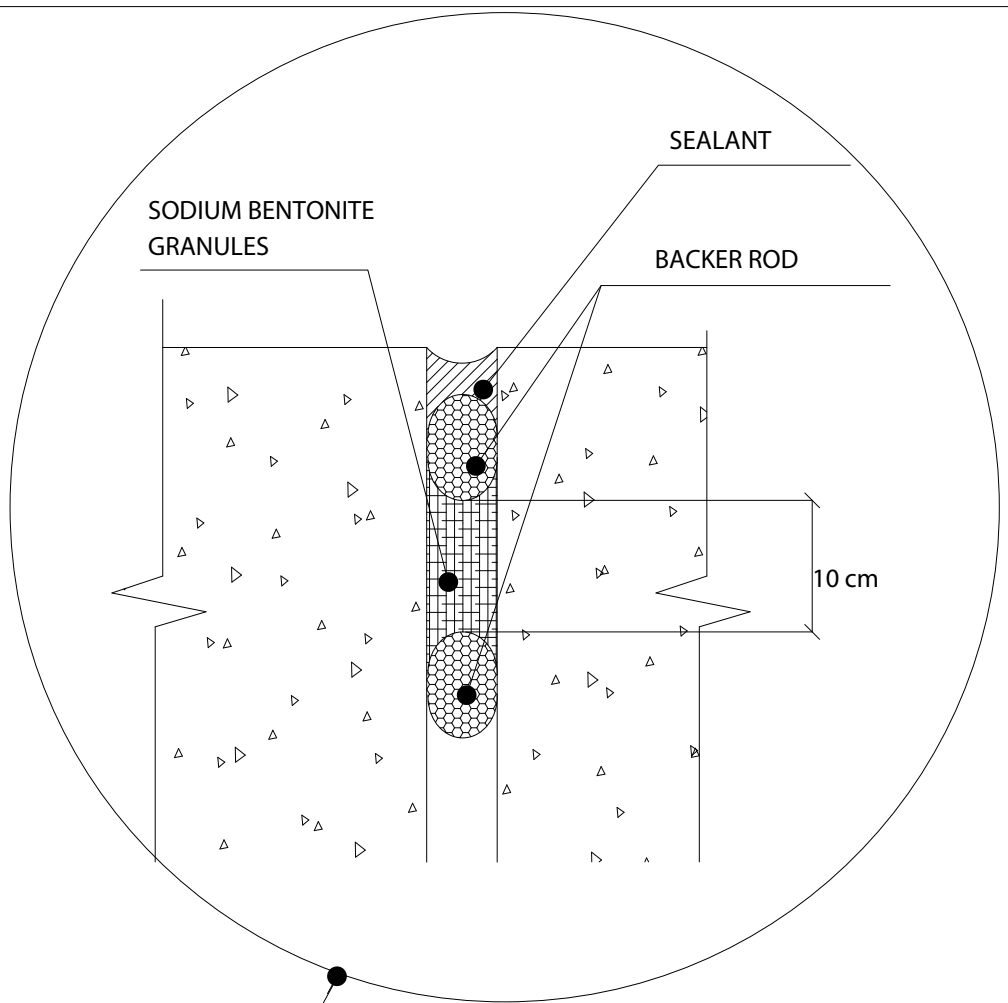
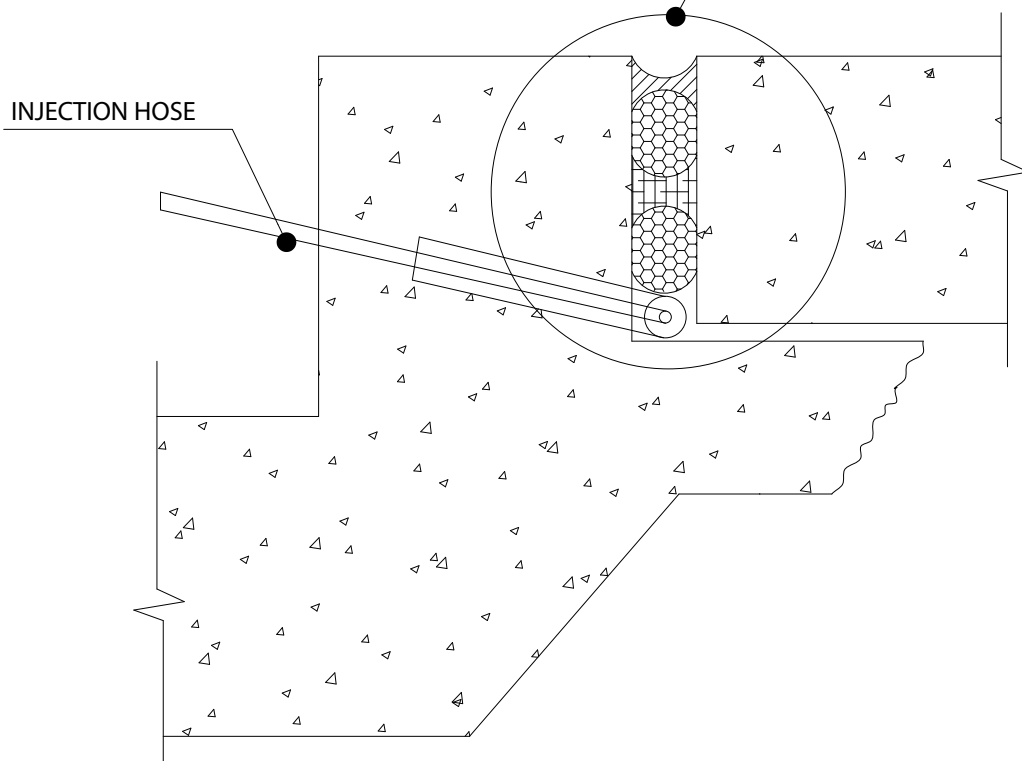
LCT - 108

EXPANSION JOINT SUBMERGED IN WATER

- 3.4 The Israeli National Geophysical Institute has sites throughout the country. The sites are instrumented to monitor earthquakes. The instruments are positioned on a concrete "table" cast directly on the subgrade rock. The below - ground structure is built around this concrete "table". An expansion joint separates the concrete table and the building. See figure LCT-109. SBS modified bituminous membranes were used to waterproof the underground envelope of the structure. The problem was how to terminate the waterproofing membrane along the expansion joint around the concrete table. A special terminating and anchoring accessory, was used for that purpose. This anchoring accessory is a strip similar to a flat-sided PVC waterstop, but it is made of a special blend of modified polymeric material that is compatible with and torchable to the waterproofing membranes. A preformed polymeric adhesive strip, Ram-Nek, was used as a secondary waterproofing of the joint between the anchoring accessory and membrane.
