Aging and Hail Research of PVC Membranes

Frank J. Foley, Jim D. Koontz and Joseph K. Valaitis

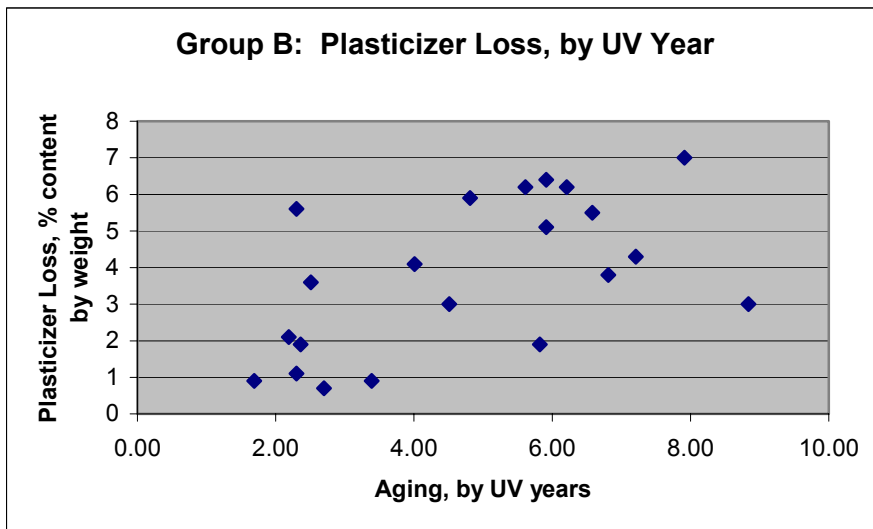
Graph 1: Group B plasticizer loss by UV year

A glance of the graphs provides two quick observations. The cluster of data for group D is much tighter than group B.   This visual observation is consistent with Pearson Correlation Analysis in *Table 8*. Furthermore, plasticizer loss in the samples in group D does not actually begin until the sixth year. At least at the outset, group D plasticizer ingredients appear to be vastly more stable in the membrane to those in group B. The visual comparison of the scatter patterns of the two graphs also reveal that group D

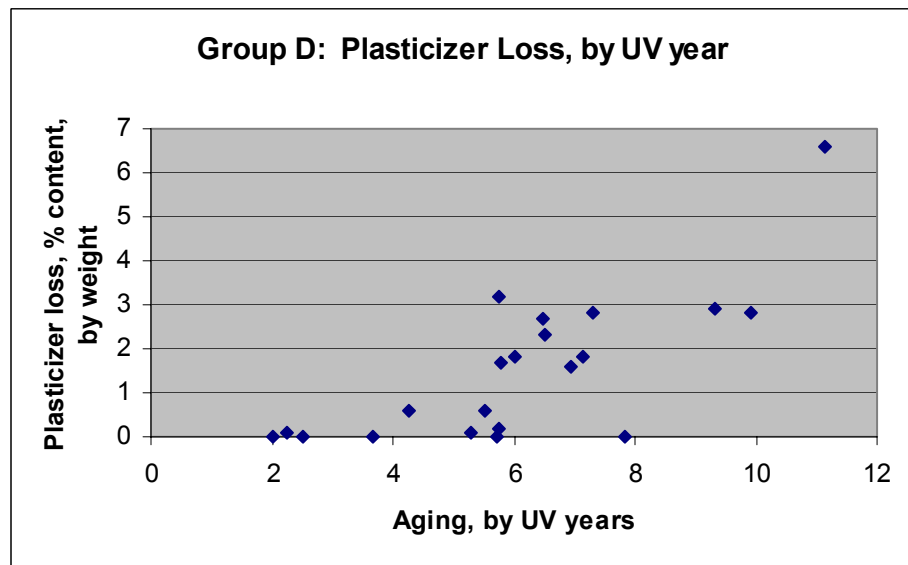
Graph 2: Group D plasticizer loss by UV year

new sample. Another example is found in Sample 1 on *Table 12*. The significant level of plasticizer loss for this sample (19.24 %) was not characteristic for this group. This data point is also the lone, high data point on *Graph 2*.
