FIELD PERFORMANCE RESEARCH OF APP MODIFIED BITUMEN ROOF MEMBRANES AND COATINGS

JAMES D. CARLSON and THOMAS L. SMITH

National Roofing Contractors Association
Rosemont, Ill.

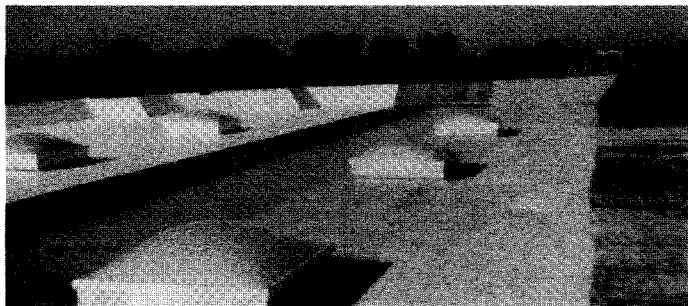
APP modified bitumen roofing has been used throughout the majority of the different climatic regions of the U.S. In some regions, this material has been used for more than a decade. The majority of these roofs have been left uncoated. Many roofs have exhibited limited signs of weathering (see Figure 1). However, numerous roofs have exhibited premature degradation (e.g., surface cracking) (see Figure 2).^{1,2}

Figure 2 Surface cracking on six-year-old APP modified bitumen membrane near Chicago. A lumber keel shows the scale.
