STEEL DECK CORROSION ASSOCIATED WITH PHENOLIC ROOF INSULATION: PROBLEM CAUSES, PREVENTION, DAMAGE ASSESSMENT AND CORRECTIVE ACTION

THOMAS L. SMITH and JAMES D. CARLSON

National Roofing Contractors Association
Rosemont, Ill.

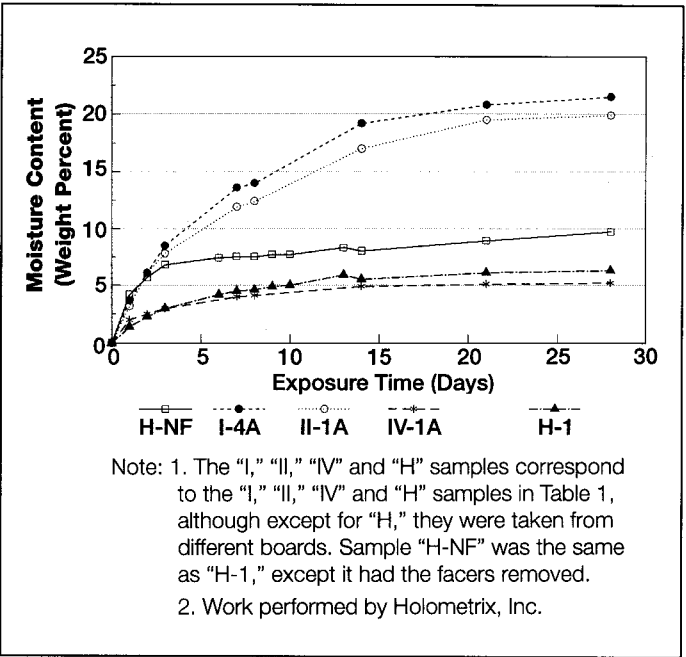
Figure 14 Moisture gain of roof insulation samples.

The results of this study are shown in Figure 14. The domestic phenolics "I-4A" and "II-1A" (with and without a corrosion inhibiting facer) essentially had the same moisture gain curve. After 28 days, they had a moisture content of approximately 20 percent (by weight). The moisture content of the polyisocyanurate sample ("IV-1A") was approximately 5 percent. The moisture content of the Canadian phenolic was approximately 6 percent with facers and 10 percent without facers.
