A STUDY OF SOME STRUCTURAL INTERRELATIONSHIPS BETWEEN POLYURETHANE FOAM AND PROTECTIVE COATINGS

ADRIAN L. JENKINS

Gaco Western, Inc.
Seattle, Wash.

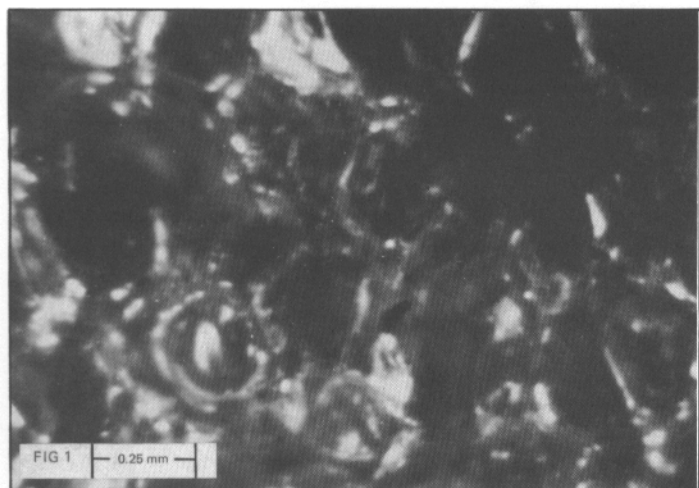
Two problems limit the usefulness of the cut foam and coating technique. First, no matter how sharp and thin the knife or razor blade, some distortion of the foam and coating occurs during the cutting. Second, polyurethane foam is translucent and efforts to view or photograph the magnified structure are partially obscured by the internal scattering and reflection of light (*Figure 1*).

Figure 1 Three-pound foam cut with a razor blade and photographed in reflected light

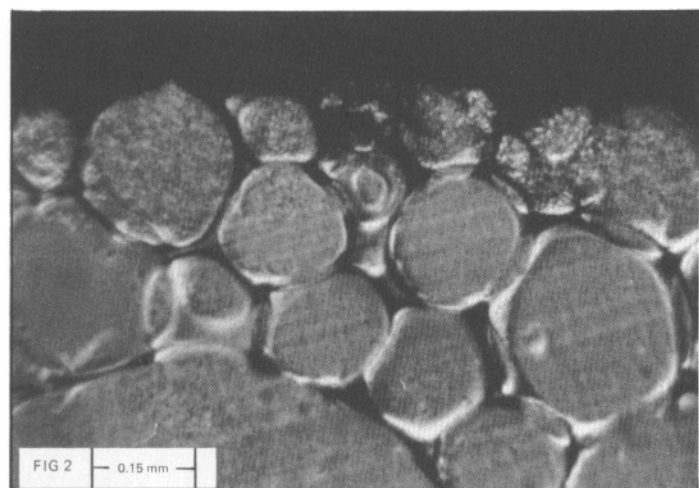
The method chosen for this study was to view and photograph very thin sections of both the foam and the coating under a microscope utilizing transmitted light. This method corrects the two problems mentioned above (*Figure 2*).

Figure 2 Thin section of three-pound foam photographed in polarized light
