# A STUDY OF THE BEHAVIOR OF LOOSE-LAID, BALLASTED SINGLE-PLY ROOFING SYSTEMS SUBJECTED TO VIOLENT WINDS

KENNETH G. SCHNEIDER, JR.

Schneider & Associates  
Nashville, Tenn.

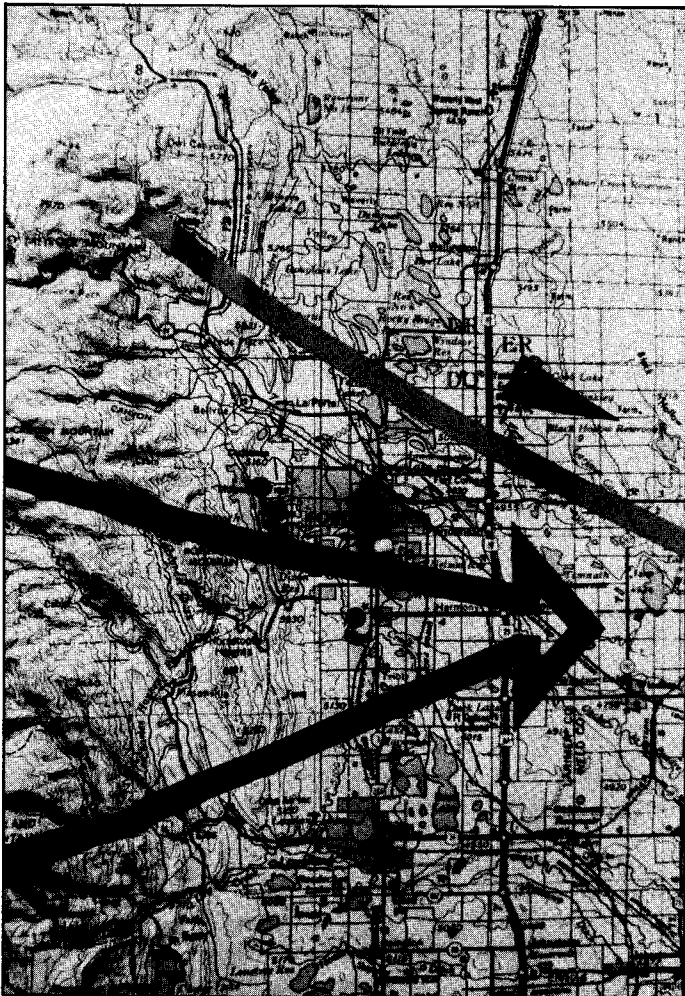
**Group A Map—Ft. Collins, CO**

Color-coded pins show locations of reported roof damage. Mean elevation in Ft. Collins is 5100'. Pin at upper left is Class I rupture; lowest pin is minor Class II; flag is U.S. Weather Station, Yankee Field.

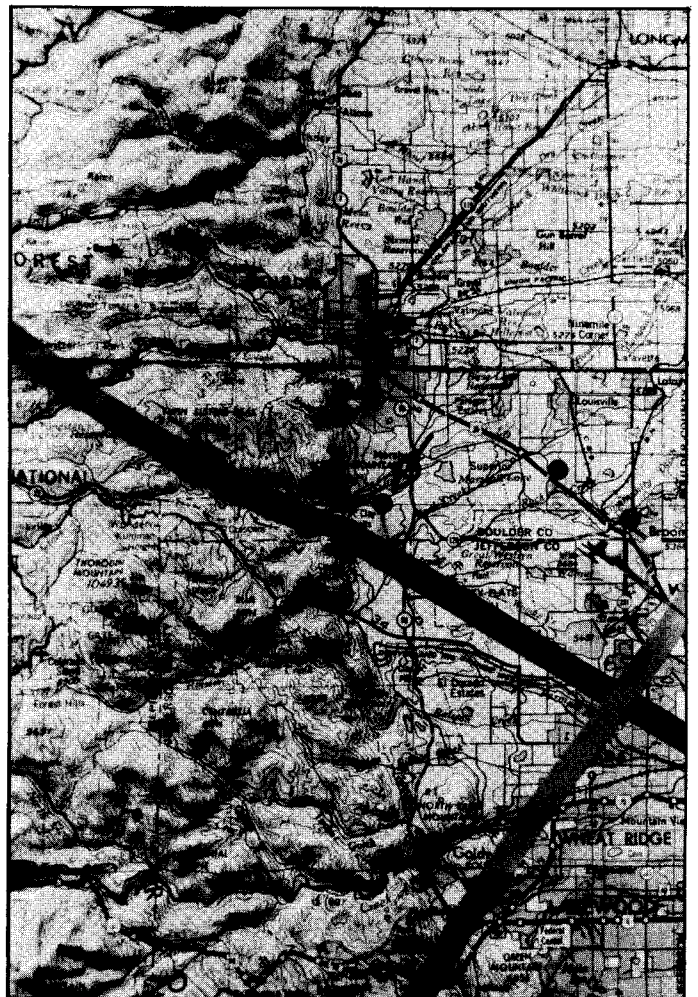
**Group B Map—Boulder, CO**

Lowest pin in center (arrow) is USDOE, strategically located in venturi between two peaks

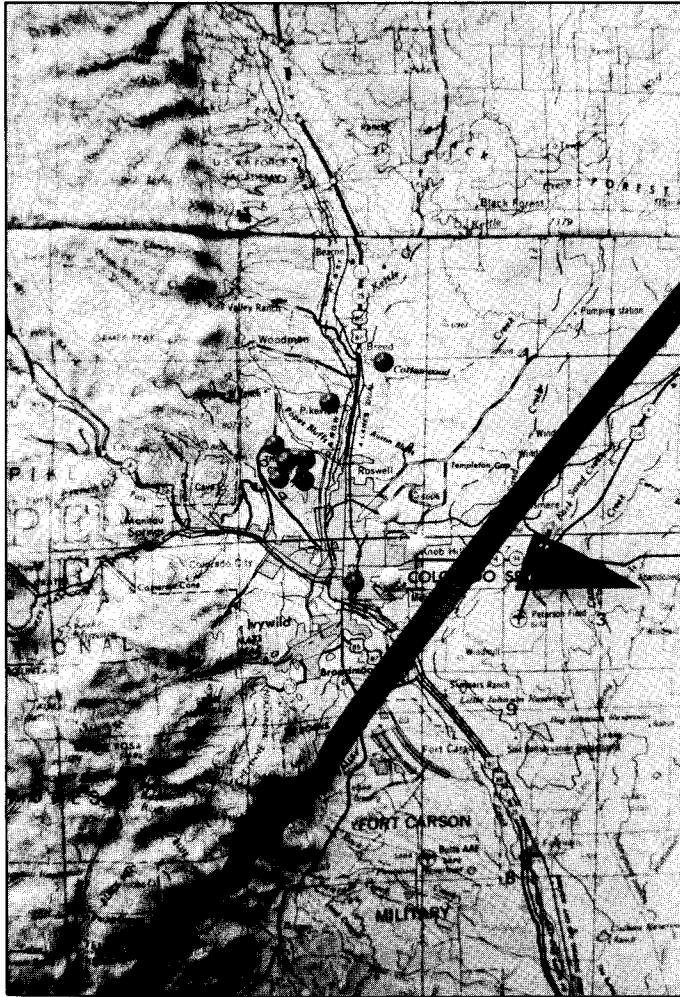
**Group C Map—Colorado Springs, CO**

Here, popular wood-shingled residential roofs receive customary annual repair due to “normal” wind damage

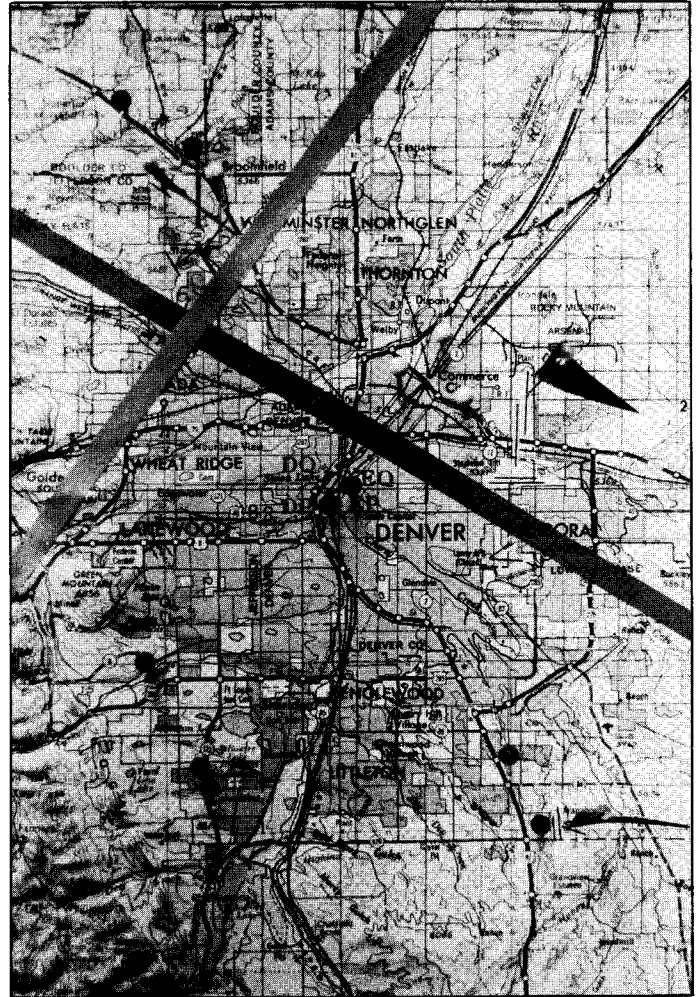
**Group D Map—Denver, CO**

Even though tall buildings present good targets for “Chinooks”, use of high parapets and proximity of other buildings provide “spoilers” for keeping ballast in place
