AN INVESTIGATION OF THE ROLE OF DIFFERENTIAL STRUCTURAL MOTION AS THE CAUSE OF FLASHING PROBLEMS

JAMES R. WELLS and JEFFREY A. TILTON

Owens-Corning Fiberglas
Granville, Ohio

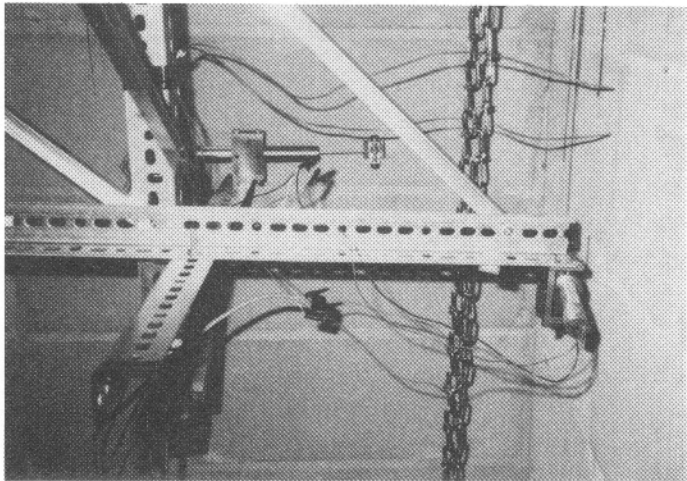
The motion sensors were mounted to detect and record any relative motion between the steel roof deck and the building's outside walls. Two linear variable differential transformers (LVDTs) with a range of ± 2 inches and guaranteed linearity were used. The bodies of both sensors were attached to a rigid support structure which was attached to the underside of the steel deck near the northwest corner of the building, which was the location of the most severe flashing wrinkling. The core of one LVDT was attached to a support which was cemented to the inner surface of the west (front) wall approximately 18 inches below the deck and 12 inches from the north wall. This sensor measures the relative motion between the roof deck and the west wall in the north/south direction. The core of the second LVDT was mounted on the north wall approximately 18 inches below the deck and 12 inches from the west wall. The second sensor measures relative motion between the roof deck and the north wall in the east/west direction. The sign of the displacement transducer data reported in this paper was chosen so that a positive change in the transducer output indicates motion of the steel deck toward the wall and a negative change in the output indicates deck motion away from the wall in each case. The LVDTs and the mounting supports are shown in Figures 5 and 6.

Figure 5 LVDTs and mounting supports.
