IMPROVING WIND PERFORMANCE OF ASPHALT SHINGLES: LESSONS FROM HURRICANE ANDREW

THOMAS L. SMITH

National Roofing Contractors Association
Rosemont, Ill.

Hurricane Andrew caused very extensive roof covering damage in south Florida. This paper describes asphalt shingle roof covering damage, wind loading, failure modes, life safety and property damage, workmanship, perimeter metal flashings, deck influences, testing, code requirements, and design guides. Finally, it provides conclusions and recommendations for enhanced performance in hurricane-prone and other high-wind regions.

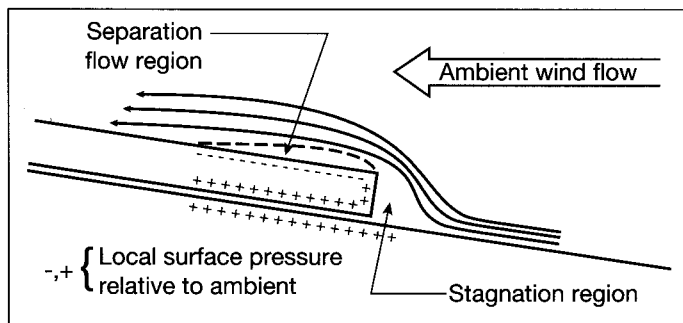
Figure 1. Local flow over a shingle (adapted from Reference 7).

Peterka reported that positive pressure on the underside of asphalt shingles can vent very rapidly, thereby minimizing the uplift load on the shingles.⁷ He described the wind flow mechanism that produces the uplift loads on shingles, as shown schematically in Figure 1: "Local flow separation over the top of the shingle causes negative, or uplift, pressures on the top of the shingle. At the same time, a stagnation region forms on the front edge of the shingle, which causes positive pressures (acting toward the shingle surface) in that region. This positive pressure acting toward the shingle surface from below adds to the uplift force on the shingle."
