# LABORATORY TESTING FOR LOW-SLOPE STANDING SEAM METAL ROOF APPLICATION

LARRY R. MEYERS, RICHARD S. KOZIOL, DENNIS K. JOHNSON, and NORBERT V. KROGSTAD

Wiss, Janney, Elstner Associates, Inc.  
Chicago, Illinois

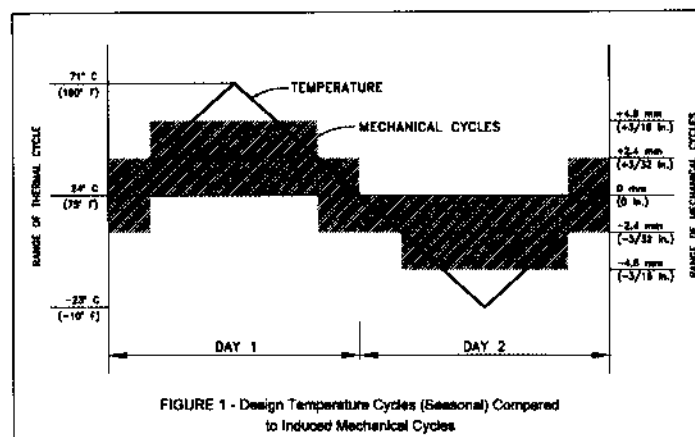
Figure 1.

FIGURE 1 - Design Temperature Cycles (Seasonal) Compared to Induced Mechanical Cycles

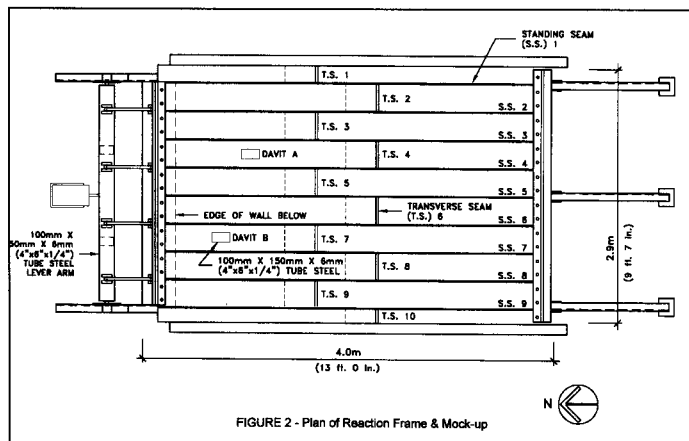
Figure 2.

102-mm- (4-in.-) wide strips of plywood at 305 mm (12 in.) on center to allow for visual observation of the underside of the roof system. The window washing davits were constructed of steel tubes bolted to wood blocking between the roof joists. The side walls of the test chamber were constructed of wood studs and plywood (refer to Figure 2).

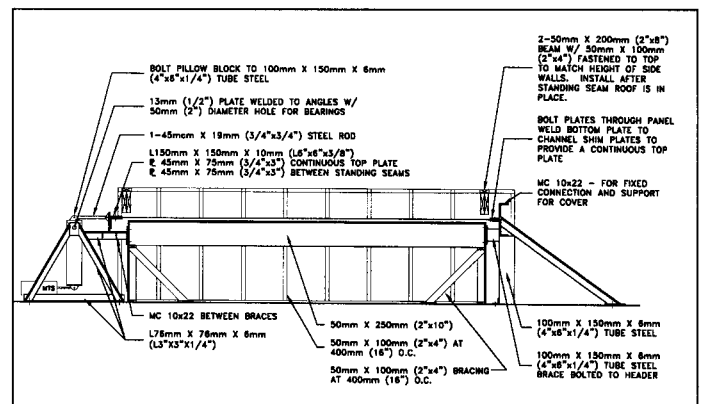
Figure 3.

A steel reaction frame was designed to resist the load required to mechanically cycle the metal panels and induce differential movement at the transverse seams. The load was generated from an MTS dynamic machine, a servo-controlled hydraulic actuator capable of delivering either tension or compression with a maximum throw of 102 mm (4 in.) and adjusted to electronically monitor and control deflection. The load is applied to one side of the roof system via a lever arm that is connected to the MTS machine and a steel tube with four rectangular rods that are attached to a continuous plate secured to the underside of the roof panels. Small plates were placed on the top surface of the roof panels and secured to the continuous plate with two bolts through each standing seam panel. The bolts were tightened to create a friction connection allowing zero slippage of the standing seam roof at the connection. Three triangular steel trusses were constructed at the opposite end of the roof system to form the fixed connection of the reaction frame. The opposing end of the standing seam roof was attached to the trusses with a continuous plate in a similar manner. The entire test chamber and steel reaction frame were bolted into the concrete floor (refer to Figure 3).

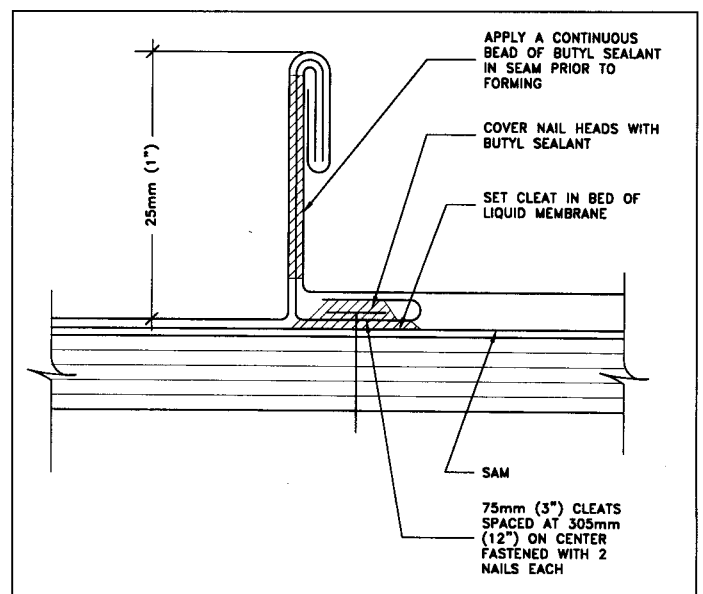
Figure 4

4. TCS panels 305 mm (12 in.) wide were laid over the rosin paper. The panels were held down with cleats at 305 mm (12 in.) on center. Each cleat was set on the SAM in a bed of liquid membrane (trowel grade modified asphalt compatible with SAM and nailed to the deck with two nails. The nail holes were covered with butyl sealant and the bottom leg of the cleat folded over the sealed nail heads (refer to Figure 4).

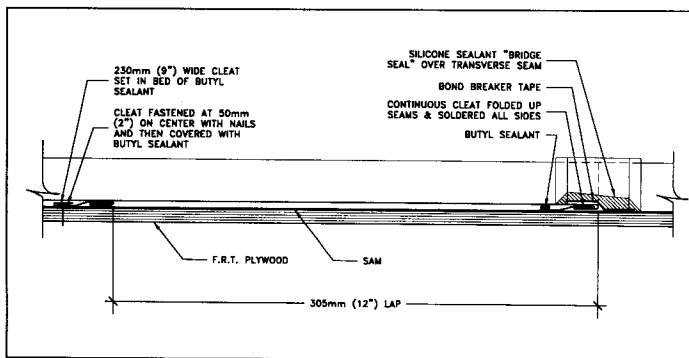
Figure 5.

10. The exposed transverse seams were sealed using a 19-mm ( $\frac{3}{4}$  in.) bond breaker tape over the seam joints and applying a 6-mm x 50-mm ( $\frac{1}{4}$  in. x 2 in.) bead of silicone sealant over the bond breaker tape (refer to Figure 5).
