INFLUENCE OF NAIL LOCATIONS ON WIND RESISTANCE OF UNSEALED ASPHALT SHINGLES

THOMAS L. SMITH, AIA, RRC

MATT MILLEN

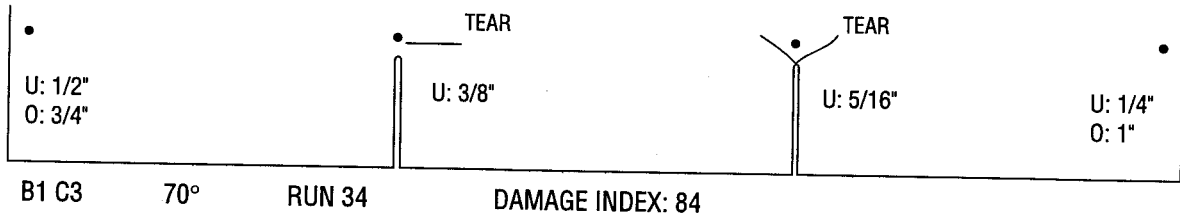
B1 G4 35° RUN 93 DAMAGE INDEX: 86

Although the greatest distance from the specified location occurred with end fasteners, tears only occurred at four end fasteners (decks B1A3, B1G3, B1G4 [tab blew off] and B2C7). A severe crack also occurred at one end fastener (B1A1). Hence, while only 5 percent of the shingles had damage at their ends, 68 percent of the end nails were greater than ¼ inch (3.2 mm) from their specified location.⁵
