INFLUENCE OF NAIL LOCATIONS ON WIND RESISTANCE OF UNSEALED ASPHALT SHINGLES

THOMAS L. SMITH, AIA, RRC

MATT MILLEN

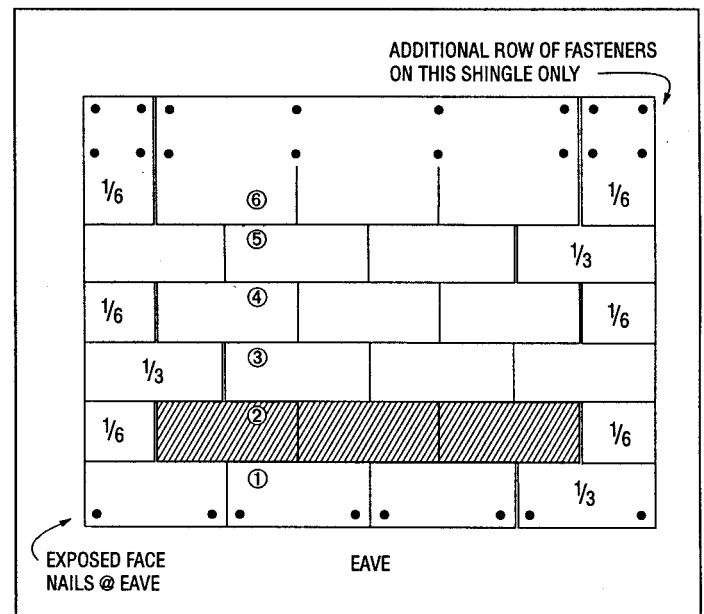
Figure 1. Test deck layout. Note: Fastener data analysis of this paper was limited to row 2 (shaded area).

Most of the decks that experienced damage had damage in rows two and six (see Figure 1).⁴ Little or no damage typically occurred in rows 3, 4 and 5 (row 2 typically lifted and shielded rows 3 and 5). The top row (row six, or row five in the case of the metric shingles), was an atypical condition because the top row was not restrained by overlying shingles. Therefore, this evaluation is based only on nail locations in the full shingle on row two (Figure 1). This resulted in an evaluation of 198 nail locations.

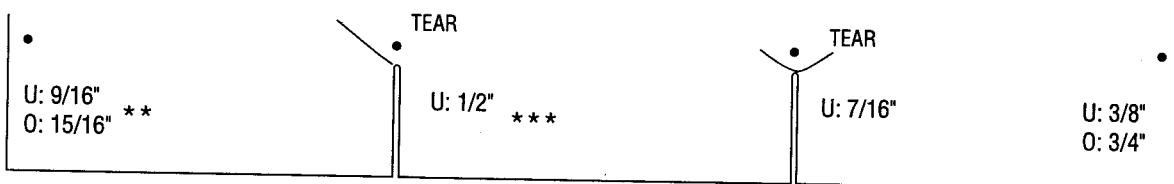
B1 C3 70° RUN 34 DAMAGE INDEX: 84

Although the greatest distance from the specified location occurred with end fasteners, tears only occurred at four end fasteners (decks B1A3, B1C3, B1C4 [tab blew off] and B2C7). A severe crack also occurred at one end fastener (B1A1). Hence, while only 5 percent of the shingles had damage at their ends, 68 percent of the end nails were greater than ¾ inch (3.2 mm) from their specified location.⁵
