Lesson Learned from Hurricane Wind Investigations of Low-slope Roof Assemblies—A Researcher Prospective

A. Baskaran¹ and D. Roodvoets²

National Research Council Canada Ottawa, Ontario, Canada

**Roofing Industry Committee on Weather Issues,
Montague, Mich., U.S.,**

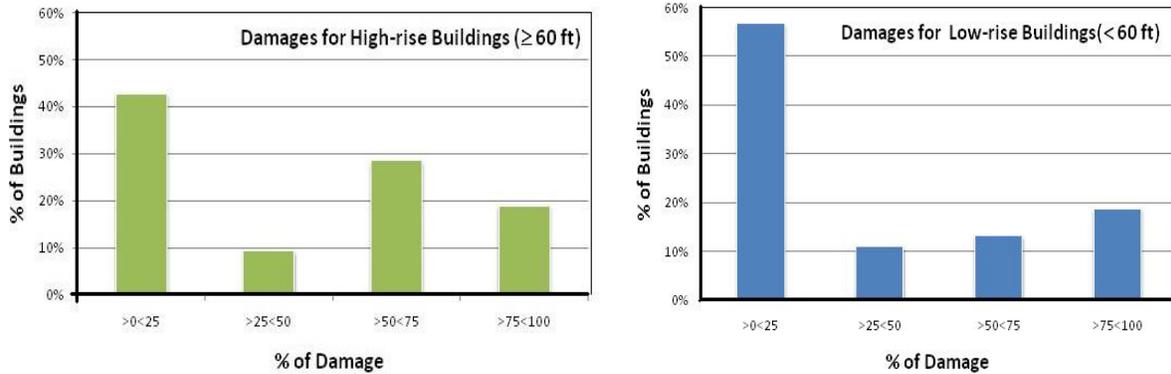
Figure 3. Damage Severity Classification from the RICOWI Database

As shown in Figure 2, a majority of the investigated roofs also had membranes as the waterproofing component; about 17 percent had metal roofs and of the others, 11 percent of the majority were spray polyurethane foam roofs. Figure 3 groups the intensity of the damage into four categories for low-rise and high-rise buildings. A majority of buildings had damage less than 25 percent of the roof area. Total failure, damage greater than 75 percent of the roof area, was observed on about 20 percent of low- and high-rise buildings inspected.
