PRACTICAL EXPERIENCES IN DESIGN, APPLICATION AND FIELD PERFORMANCE

EDWARD P. LITOW

Case Study: Mayfield Recreation Complex, Town of Caledon, Ontario, Canada

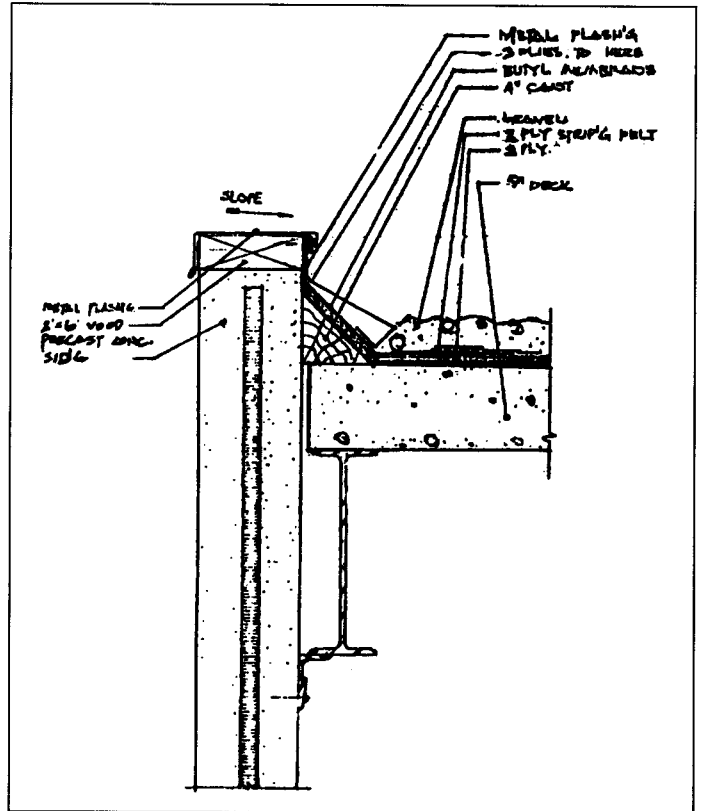
Simplicity in construction was achieved with the choice of a load bearing, insulated, precast concrete, tilt-up sandwich panel wall system.

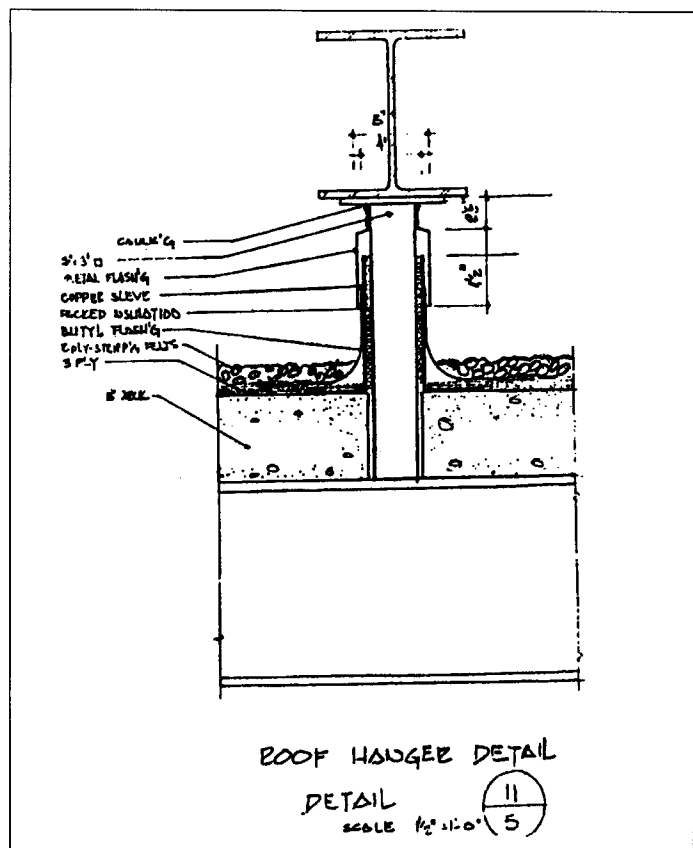
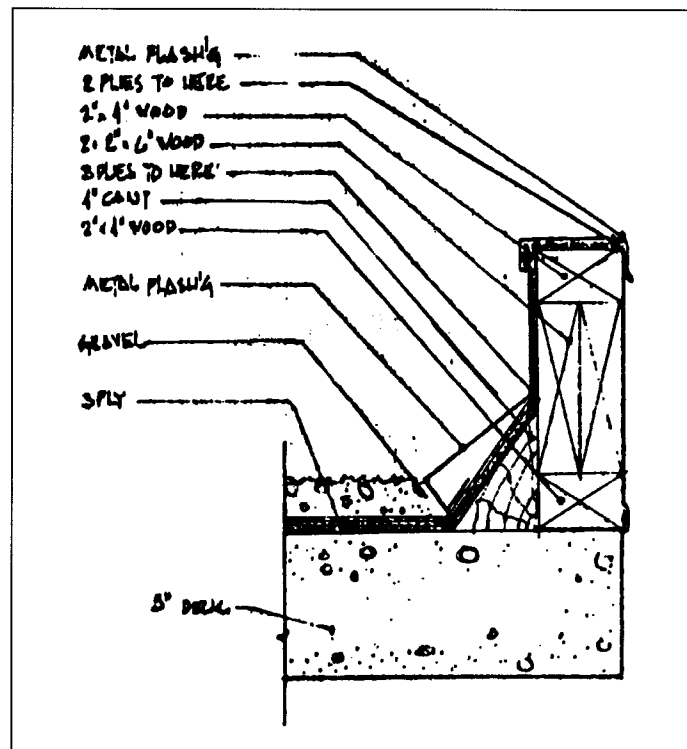
The engineer determined that the exterior structural elements were in good condition, but that the roof membrane was severely blistered throughout the areas of the arena and swimming pool. In addition to the blistered membrane, portions of the precast roof deck panels had spalled off, exposing their steel reinforcing wires. Discussions with building staff also revealed that a section of the roof deck had "fallen

out" in 1986 and had to be replaced. It was also observed that steel cross members (welded to the purlins) were installed in areas where the precast deck appeared weak (cracks and deflection) in both the arena and the pool areas.
