# PROTOCOL FOR ASSESSMENT OF HAIL-DAMAGED ROOFING

TIMOTHY P. MARSHALL and RICHARD F. HERZOG

Haag Engineering  
Carrollton, Texas, U.S.A.

A protocol has been developed for assessing hail-impact damage to steep-slope roof systems. The protocol includes a definition of hail-caused damage to roofing, a detailed field inspection procedure, and a calculation method for determining repair or replacement of hail-damaged roofing materials based on economics. This paper limits its discussion to asphalt shingles and wood shingles and shakes, although the general principles can be applied to other steep-slope roof systems. Hail damage is quantified by examining test areas on directional roof slopes to determine the number of damaged shingles/shakes per roofing square. The difficulty in making roof repairs is incorporated via a repair difficulty factor. Finally, the decision to repair or replace hail-damaged roofing is made on an economical basis by comparing expected costs to remove damaged shingles/shakes versus costs to replace roofing on entire slopes.

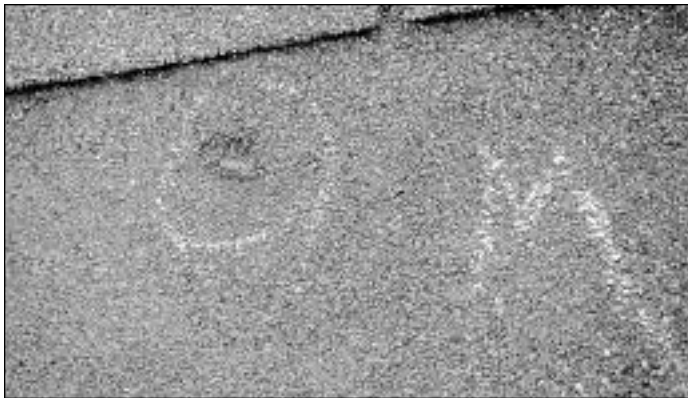
Figure 4. Marring of a composition shingle surface from mechanical abuse.

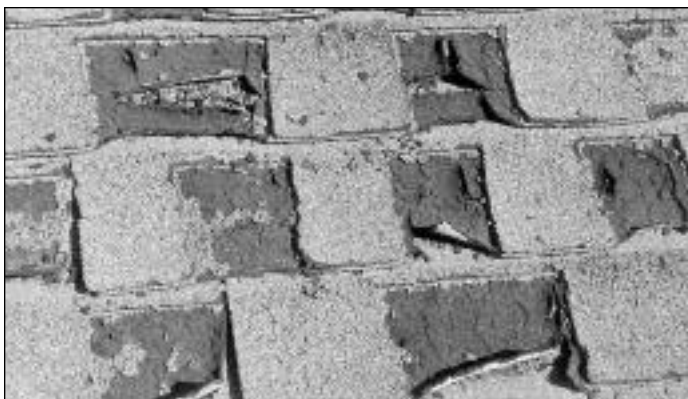
Figure 5. Delamination and flaking of the tack coat and granules because of material deficiencies.

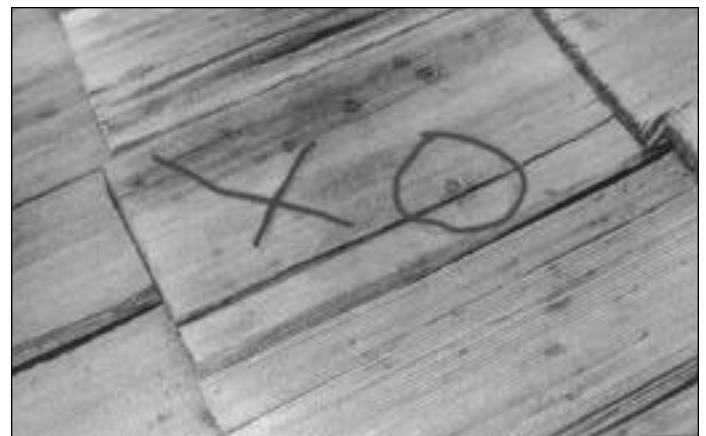
Figure 6. Hail-caused split in a cedar shake with the impact mark circled.

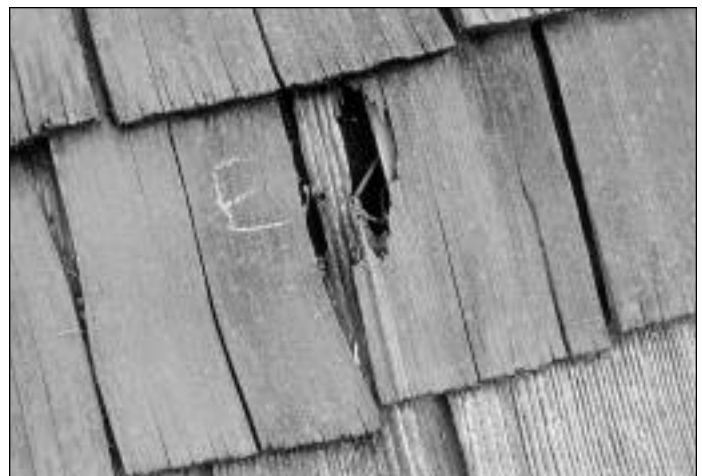
Figure 8. Eroded opening in a cedar shake.

Hail-caused punctures in a wood shingle or shake are discernible because sharp-edged openings expose unweathered wood of the underlying shingle or shake. Additionally, there still may be pieces of wood broken away by impact along the edges of the opening. Openings due to long-term water erosion, on the other hand, are contrasted by having smooth edges and thin wood around the opening. The eroded openings most commonly form just below the overlying butt of a shingle or shake or in the upper portion of the joint between shingles or shakes (Figure 8). The wood exposed on the underlying shingle or shake will be a weathered gray similar to other exposed areas of the wood. It can take approximately six to 12 months of exposure to weather, or oxidize, cedar from orange to gray. Areas that have an eroded opening often will have a comblike appearance, where the denser winter wood remains and the less dense summer wood has eroded.
